# SAN FRANCISCO PLANNING DEPARTMENT

**MEMO**

**DATE:** November 9, 2011  
**TO:** Historic Preservation Commission  
**FROM:** Rich Sucre, Historic Preservation Technical Specialist, (415) 575-9108  
**REVIEWED BY:** Tim Frye, Preservation Coordinator, (415) 575-6822  
**RE:** **Review and Comment**  
**850-870 Brannan Street**  
**Case No. 2011.0583B**

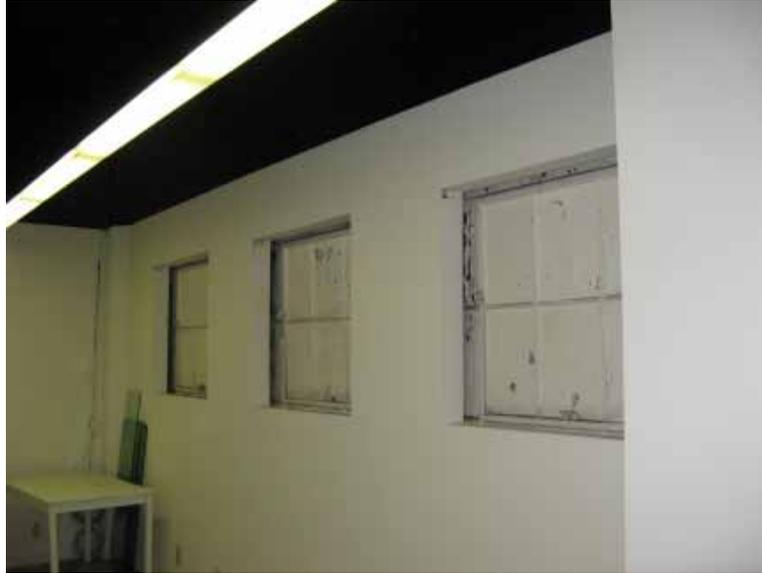
Figure 6: Interior finishes covering window except operable vents (Brannan St.)

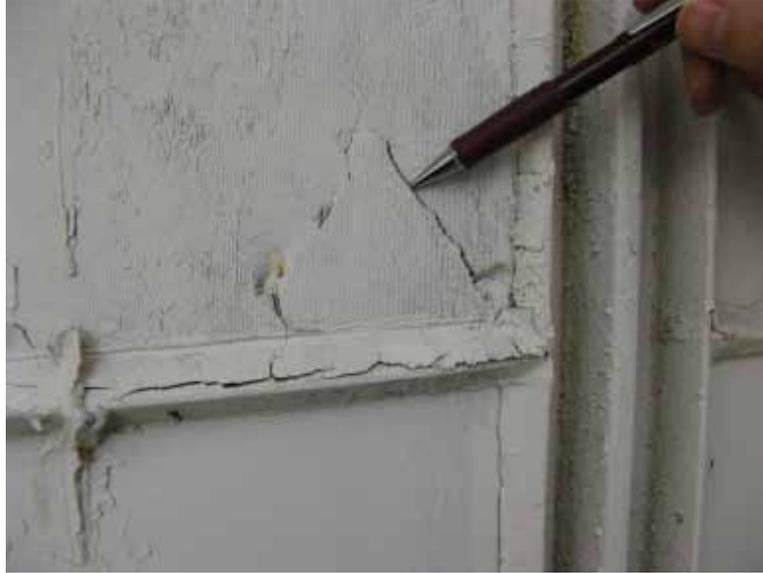
Figure 7

**Cracked Glass:** Despite being obscured with paint coatings, a high percentage of broken glass was observed throughout the building (refer to Figure 7). The proportion of cracked individual lights varies from window-to-window with the maximum number of cracked lights observed in an individual window was 16 (or 18-percent of glass panes) on the Brannan Street elevation and 13 (or 14 percent of glass panes) on the Eighth Street elevation. We conservatively estimate that 5-percent of the glass lights are cracked or broken, which represents over 400 broken panes.

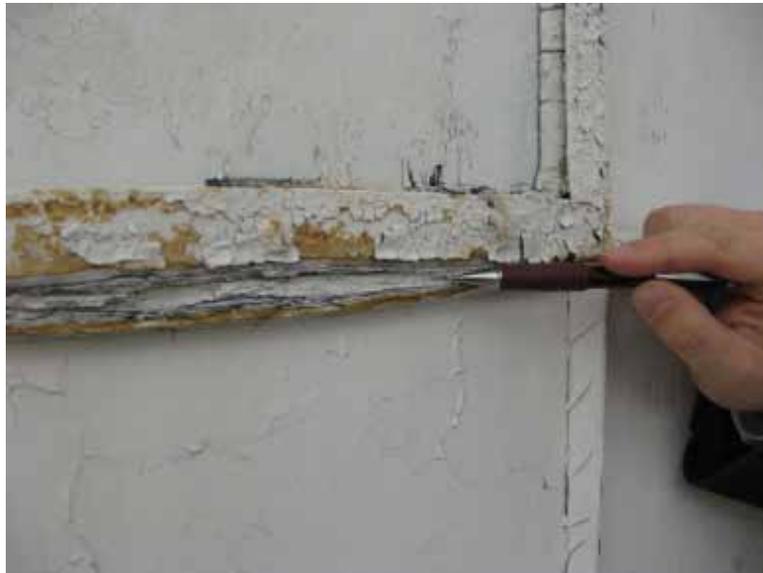
**Steel Corrosion and Warping of Steel Frame:** Steel corrosion varying from mild (or surface) to heavy is present on the window frames throughout the primary facades. The rust product of steel corrosion can take up to 10 times the volume of unaffected steel. Commonly called “rust jacking”, this expansion can create significant stress levels within material adjacent to the corroding steel. At 888 Brannan Street, heavy corrosion of steel frame members is resulting in distortion and warping of the frame. This condition was frequently observed at the bottom rail of the operable ventilator (as shown in Figure 8) where rain water can collect if the window is not properly closed or sealed (refer to Figure 9). The warping frame makes it that much more difficult to close and seal the ventilator, exacerbating the problem. We estimate 50-percent of sashes are experiencing heavy levels of corrosion.

Figure 8; Corrosion leading to deformation of the steel window frame (Eight St.)

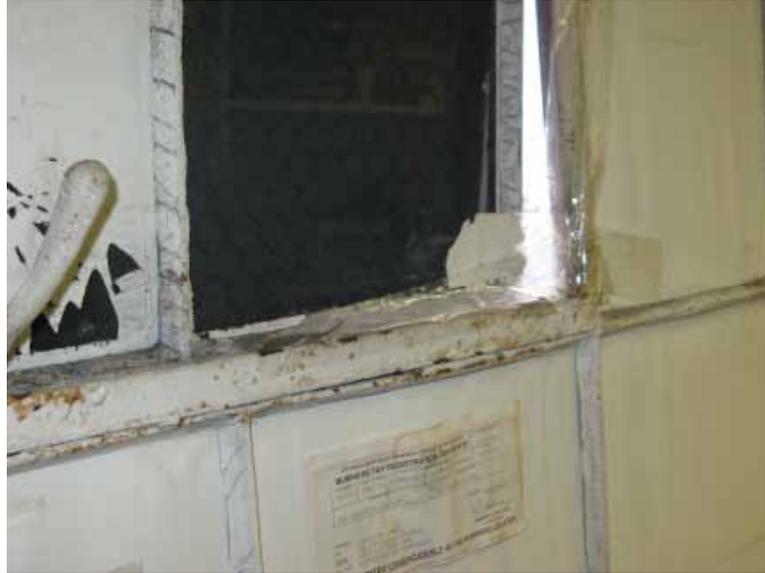
Figure 9: Warped ventilator no longer closes properly (Brannan St.)

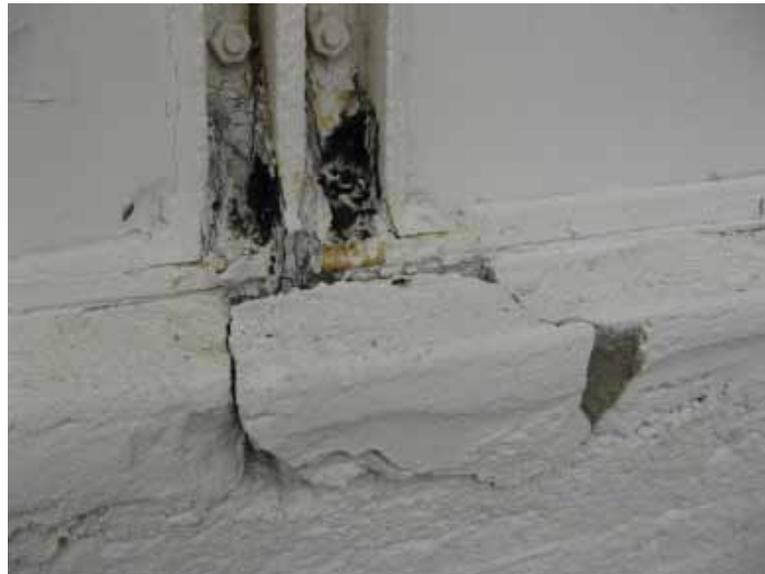
**Steel Corrosion and Concrete Spalling:** Steel corrosion of the window frame and the vertical structural “T” section ganging the sashes has led to the cracking and spalling of the interior concrete sill below the frame (as shown in Figures 10 & 11). While the majority of the interior concrete sills are hidden by interior finishes, cracking and/or spalling of the concrete was observed at all exposed sills within our survey area. At several locations, it appeared as if previous repair attempts had been made to the concrete only to fail again. The concrete deterioration appears endemic to the building interior. The concrete deterioration was not observed at the building exterior.

Figure 10: Concrete spalling at structural steel “T” (Eight St.).

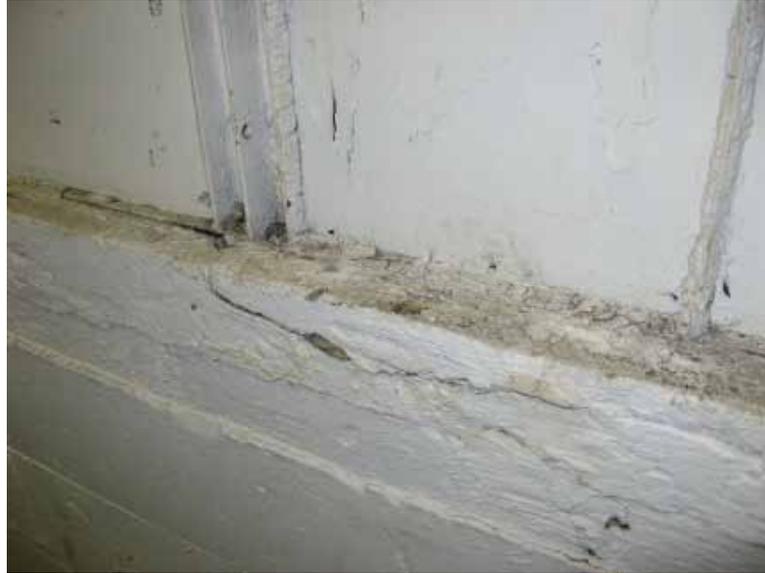
Figure 11: Concrete spalling due to steel "T" corrosion (Brannan St.).

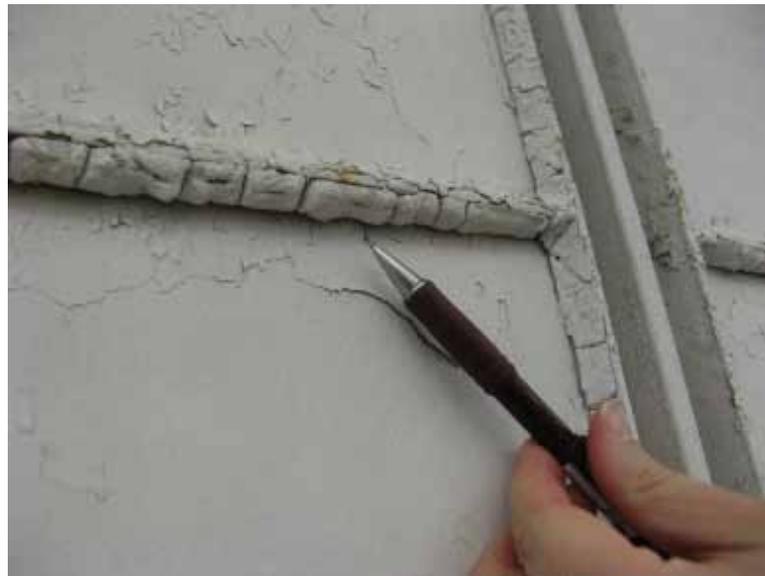
Figure 12

**Deteriorated Window Putty:** The interior window putty is heavily cracked and deteriorated (as shown in Figure 12). Corrosion of the steel frame underneath the putty is likely accelerating the rate of deterioration. 100-percent of the observed putty requires removal and replacement. Occasionally putty had fallen away to reveal wire glazing clips

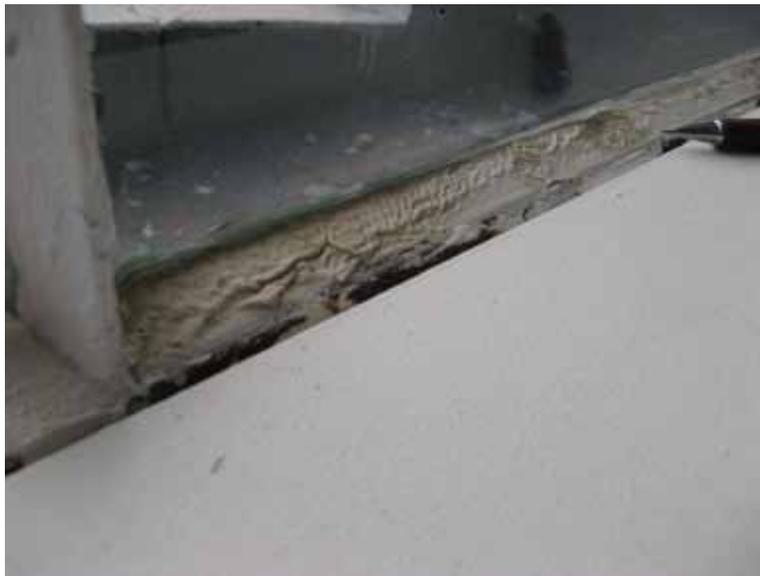
- Rehabilitation work was performed several months ago and the portions of the putty had not yet set to “thumbprint” hardness.
- Putty work is generally sloppy (refer to Figure 14).
- Steel corrosion is on-going and new putty is already rust-stained (refer to Figure 15).
- It did not appear that any attempt was made to straighten deformed/warped steel framing (refer to Figure 16). Ventilators remain difficult to operate and close securely.
- No attempt was made to replace missing muntins.

Figure 14: Sloppy putty work.

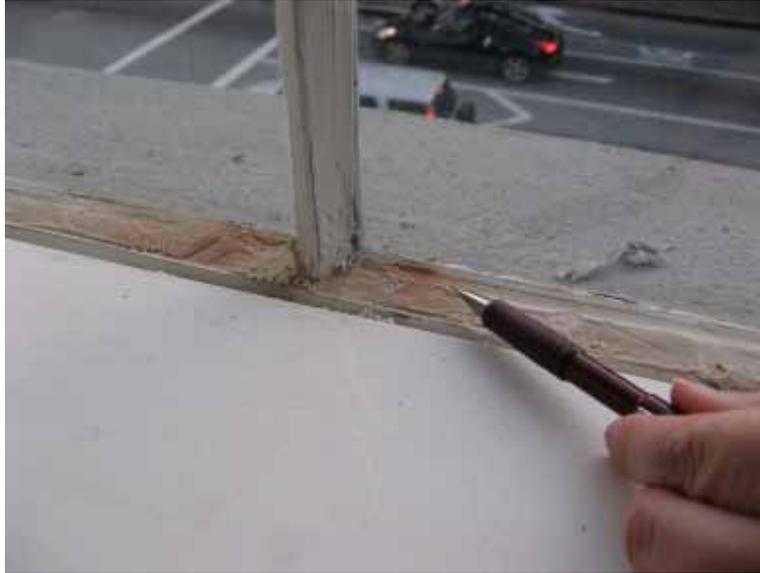
Figure 15: Rust stained putty.

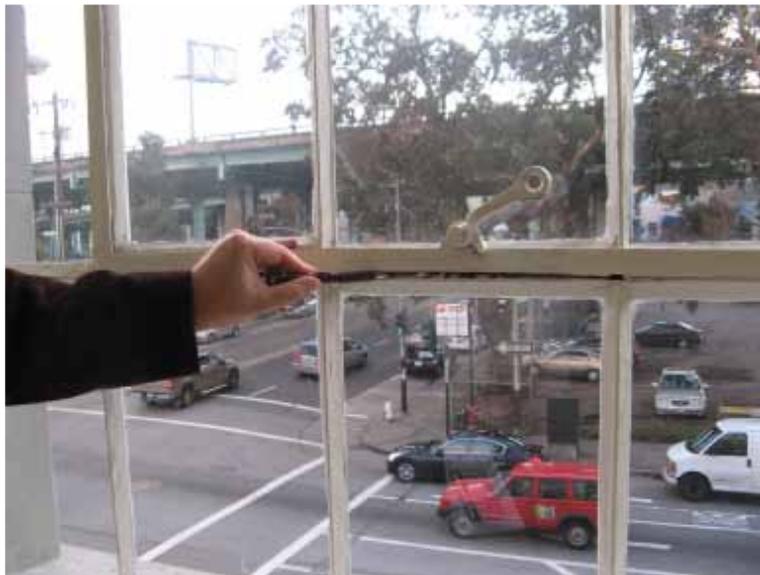
Figure 16: Deformed Frame.
