SAN FRANCISCO PLANNING DEPARTMENT

Certificate of Appropriateness Case Report

HEARING DATE: JULY 6, 2011

Filing Date: June 13, 2011
Case No.: **2011.0613A**
Project Address: **130 Sutter Street**
Historic Landmark: No. 37 – The Hallidie Building
Zoning: C-3-O (Downtown Office)
80-130F Height and Bulk District
Block/Lot: 0288 / 027
Applicant: Bruce Albert, The Albert Group
114 Sansome Street, Suite 710
San Francisco, CA 94104
Staff Contact Sophie Hayward - (415) 558-6372
sophie.hayward@sfgov.org
Reviewed By Tim Frye – (415) 575-6822
tim.frye@sfgov.org

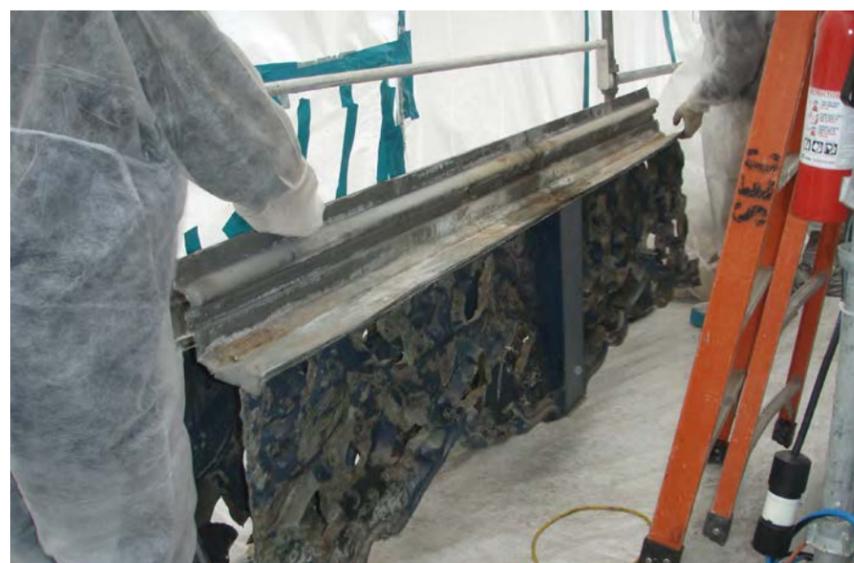
Decorative sheet metal is being removed where there are existing seams

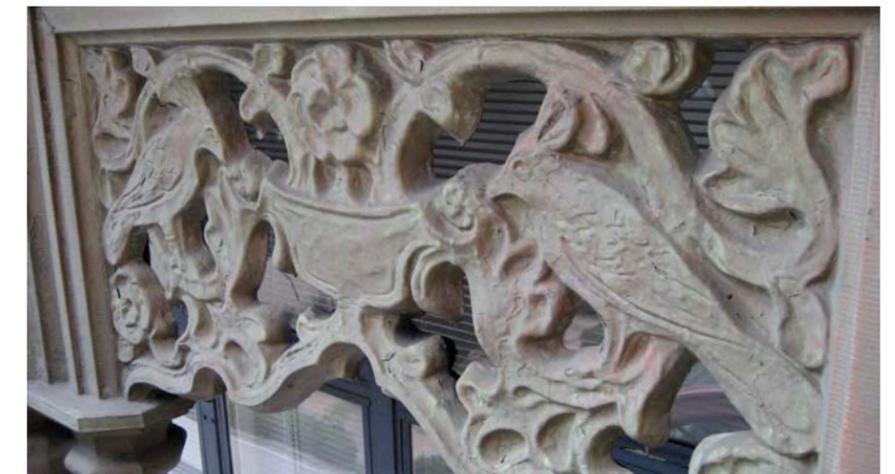
Decorative sheet metal below balconies

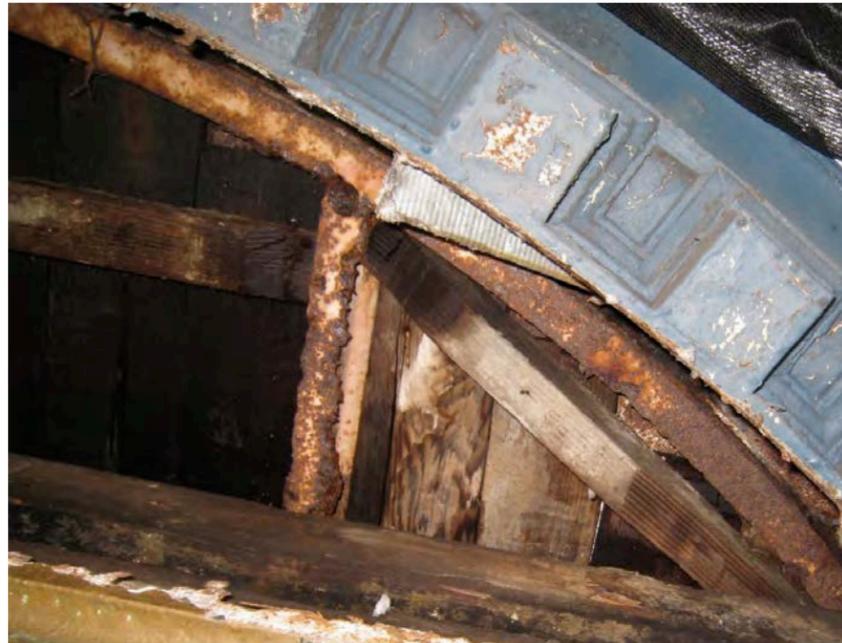
Deterioration at steel framework supporting a balcony

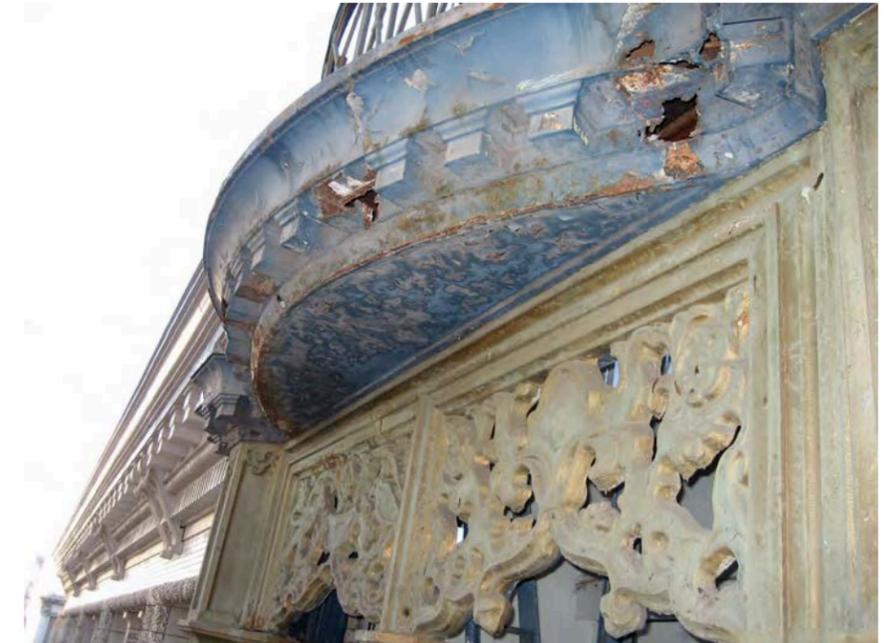
Deterioration at decorative sheet metal

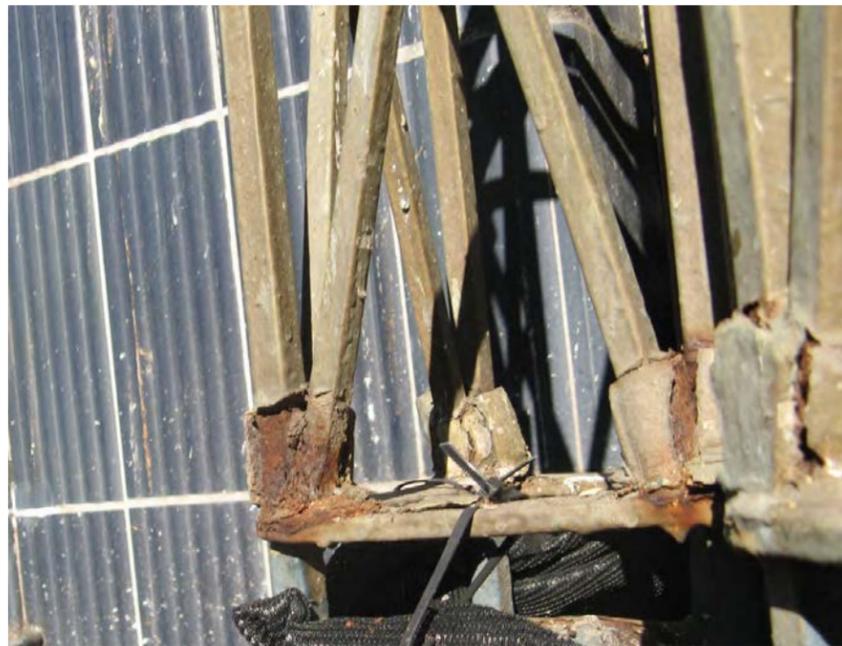
Deterioration at iron railings

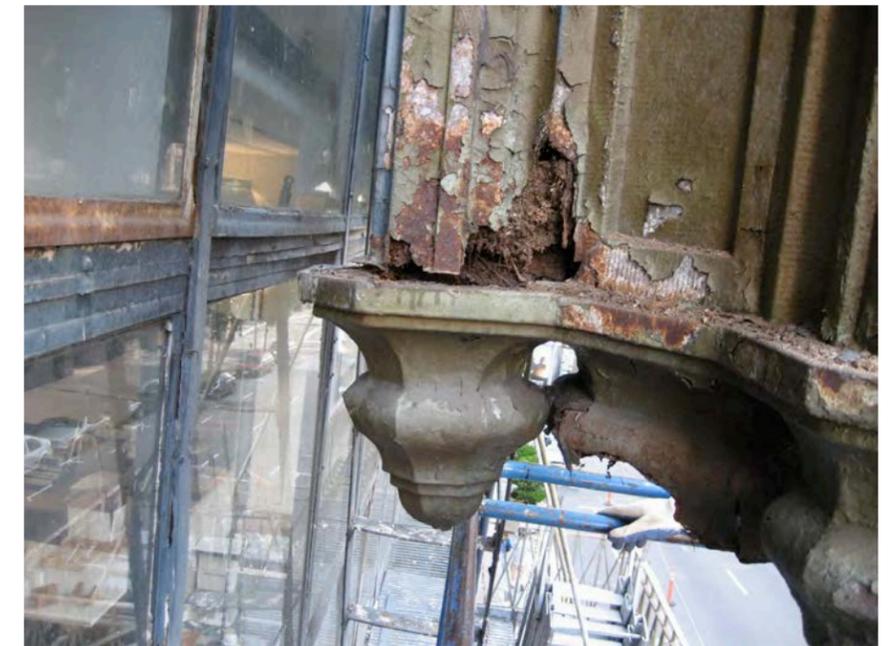
Deterioration at decorative sheet metal

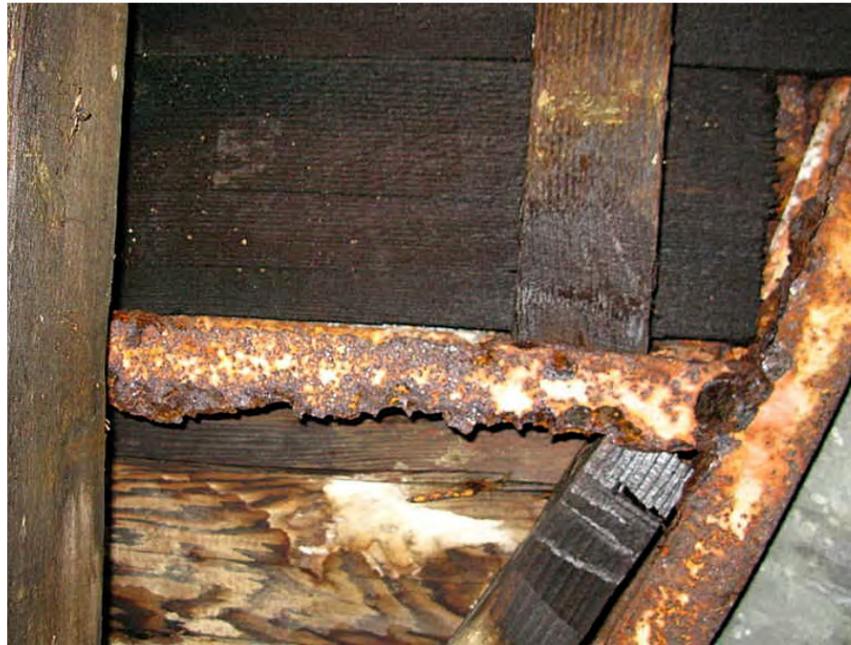
Deterioration at structural framework

The structural steel framework that supports the balconies and decorative sheet metal consists of small steel “I” beams that exhibit extensive corrosion. The framework will be replaced with beams similar in shape and size. “I” beams currently available are not identical in size as the original. However, any difference in size will be minimal and will not be noticeable from the public right of way.

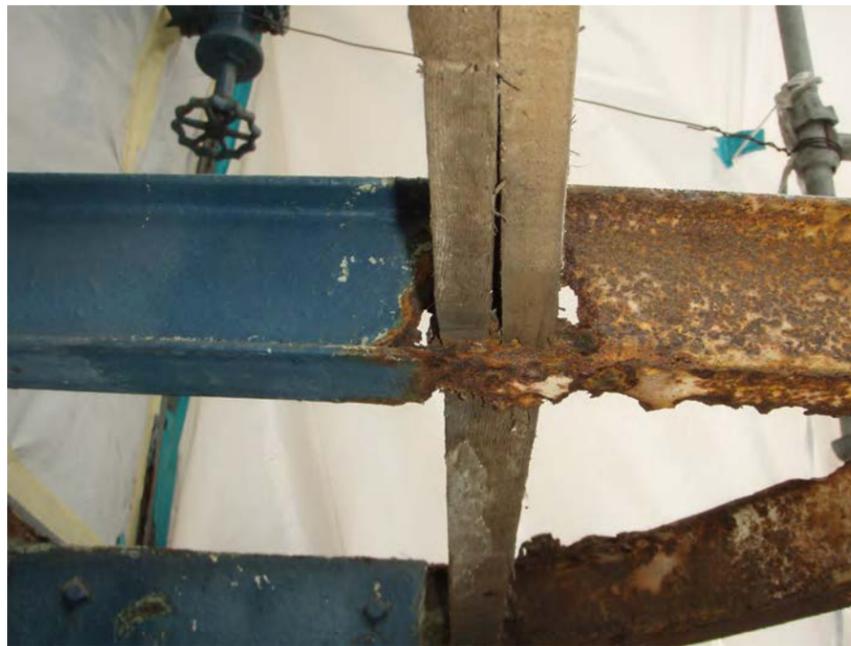
Deterioration at structural framework

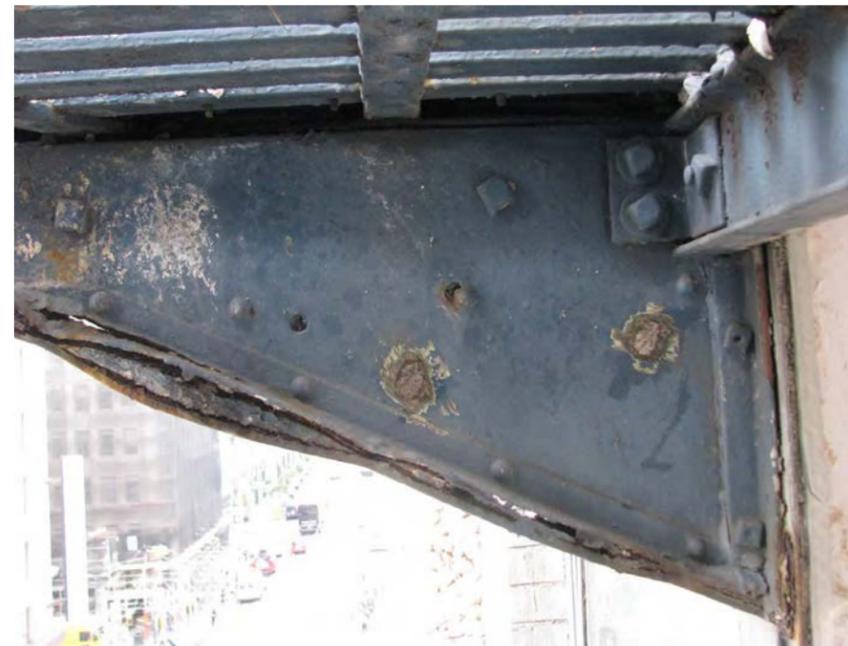
Deterioration at structural outrigger

5. **Structural Steel Framework Repair.** Much of the exposed structural steel framework that supports the cornice and sheet metal panels has deteriorated. The steel outriggers that tie the sheet metal panels back to the building will be removed (down to the level of sound steel) and replaced with new framework similar to the original.

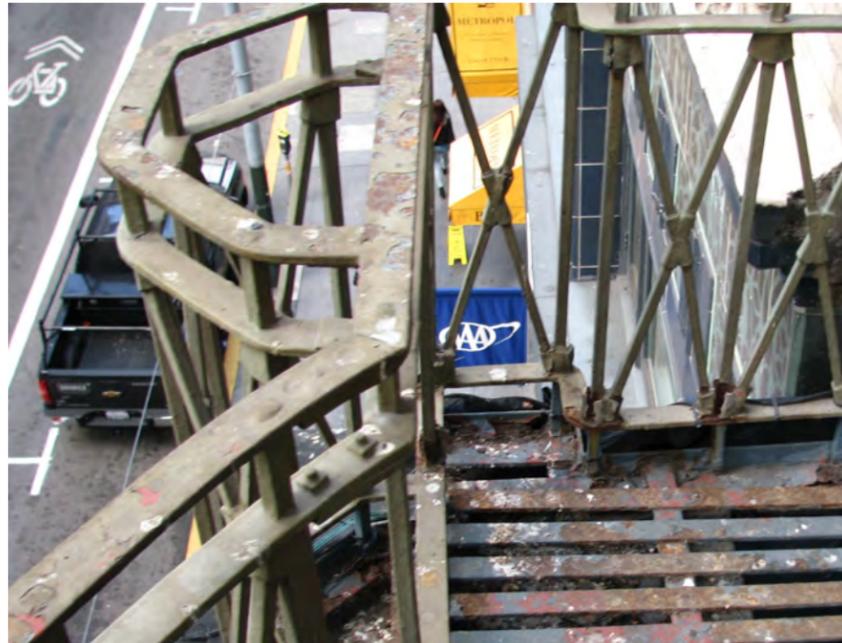
Deterioration at railings

The railings and balconies consist of simple iron flat steel bars at the floor of the balconies and square iron pickets. Where elements have deteriorated beyond repair, they will be replaced in kind. Repairs to the iron railings will include the removal of rust, in-kind replacement of elements deteriorated beyond repair, and painting. The railings have brackets where the pickets cross. The original brackets were made of lead and many are in poor condition. These will be replaced in kind. The metal railings and balconies will be painted using original colors, blue and gold.

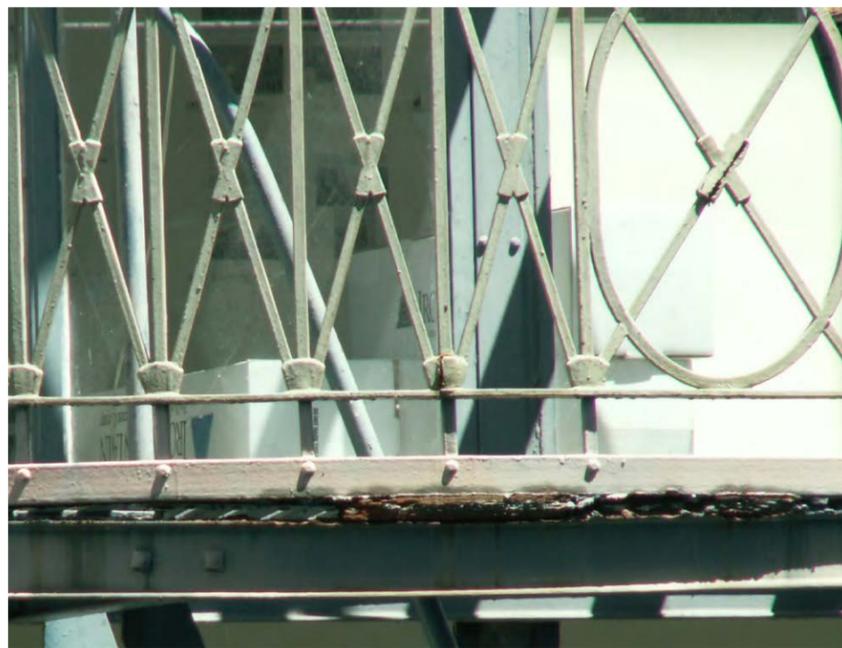
Deterioration at picket bracket

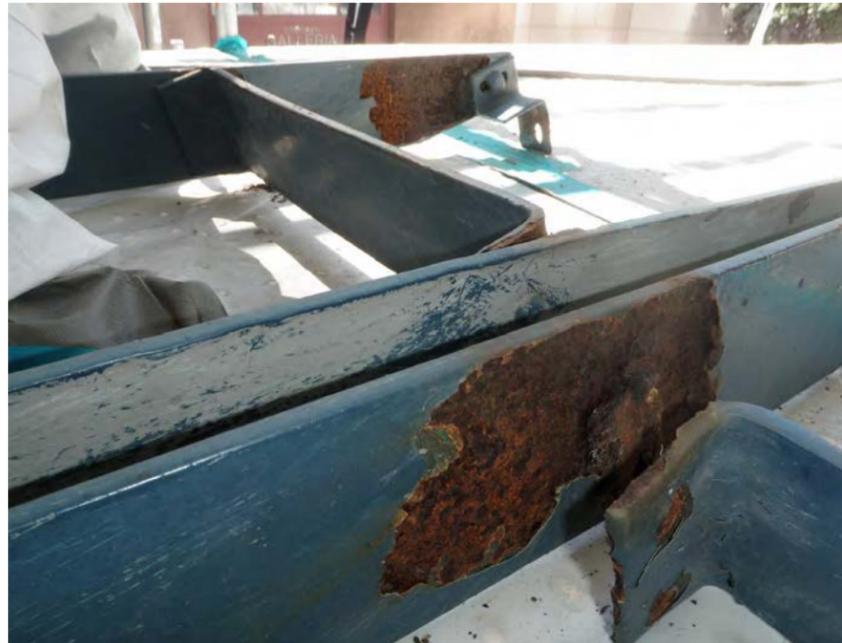
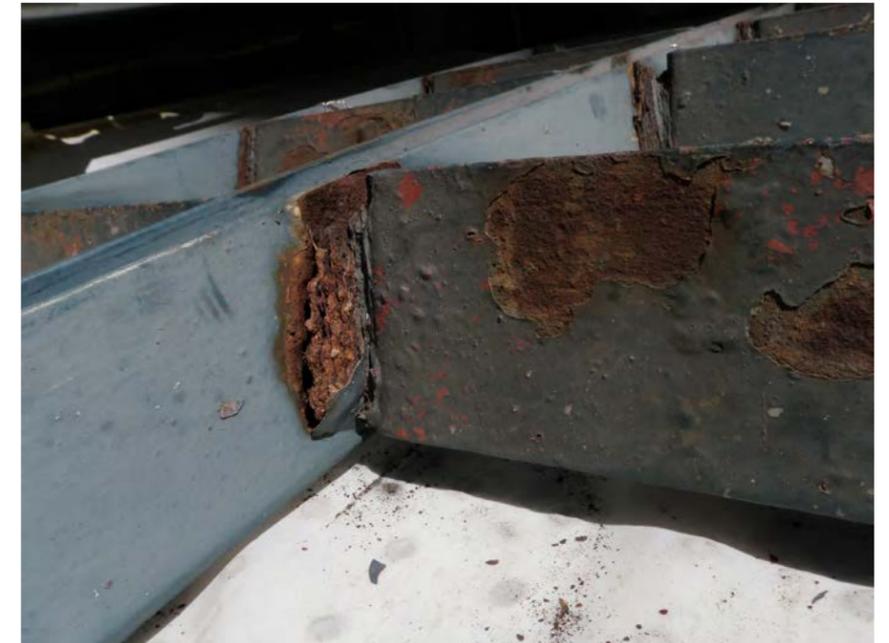
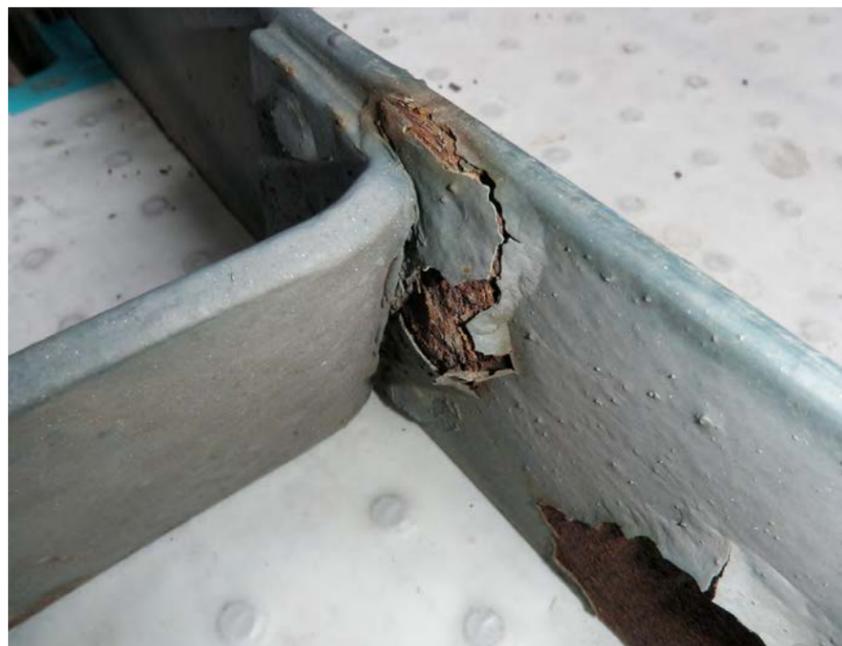
Deterioration at rung welded connections

The fire escape ladders are severely deteriorated at the rung welded connections. The ladders will be replaced with new ladders to match the existing ladders in color and material. The design will be similar except that the ladders rungs will be positioned so that they are able to shed water and therefore be less prone to deterioration. The new rungs will be supported by steel angles instead of relying only on a welded connection.

4. **Replacement of Fire Escape Ladders.** The steel fire escape ladders are severely deteriorated and are structurally unsound. The ladders will be replaced with new ladders to match the existing in color and material. The design of the new ladders will be nearly identical to the original, except that the rungs will be angled in order to shed water in order to prevent further deterioration.

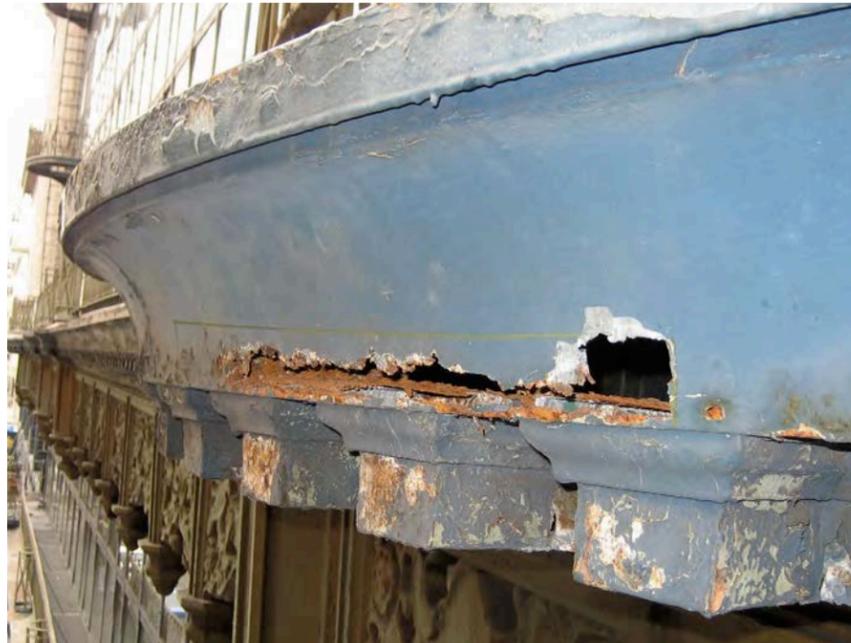
Deterioration at cornice

Sheet metal including the dentils, cornices, and back panels will be repaired. Where the extent of deterioration is beyond repair, the elements will be replaced in kind. The historic sheet metal cornices and dentils have a striated texture. This texture will be duplicated in the sheet metal used to replace these features.

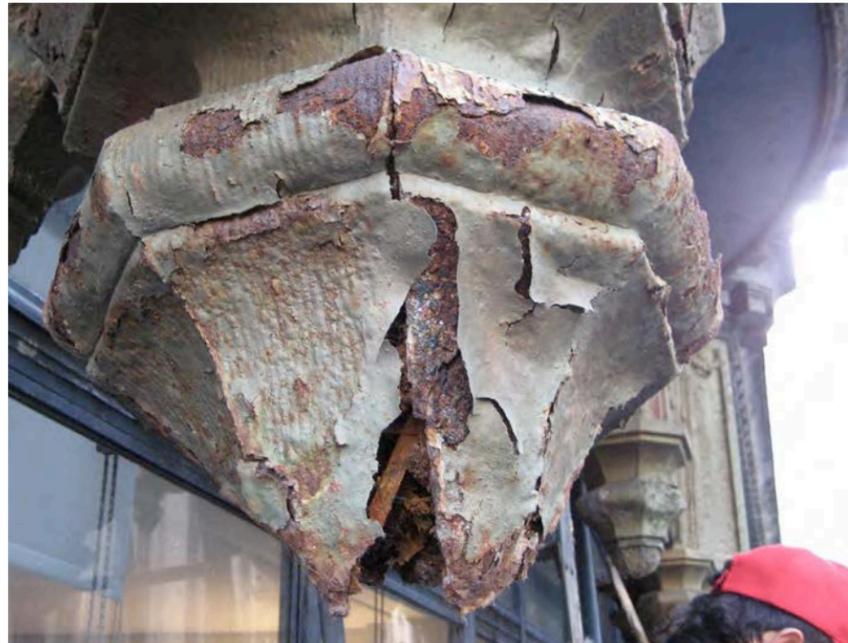
Deterioration at pendant

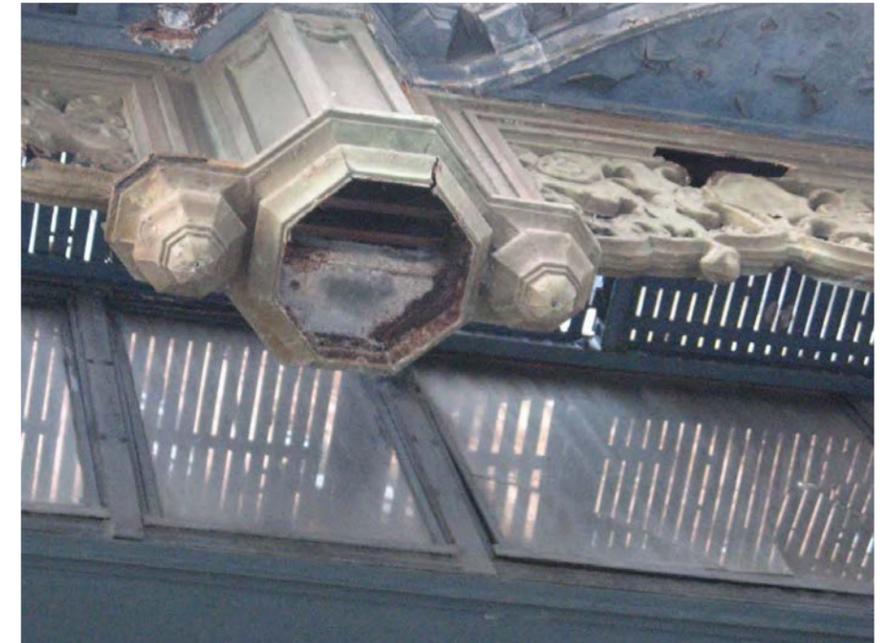
Missing pendant

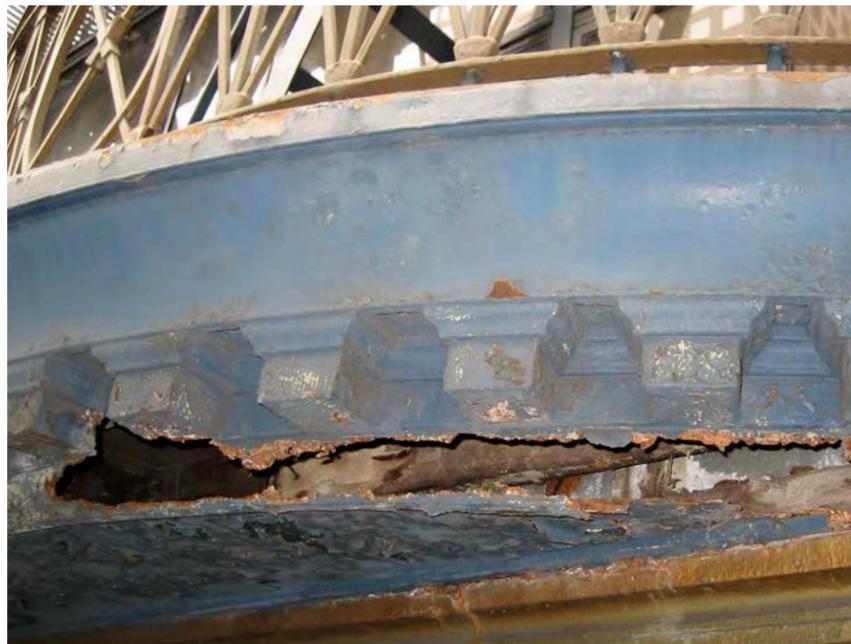
Deterioration at underside of balcony

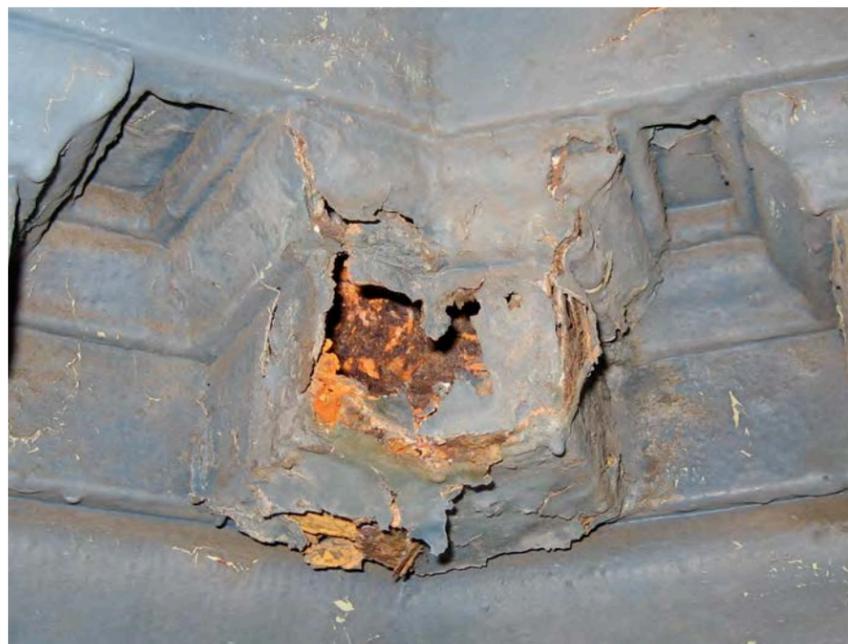
Deterioration at dentil

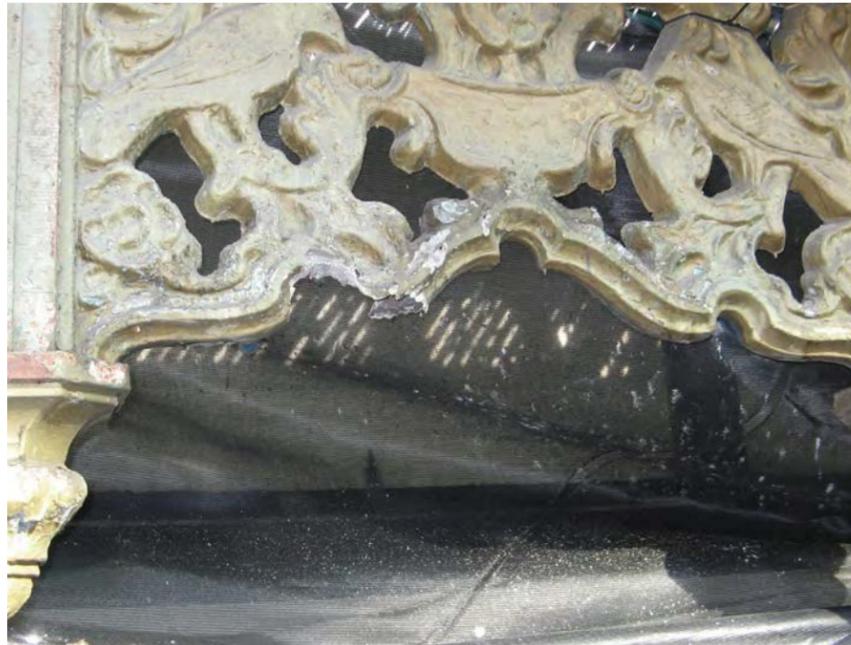
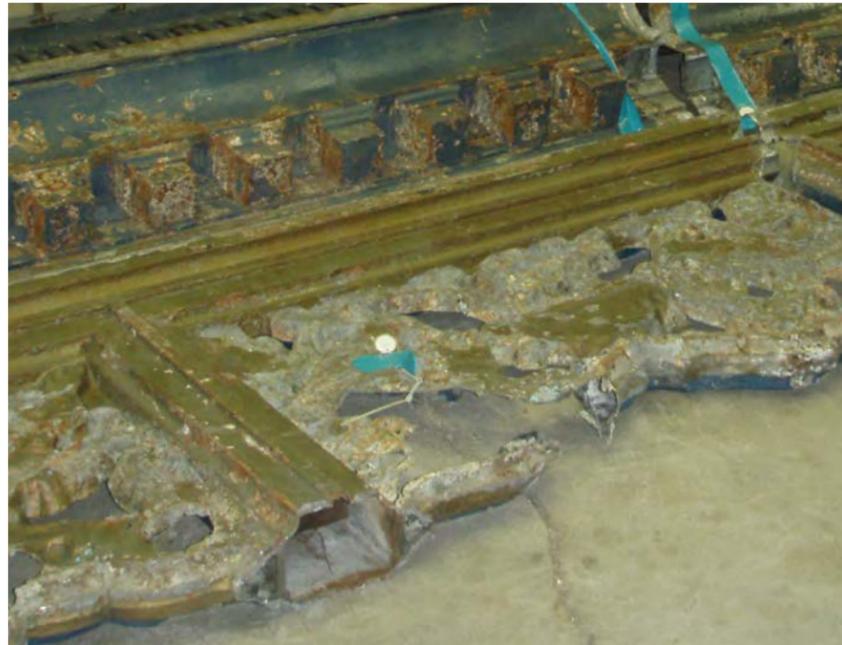
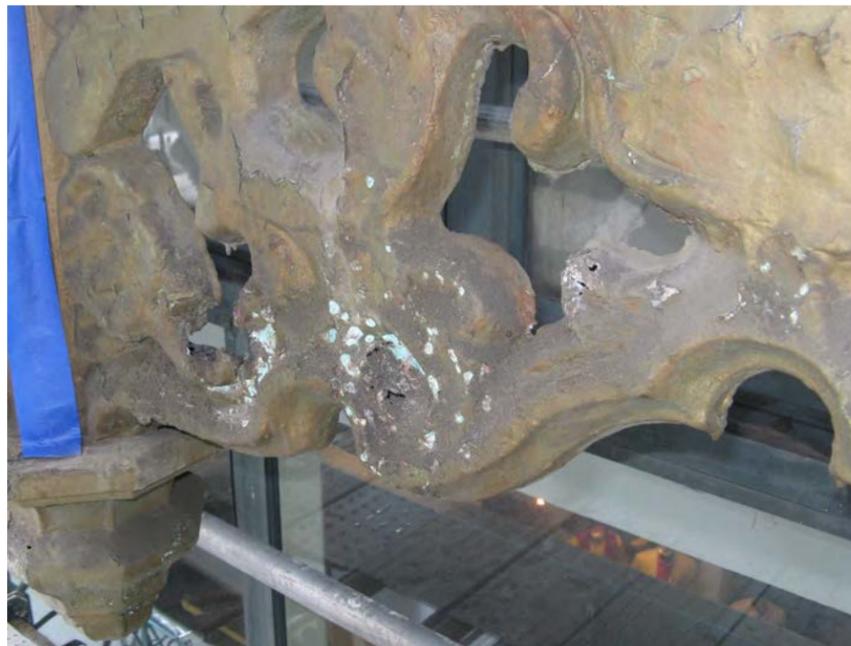
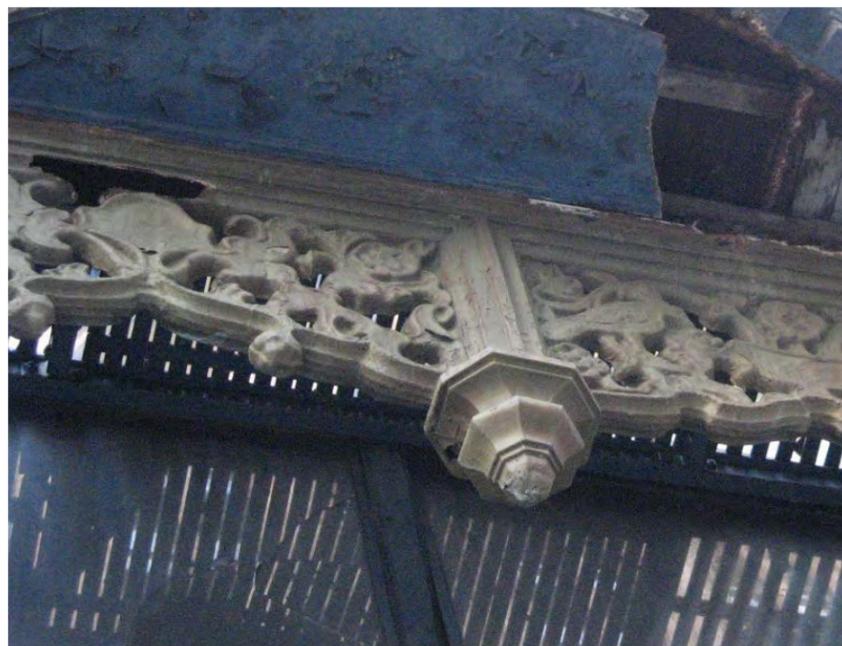
Deterioration at a frieze panel

The decorative sheet metal frieze panels will be stripped of old paint, repaired, primed with a rust-inhibiting primer, and painted. The frieze panels have varying amounts of deterioration including areas where the material is missing due to corrosion. The damage has been assessed and the proposed plan for repair is as follows:

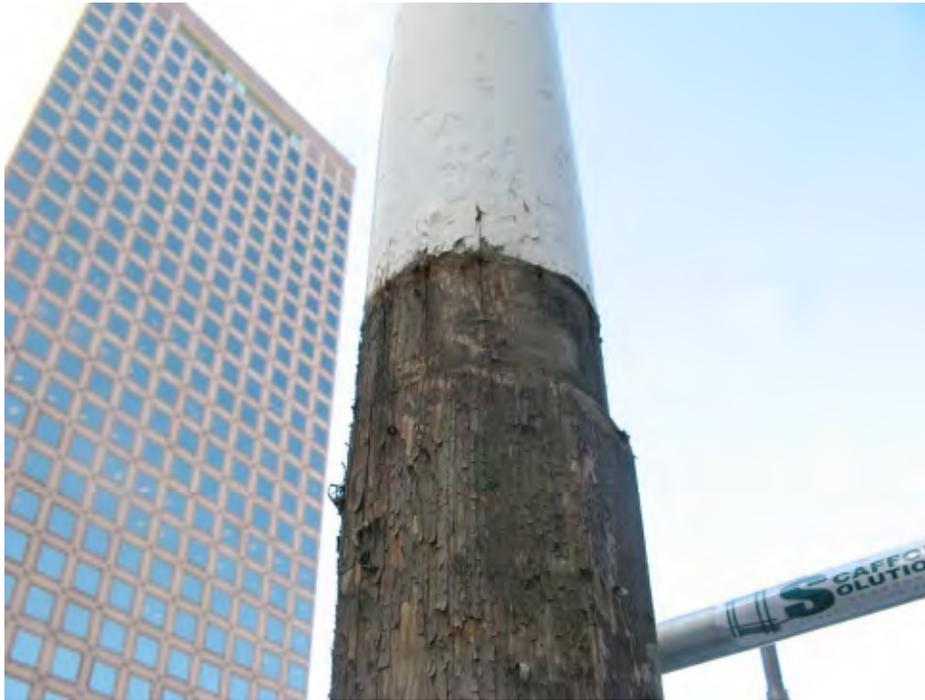
Figure 2: Detail of flagpole showing existing condition and color.

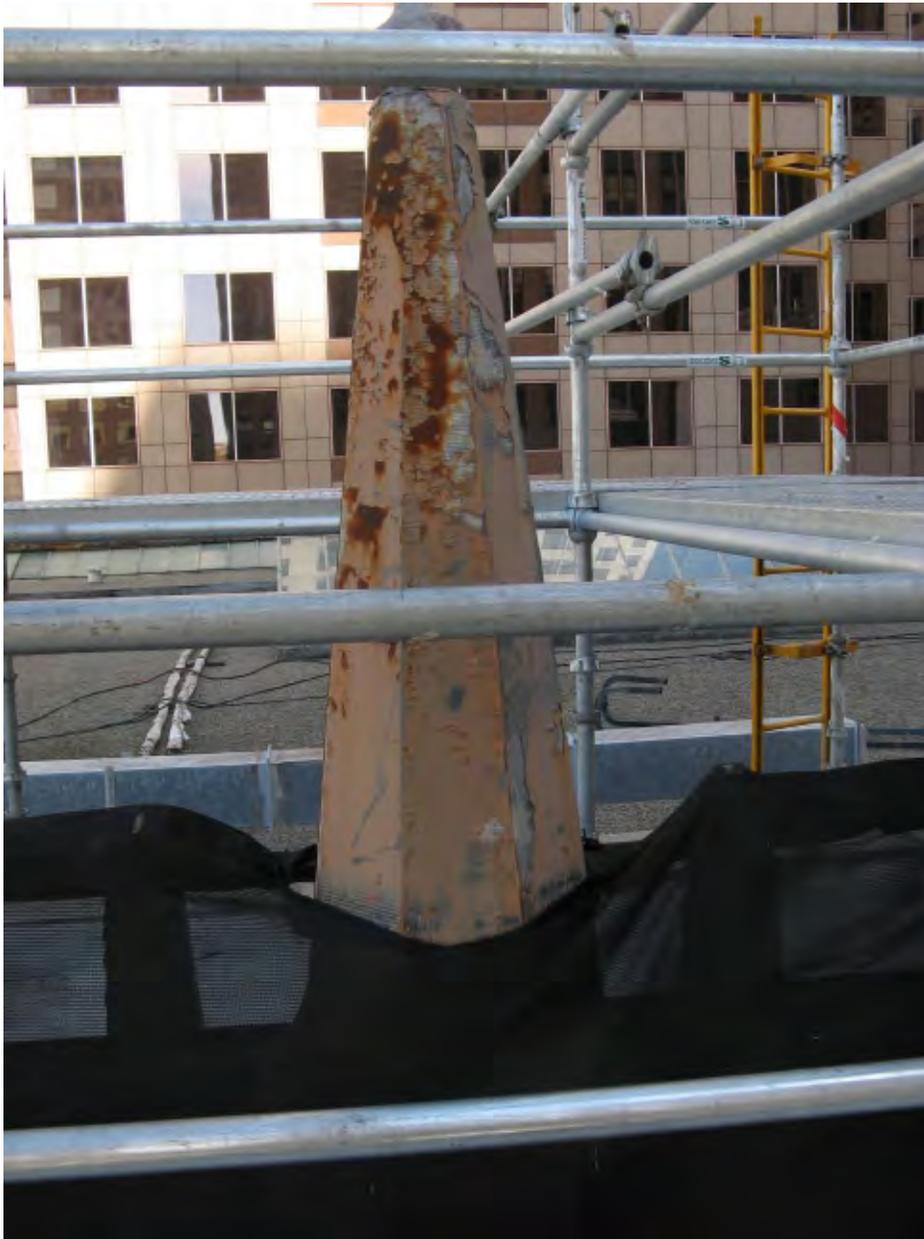
Figure 4: Spire at cornice showing existing condition and color.
