Discretionary Review Analysis Residential Demolition/New Construction

Date: May 3, 2012
Case No.: 2010.0636D / 2012.0259D
Project Address: 622 – 27TH AVENUE
Zoning: RH-2 (Residential House, Two-Family) District
 40-X Height and Bulk District
Block/Lot: 1569/031
Project Sponsor: Wah Wong
 622 – 27th Avenue
 San Francisco, CA 94121
Staff Contact: Glenn Cabreros – (415) 588-6169
glenn.cabreros@sfgov.org
Recommendation: **Do not take DR and approve demolition and new construction as proposed.**

The project is to demolish an existing three-story, single-family residence and to construct a new four-story, two-unit building.

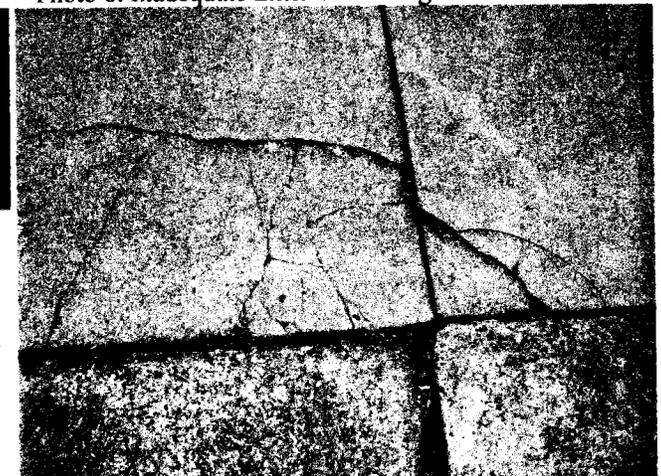
Photo 10: Damaged Driveway & Sidewalk Slab

24. Repair or replace broken and rusty gutters and downspout pipes and correct drainage slope for exterior concrete slab.
25. Repair or replace damaged concrete slab in garage and driveway.

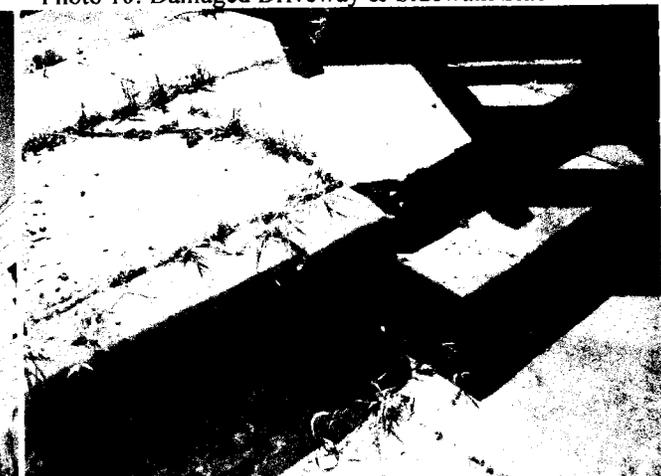
The small retaining wall and concrete patio at the back of the house are crack and falling apart.

Photo 12: Damaged Rear Concrete Patio

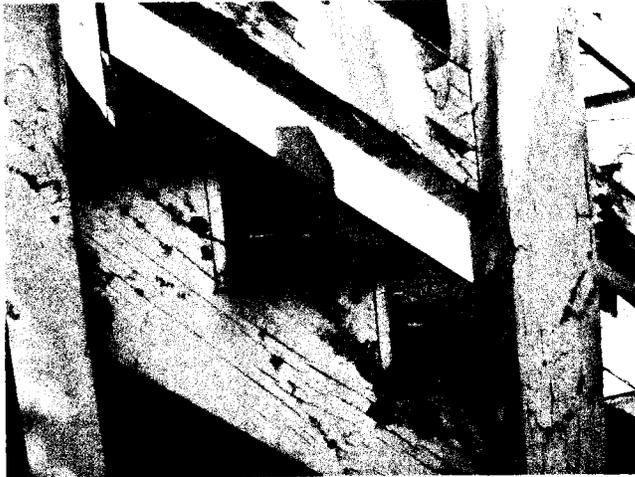
Both front and rear exterior stairs show signs of deterioration, dry rot, fungus and wood boring beetle damages. And the rear stairs and deck are not safe to use during the time of inspection.

Photo 13: Deteriorated Rear Stairs

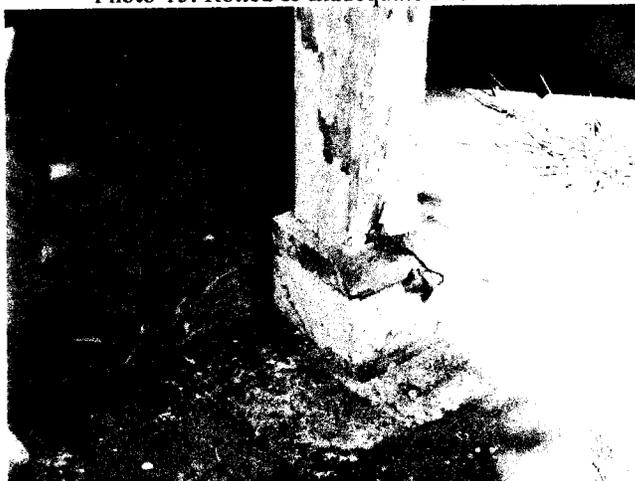
The foundation sill lacks of sill anchor bolts and property line walls are not constructed to be one-hour rated fire protection. There was no beam-post and post base connector throughout the entire level.

Photo 17: Inadequate Post Base Connection

1. Correcting lack of flashing.
2. Provide operable windows for entire house and repair damaged window framing.
3. Add sill plate and bolts to foundation, and add metal connectors to posts and beam-post connections.

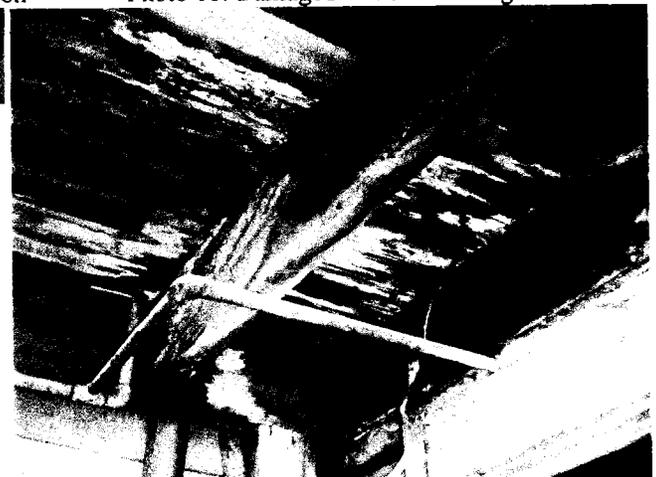
Photo 18: Rotted Laundry Room Floor Framing

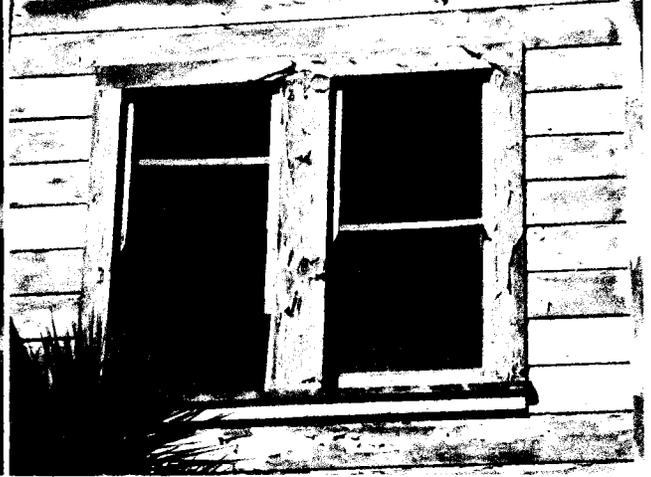
Photo 20: Damaged & Deteriorated Rear Windows

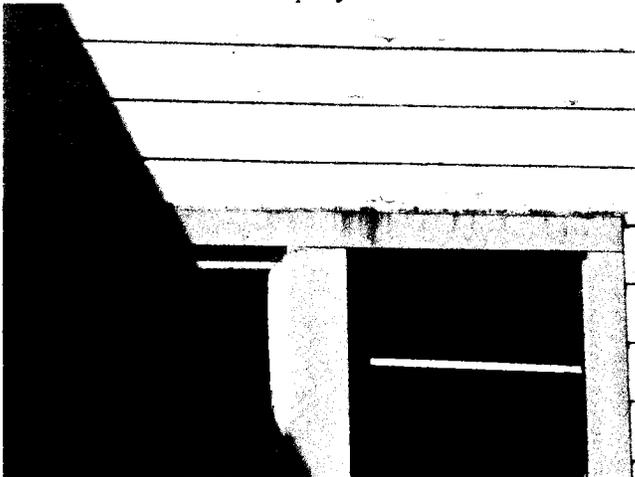
Photo 21: Rusted Window Flashing

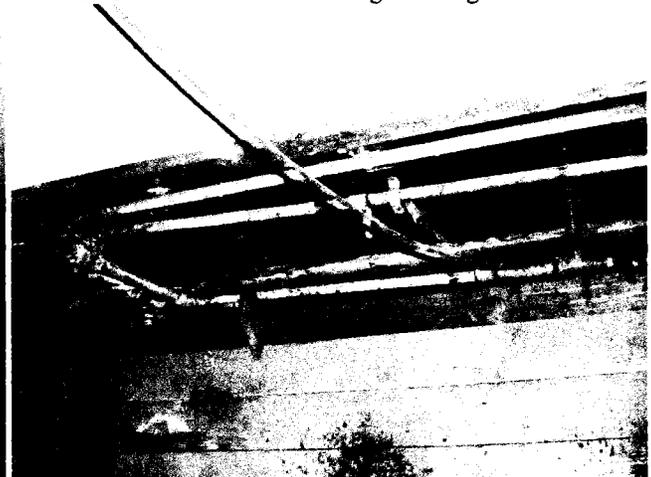
Photo 24: Rusted Pipes & Possible Mold on Garage Wall

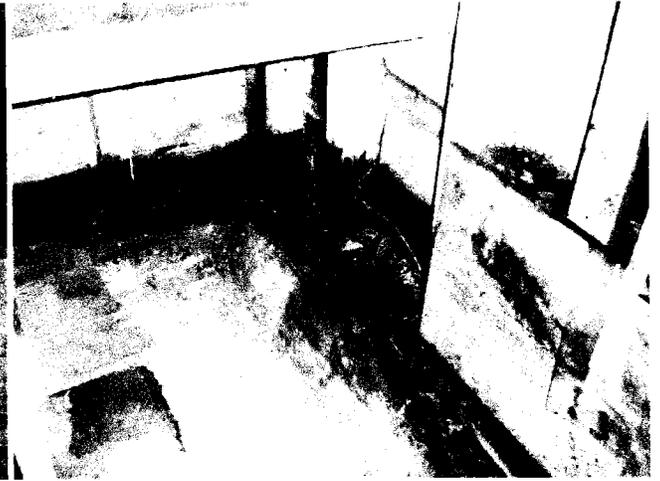
Photo 26: Rotted Wall Framing & Missing Sill Bolt

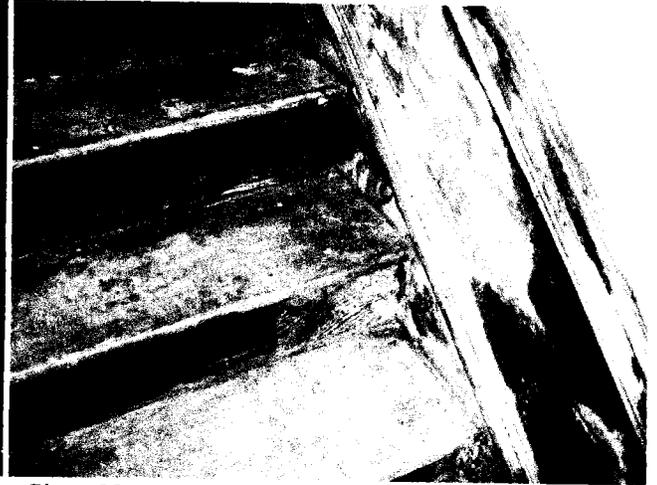
Photo 38: Wood Decay at Interior Stairs

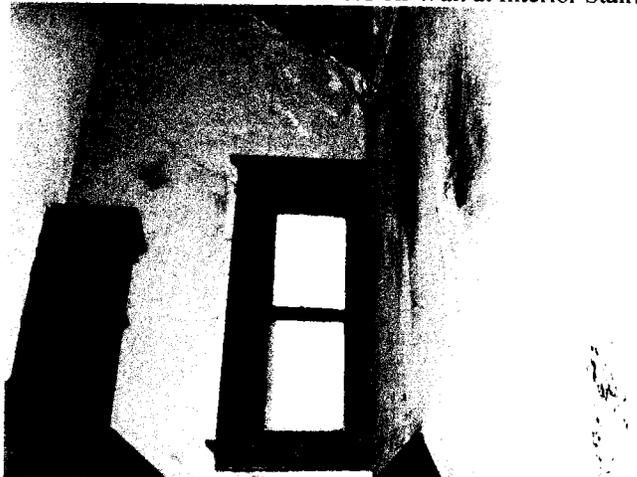
Photo 41: Wall & Ceiling Damage at Interior Stairs

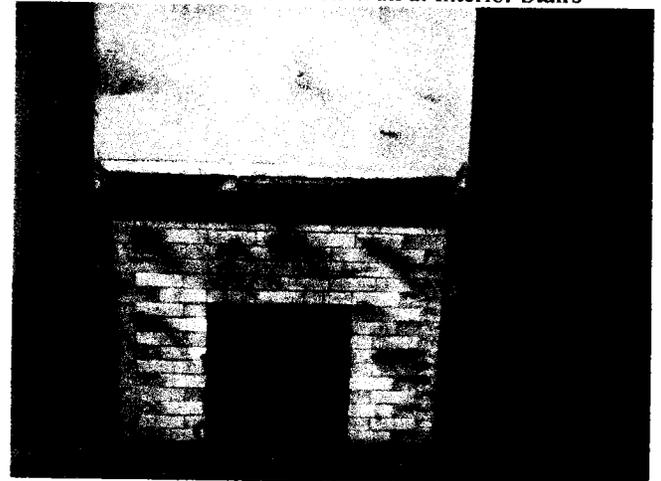
Photo 42: Fireplace Damage

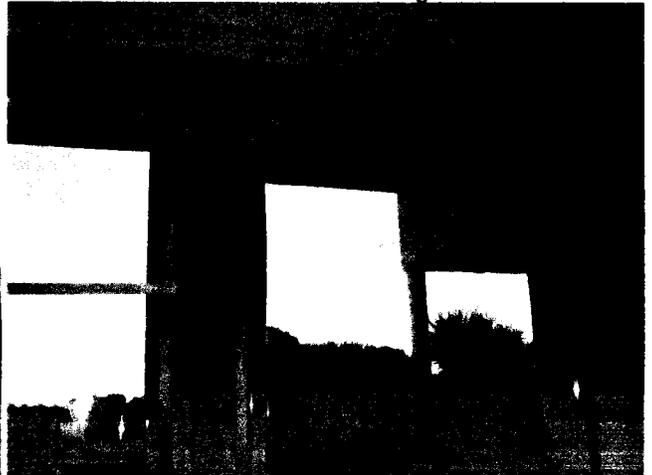
Photo 48: Cracks on Wall & Ceiling of Dining Room

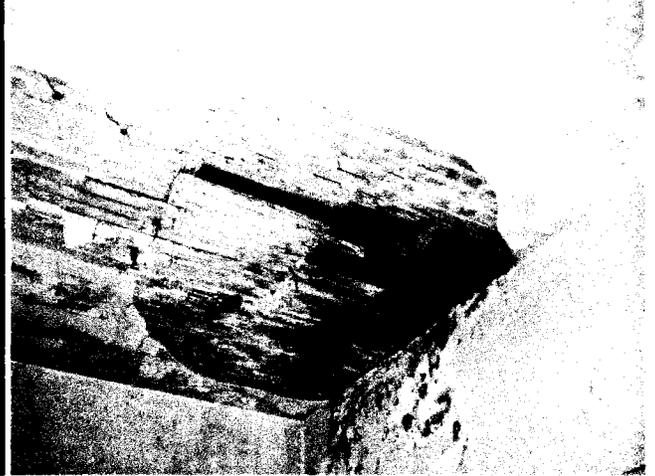
Photo 50: Wood Decay and Damage on Kitchen Ceiling

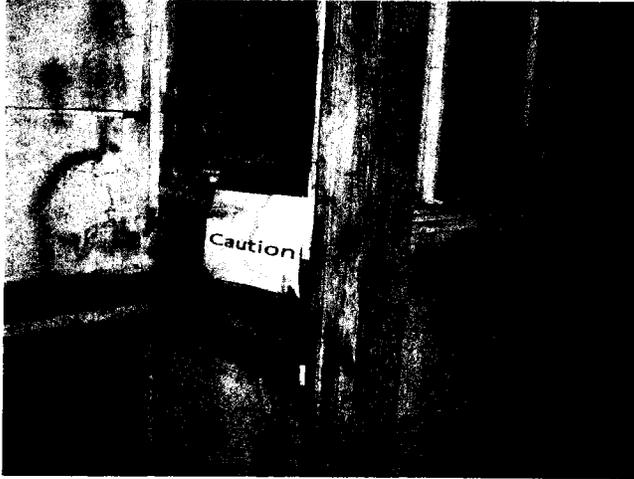
Photo 55: Wood Decay and Damage at Kitchen Window

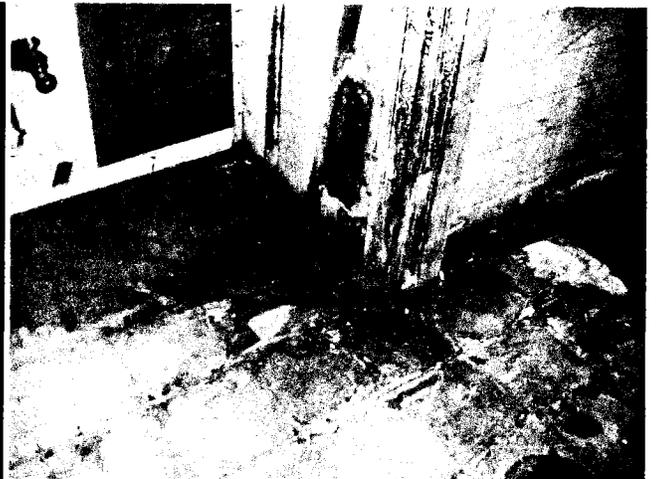
Photo 56: Wood Decay and Damage on Kitchen Floor2.

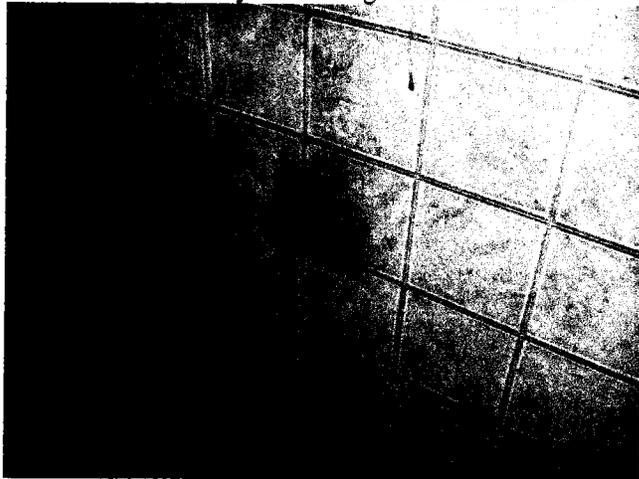
Photo 57: Non GFCI & Grounded Elec. Outlet in Kitchen

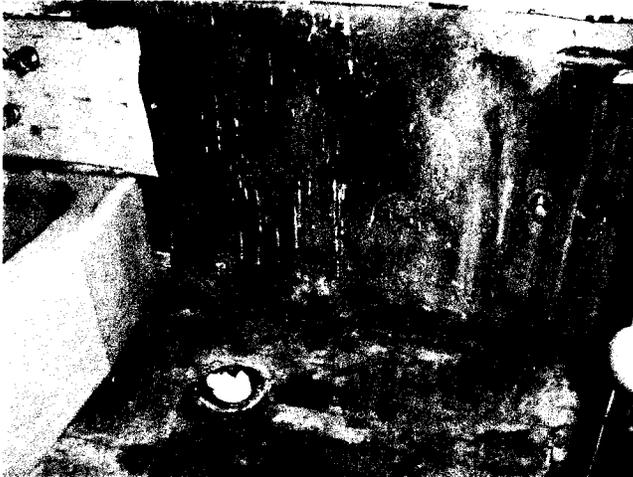
Photo 61: Missing Toilet & Molded Wall in Bathroom

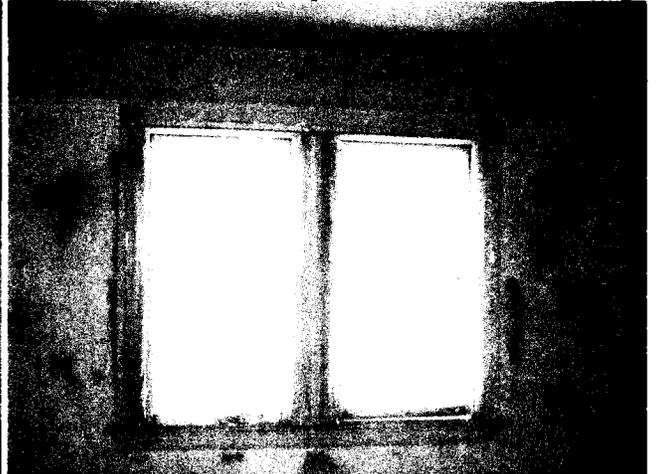
Photo 66: Damaged Windows in Front Bedroom

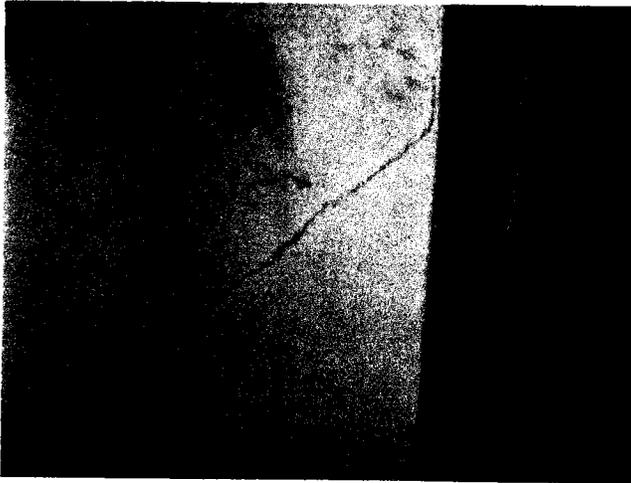
Photo 67: Damages on the Wall in Front Bedroom Closet

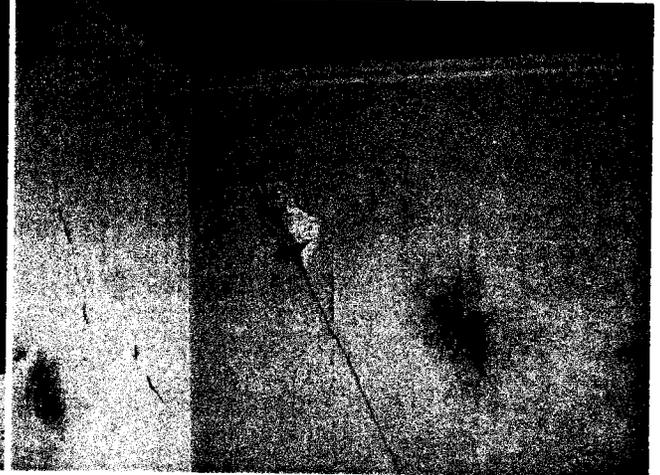
Photo 70: Damages & Cracks on Rear Bedroom Wall

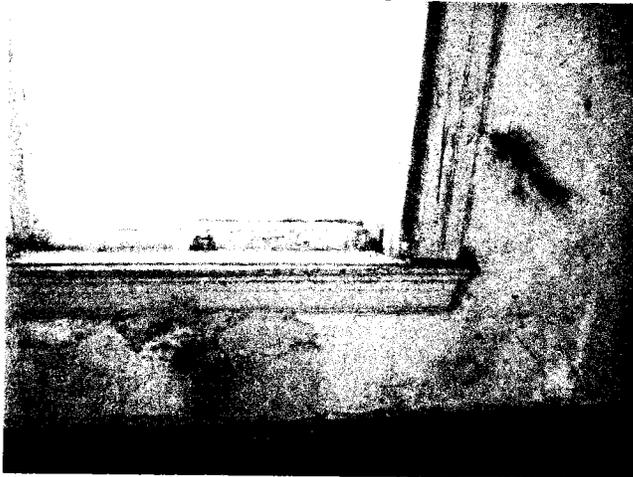
Photo 71: Damaged Windows in Rear Bedroom

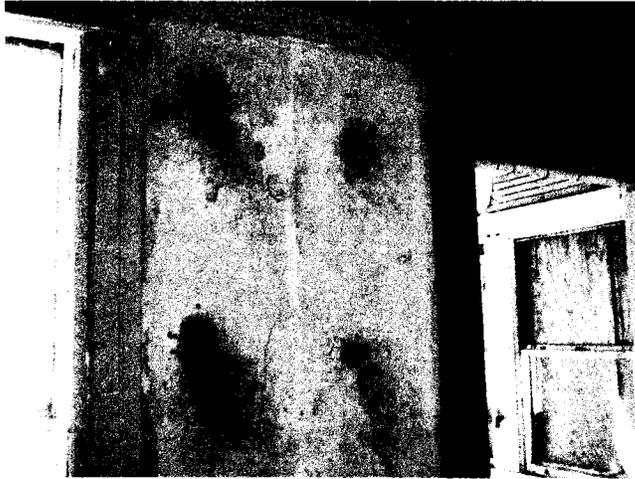
Photo 73: Damages on Rear Bedroom Wall

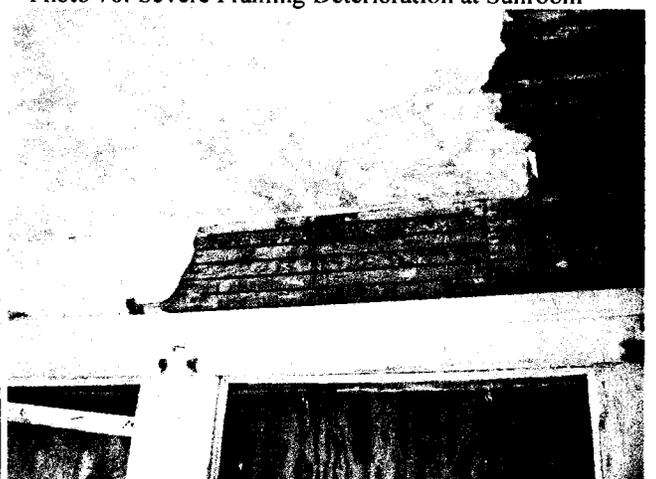
Photo 78: Sagged & Damaged Sunroom Ceiling

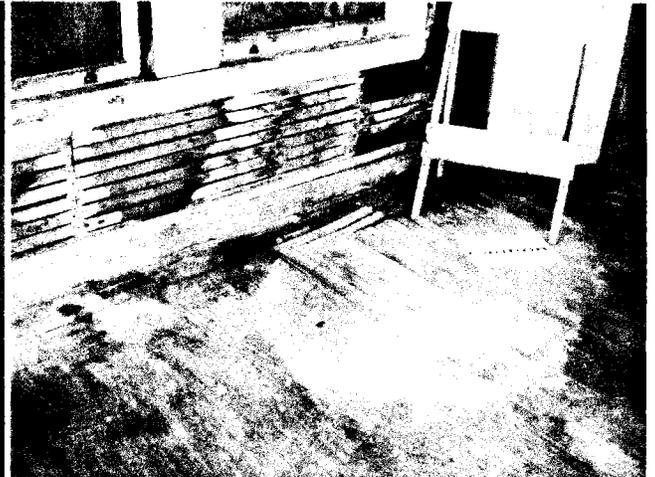
Photo 80: Deterioration & Sagging of Sunroom Floor

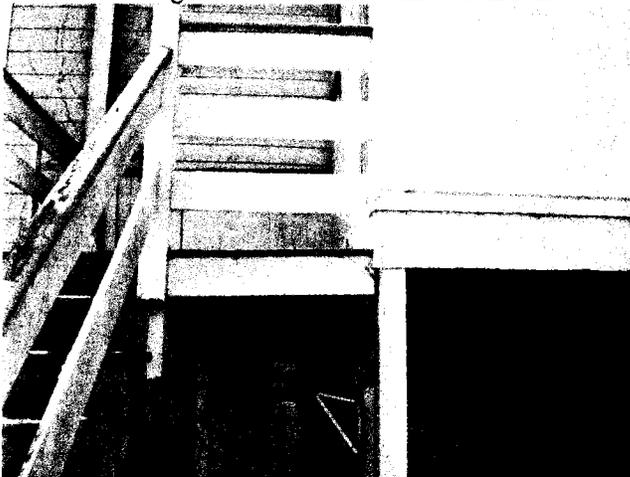
Photo 81: Questionable Framing at Rear Porch
