SAN FRANCISCO PLANNING DEPARTMENT

MEMO

DATE: January 31, 2013
TO: Historic Preservation Commission
FROM: Shelley Caltagirone, Historic Preservation Planner, (415) 558-6625
REVIEWED BY: Tim Frye, Preservation Coordinator, (415) 575-6822
RE: **February 6, 2013 Review and Comment Hearing**
55 Laguna Street Mixed Use Project Mitigation Documents
Case No. 2004.0773E!CMTR / 2012.0033ACEF

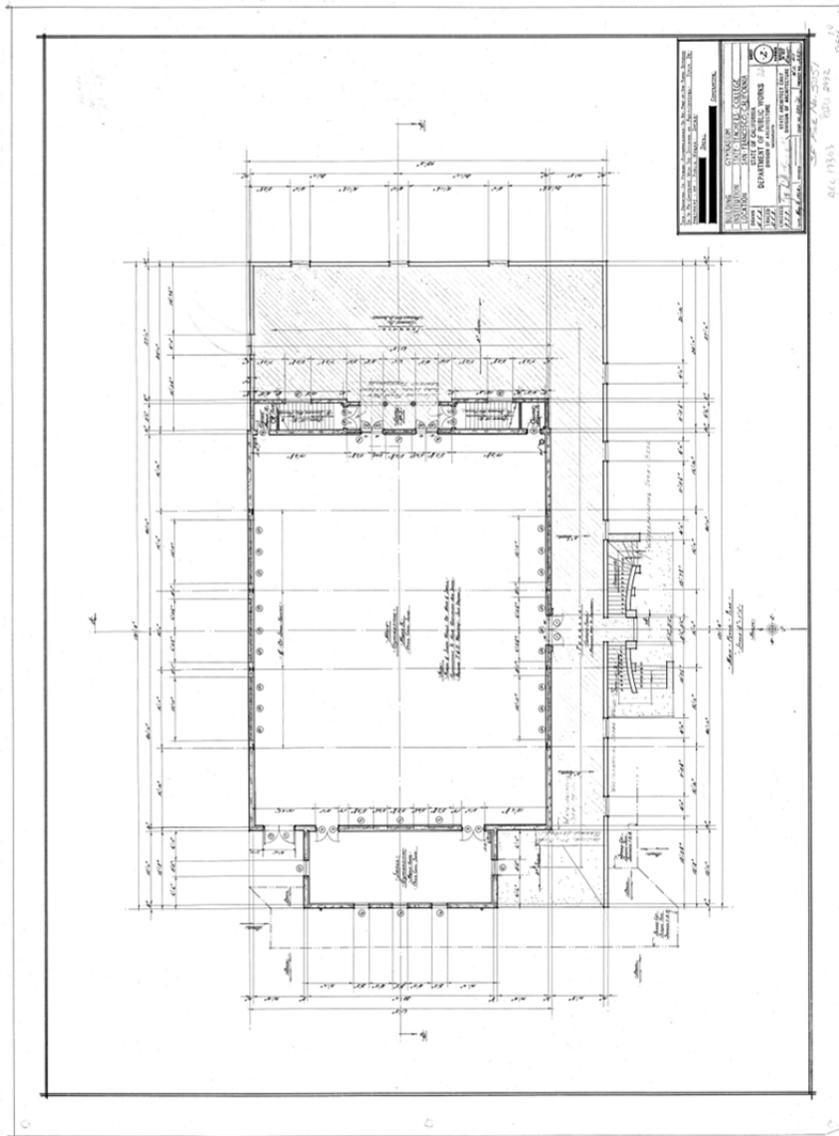
Middle Hall (Gymnasium) – Sheet A-1: Basement Plan – May 8, 1923

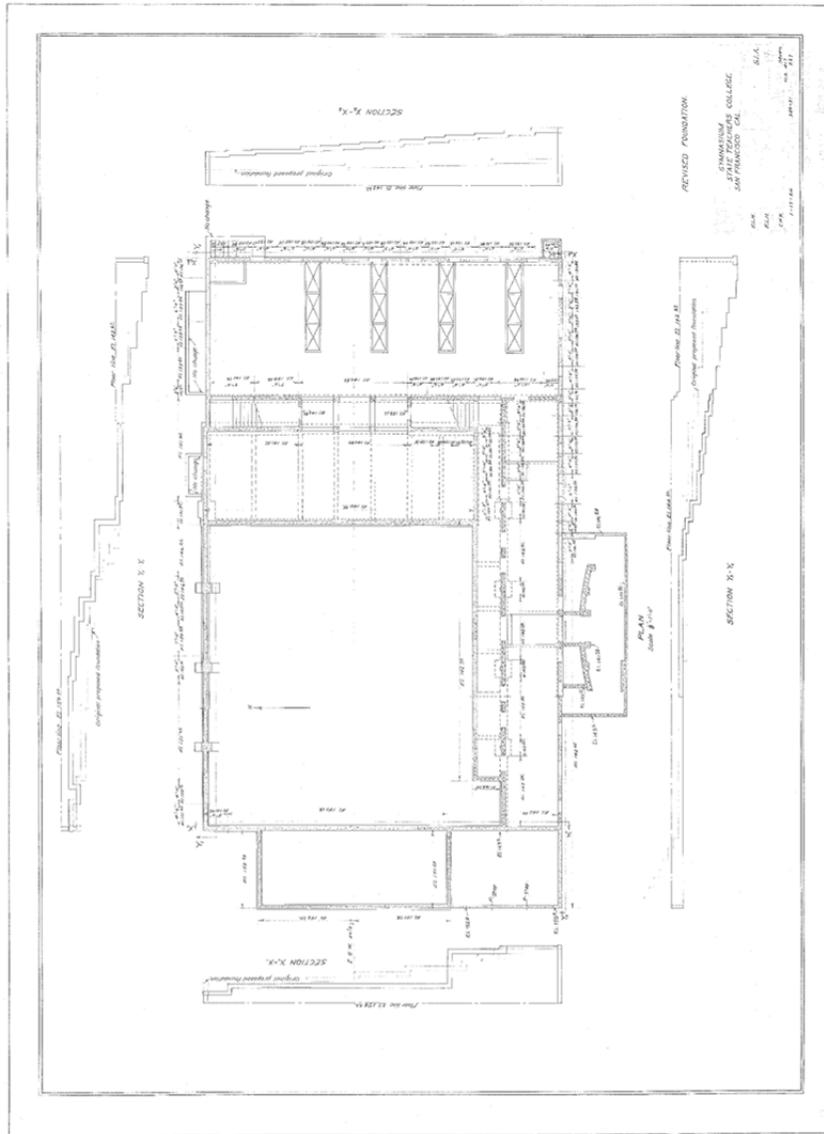
Middle Hall (Gymnasium) - Sheet S-1: Foundation Plan - May 8, 1923

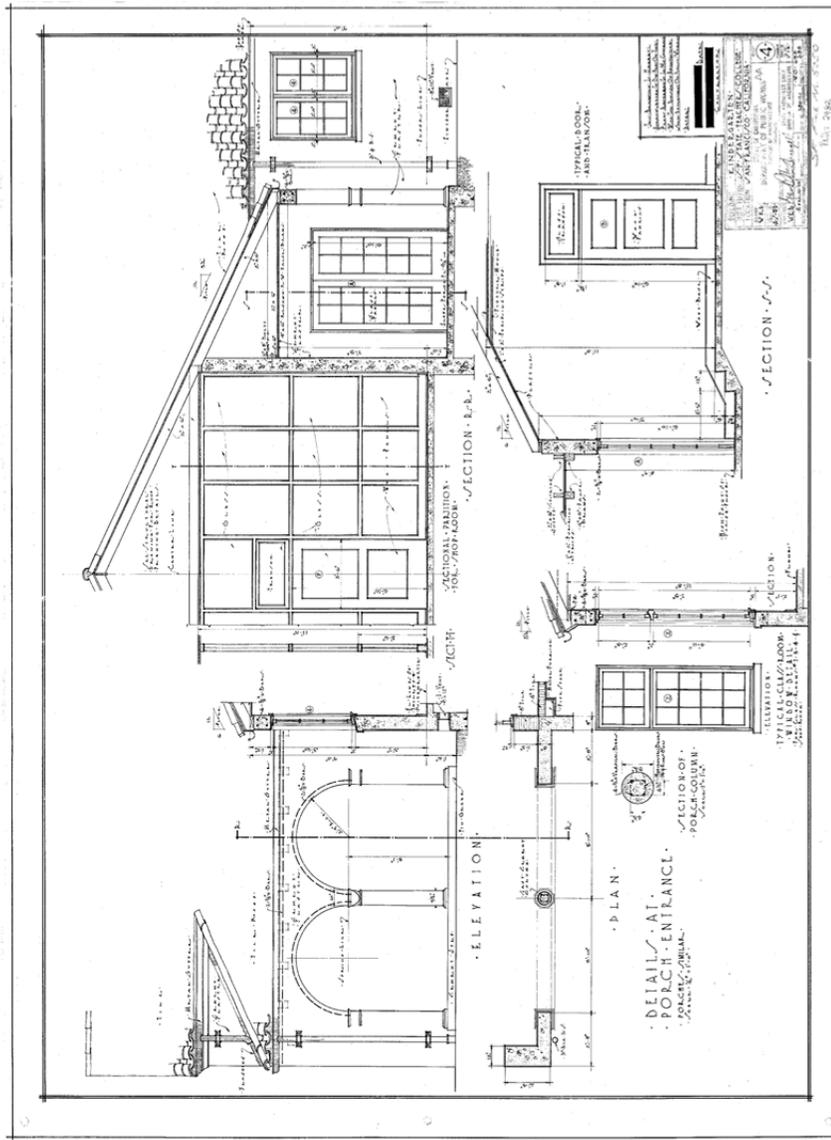
Sheet A-3: Elevations, Plans, Details—April 10, 1925

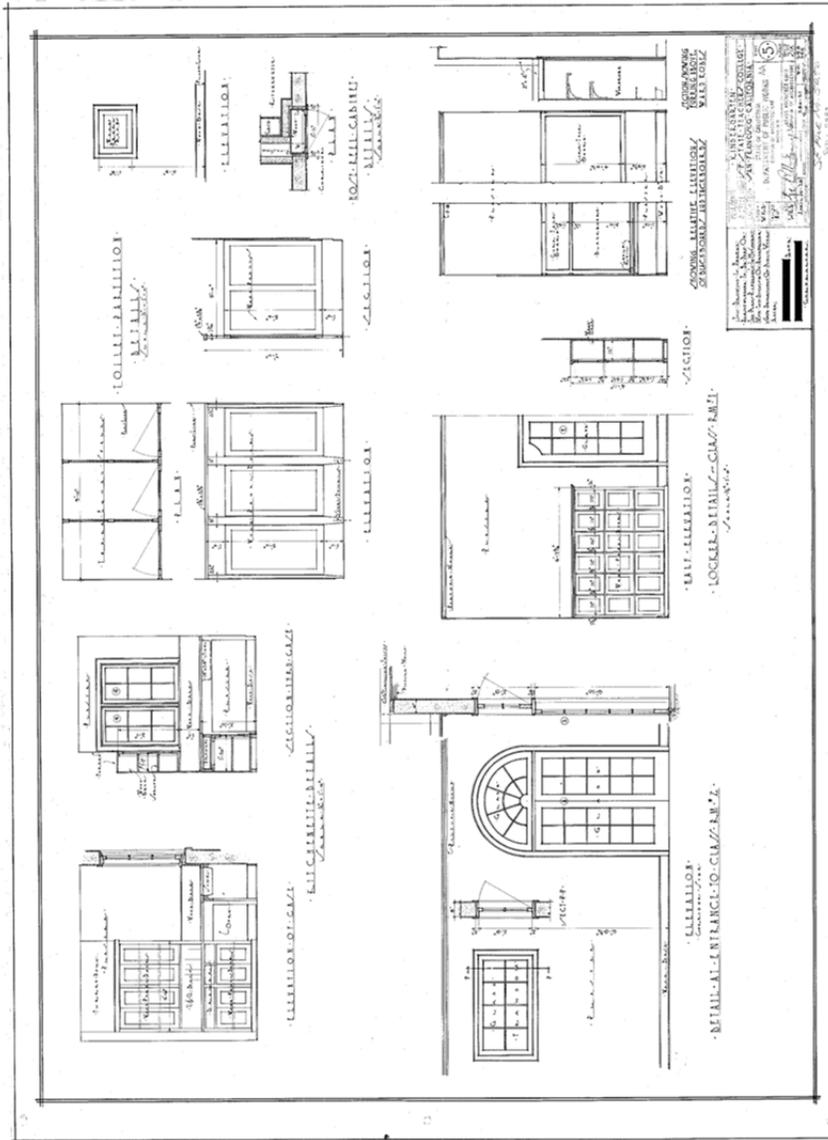
Sheet A-4: Elevations, Sections, Plans— April 10, 1925

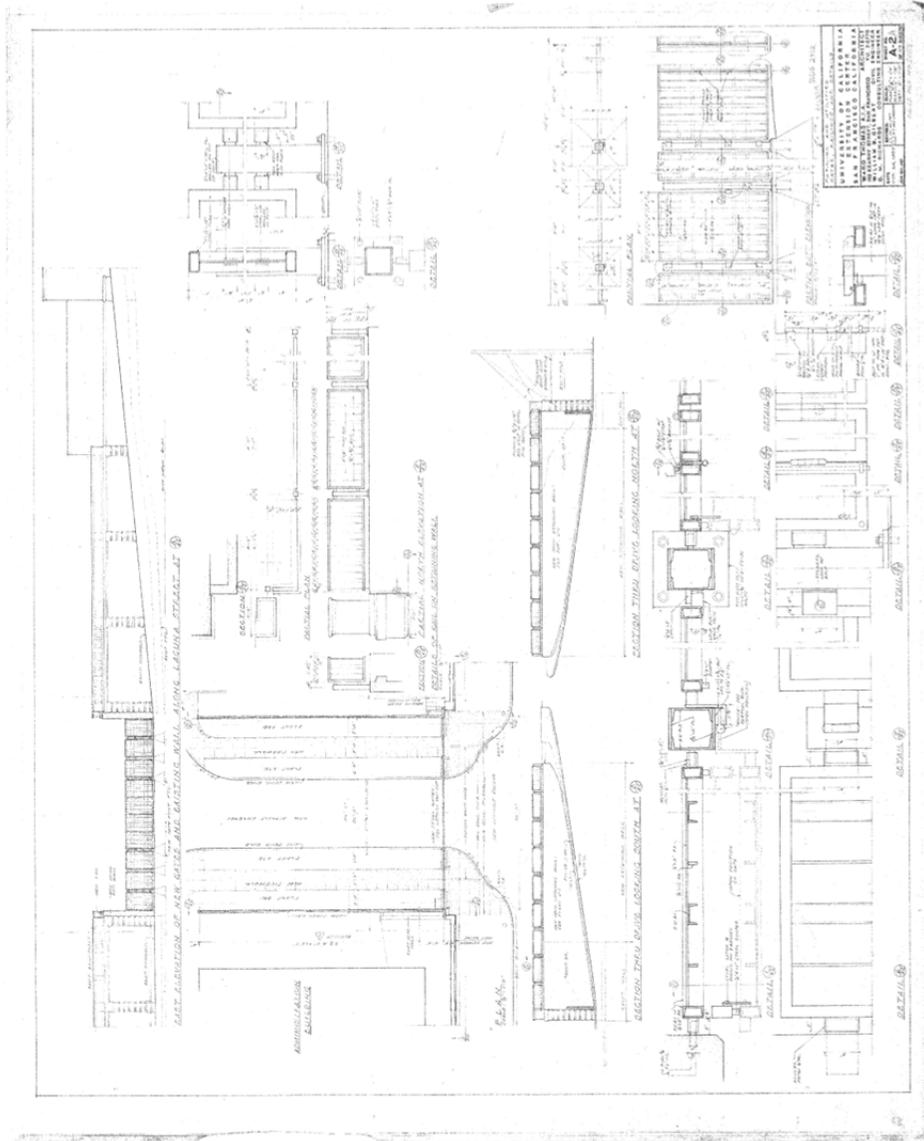
Laguna Street Wall
Sheet 2: Enlarged Elevation, Plan, and Section - April 10, 1925
Source: University of California
