# SAN FRANCISCO PLANNING DEPARTMENT

**DATE:** October 11, 2012  
**TO:** **Historic Preservation Commission**  
**FROM:** Pilar LaValley, Preservation Planner, (415) 575-9084  
**REVIEWED BY:** Tim Frye, Preservation Coordinator, (415) 575-6822  
**RE:** Informational Presentation for 1 Telegraph Hill Boulevard (Lillie Hitchcock Coit Tower) – Landmark #165  
Case No. 2012.0882E

## Lillie Hitchcock Coit Tower Renovation Project

# COIT MEMORIAL TOWER REHABILITATION PROJECT

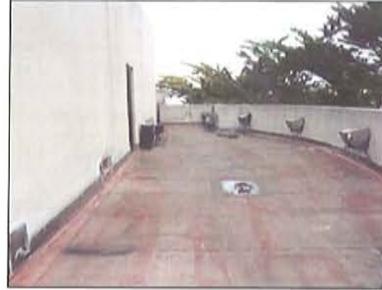
Second floor roof membrane

- Existing is rolled asphalt roofing well beyond its serviceable life
- Poor roof condition is causing leaking and water damage to existing murals

- Replacement of existing non-original leaking roof to provide waterproof condition
- Install bituminous sheet roofing for final layer and seal all copper flashing
- Roof repair scheduled for completion by November 8, prior to rainy season

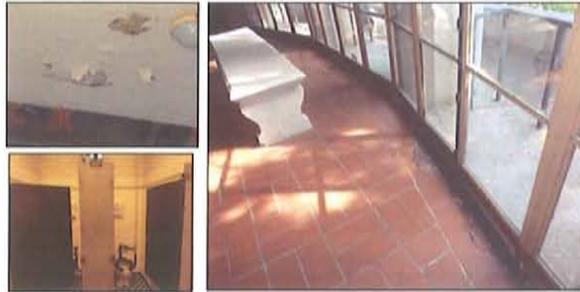
- Paint ceilings at first and second floor.
- Restroom improvements including new appropriate accessories and fixtures to improve water efficiency. New finishes throughout.
- Replacement in-kind of damaged tile at the ground floor gallery entrance.

Top left: Flaking paint and blisters on ceiling; Bottom left: Restrooms; Right: Floor tiles at the first floor gallery

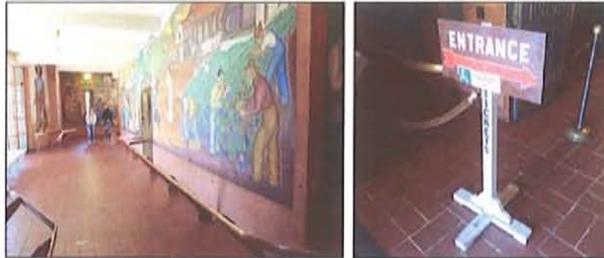
- New signs to meet accessibility guidelines
- Existing free-standing barriers to be replaced with new fixed mural barriers to match existing, to protect murals at elevator lobby and east and west niches of second floor

Existing mural barrier system

Freestanding sign

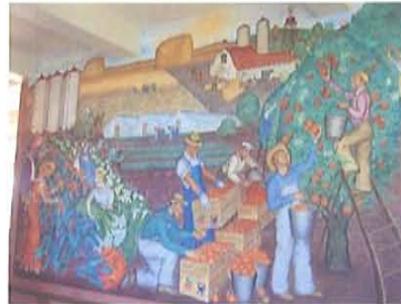
## Mural Restoration

- RPD has recently allocated \$250,000 to the Arts Commission for the purpose of restoring the murals at Coit Tower.
- The Arts Commission will contract with a certified and professional organization to perform the restorative work and repair damage to the murals.
- Preliminary cleaning work has already been completed.
- Additional mural restoration work will commence after roof replacement and historic renovation has been completed.

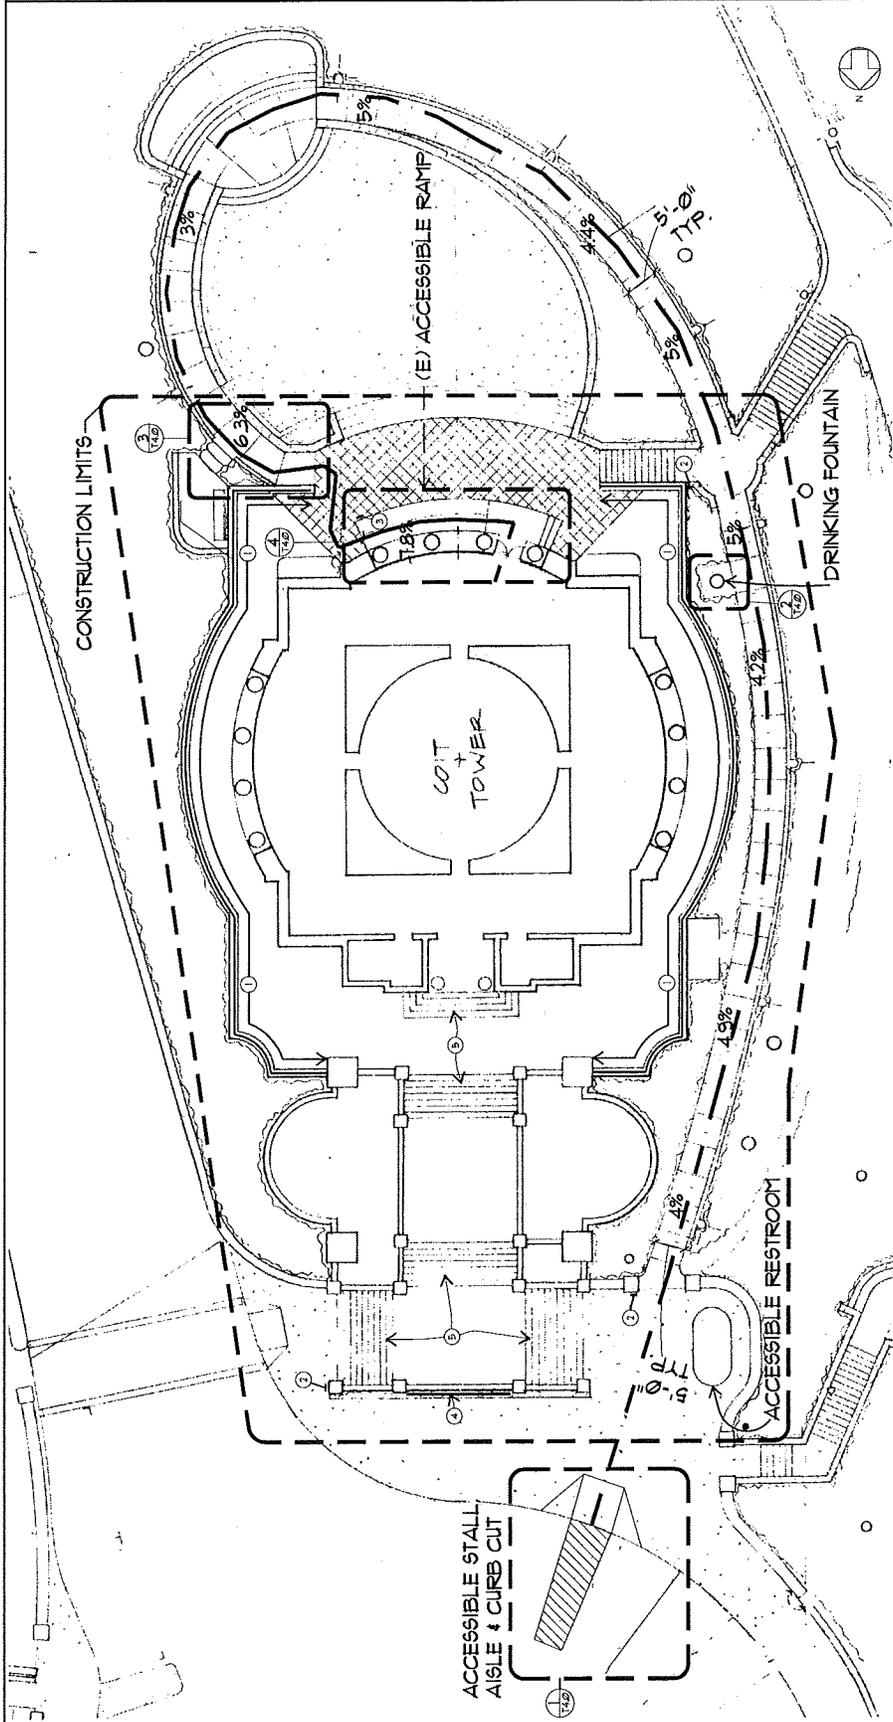
**1 SITE PLAN - PATH OF TRAVEL DOCUMENTATION**  
APPROX. 1/8" = 1'-0"

- SITE KEYNOTES**
- (N) GUARDRAIL REQUIRED AT THIS LOCATION. SEE DETAIL XXX
  - (E) ACCESSIBLE ENTRANCE DIRECTIONAL SIGNAGE
  - (N) ACCESSIBLE ENTRANCE DIRECTIONAL SIGNAGE REQUIRED. SEE DETAIL XXX
  - LOCATION OF HISTORIC PLAQUE. SEE SPECS FOR CONSERVATION REQUIREMENTS.
  - PROVIDE EDGE STRIPING AT (E) CONC. STAIR HEADS.

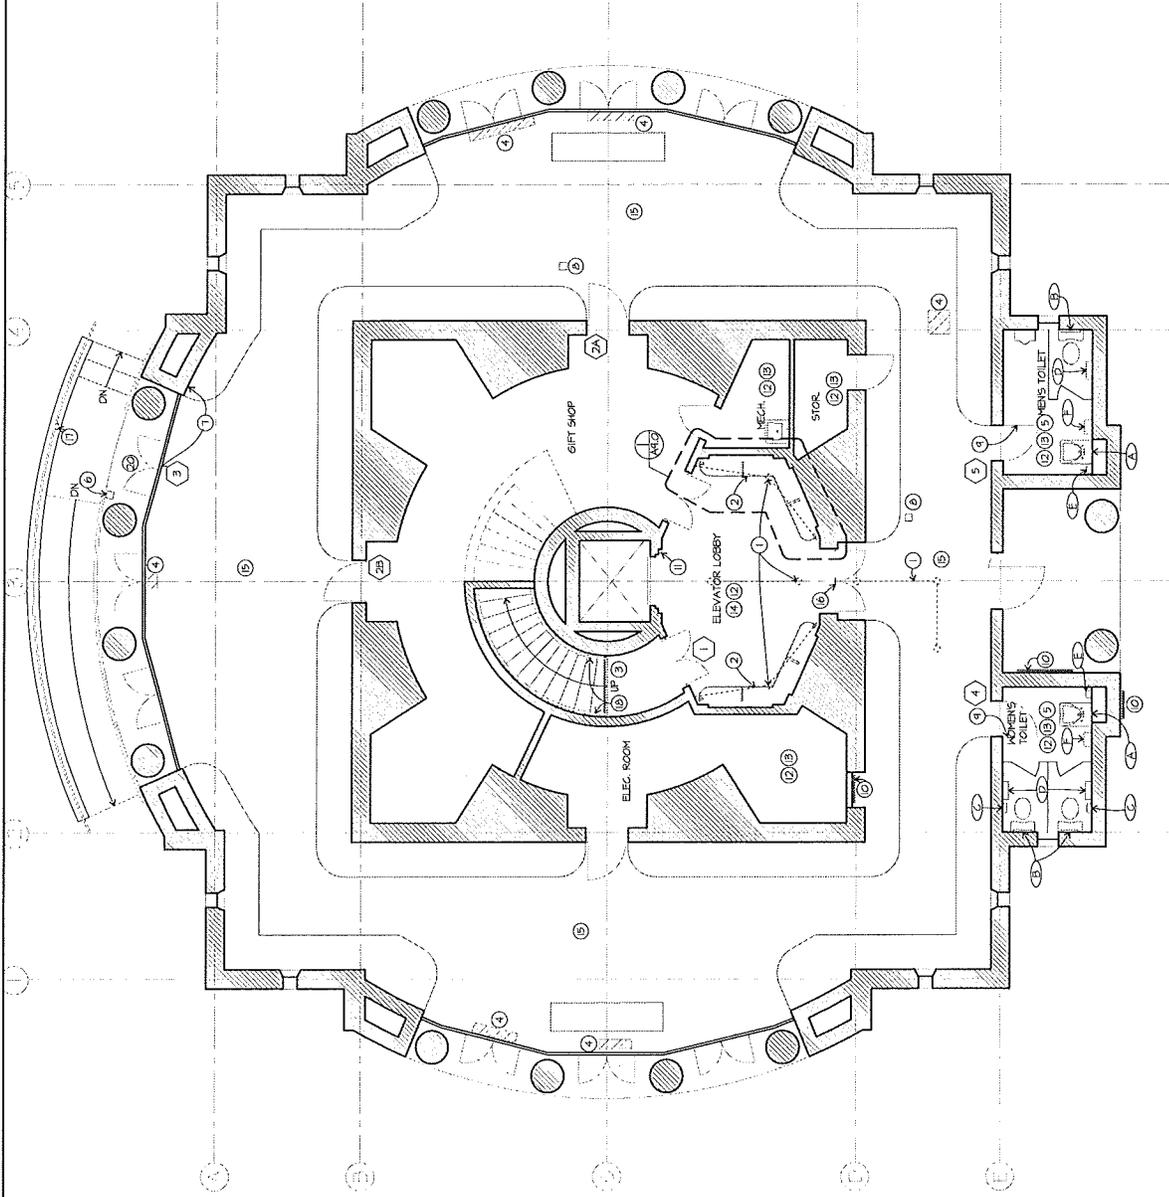
FIRST FLOOR PLAN  
SCALE: 1/8" = 1'-0"

- (1) REMOVE (E) BARRIERS.
- (2) MURAL BARRIERS TO MATCH (E) GALLERY BARRIERS. SEE DETAILS XXXX.
- (3) PROVIDE WOOD STRIPING AT UPPER APPROACH AND LOWER TREAD. SEE DETAIL 2445.

- (4) AREA OF CRACKED/MIS-MATCHED FLOOR TILE. REPLACE TO MATCH (E).
- (5) REPLACE CRACKED/DAMAGED WALL TILE TO MATCH (E).
- (6) 6"x6" FTD. STD. POST AND CAP WITH ADA PUSH BAR. SEE DETAIL XXX.

- (7) REPLACE WALL-MOUNTED ADA PUSH BUTTON WITH ADA PUSH BAR. SEE DETAIL XXX. REPLACE DOOR OPENER.
- (8) POST-MOUNTED DIRECTIONAL SIGNAGE. CONTRACTOR TO COORDINATE WITH CITY FOR DESIGN STANDARDS.

- (9) ACCESSIBLE RESTROOM SIGNAGE. SEE DETAIL XXX.
- (10) LOCATION OF HISTORIC FLAG. SEE SPECS FOR CONSERVATION REQUIREMENTS.
- (11) LOWER ELEVATOR HALL CALL BUTTON TO 3'-6" AFF. REUSE EXISTING BOX.

- (12) PAINT (E) CEILING.
- (13) PAINT (E) WALLS.
- (14) REMOVE (E) ACOUSTICAL CEILING TILE.
- (15) STRIP AND PAINT (E) CEILING. COORDINATE PAINT COLOR W/ ARCHITECT.

- (16) MAXIMUM OCCUPANCY SIGN MOUNT ON TRANSOM ABOVE DOOR. SEE DETAIL XXX.
- (17) REMOVE (E) DOOR PUSH BUTTON.
- (18) (E) HANDRAIL TO REMAIN.

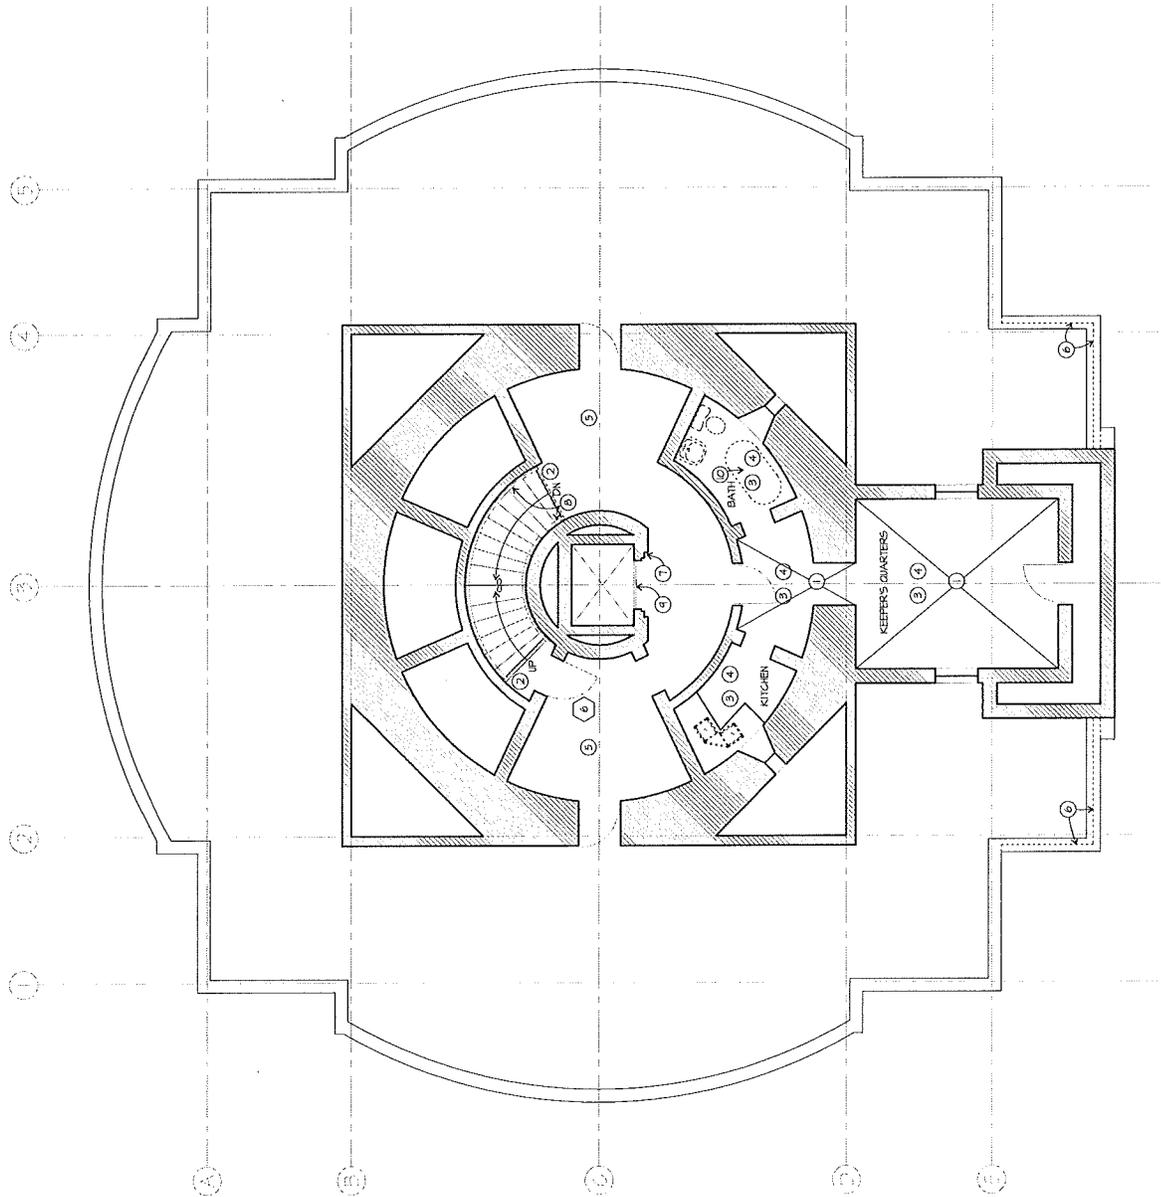
**SECOND FLOOR PLAN**  
SCALE: 1/4" = 1'-0"

1. AREA OF CARPET TO BE REMOVED AT KEEPER'S QUARTERS.
2. PROVIDE NOSING STRIPING AT STAIR UPPER APPROACH AND LOWER TREAD. SEE DETAIL XXX
3. PAINT CEILING
4. PAINT WALLS
5. STRIP AND PAINT CEILING
6. REMOVE WOOD AND FLEXI BIND SCREENS AT ROOF PARAPET. PATCH DASH COAT TO MATCH (E) AT PARAPET AS REQUIRED.
7. LOWER ELEVATOR HALL CALL BUTTON TO 3'-6" AFF. REUSE (E) BOX.
8. (E) HANDRAIL TO REMAIN.
9. MAX. OCCUPANCY SIGN. POINT AT RECESSED WALL ABOVE ELEVATOR. NOT ON MURAL.
10. REPAIR WATER DAMAGE AT CEILING ABOVE.

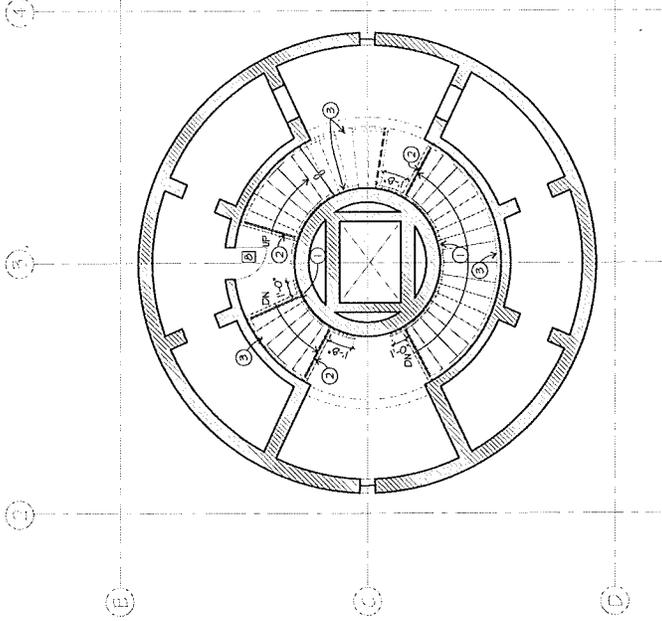
**9. TYP. FLOOR PLAN LEVEL 9**  
SCALE: 1/4" = 1'-0"

- ① (N) COMPLANT STEEL TUBE HANDRAIL 36" ABOVE STAIR NOSING, SEE DETAIL 80/ASD
- ② PROVIDE NOSING STRIPING AT UPPER APPROACH AND LOWER TREAD, SEE DETAIL 300X
- ③ (E) HANDRAILS TO REMAIN
- ④ REPAIR WATER TANK

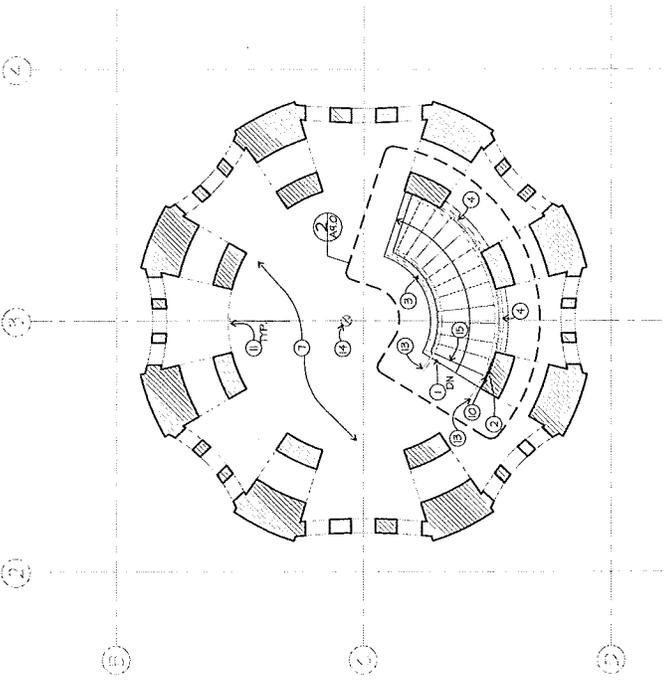
**LANTERN LEVEL FLOOR PLAN**  
SCALE: 1/8" = 1'-0"

- NOTE: NOT ALL KEYNOTES ARE USED ON ALL PLANS.
- 1 PAINT CURB YELLOW
  - 2 PROVIDE WARNING SIGN AT LAST STAIR RISER
  - 3 MODIFY STAIR GUARDRAIL AT LANTERN LEVEL. SEE DETAIL XXX
  - 4 MODIFY GUARDRAILS AT WALL, LANTERN LEVEL. SEE DETAIL XXX
  - 5 LOWER ELEVATOR HALL CALL BUTTON TO 3'-6" AFF. REUSE EXISTING BOX
  - 6 TREAT CORRODED REBAR BELOW. PATCH CONCRETE SPALL
  - 7 PROVIDE (N) TRAFFIC COATING AT LANTERN LEVEL
  - 8 (N) COMPLIANT STEEL TUBE HANDRAIL 36" ABOVE STAIR NOSING. SEE DETAIL 04A.02
  - 9 PROVIDE NOSING STRIPING AT UPPER APPROACH AND LOWER TREAD. SEE DETAIL XXX
  - 10 MAX. OCCUPANCY SIGN. SEE DETAIL XXX
  - 11 (E) SCUFFER LOCATIONS ABOVE
  - 12 (E) HANDRAIL TO REMAIN
  - 13 (E) HANDRAIL TO PROVIDE IF EXTENSION
  - 14 (E) FLOOR DRAIN
  - 15 PROVIDE WARNING SIGN AT LAST STAIR RISER

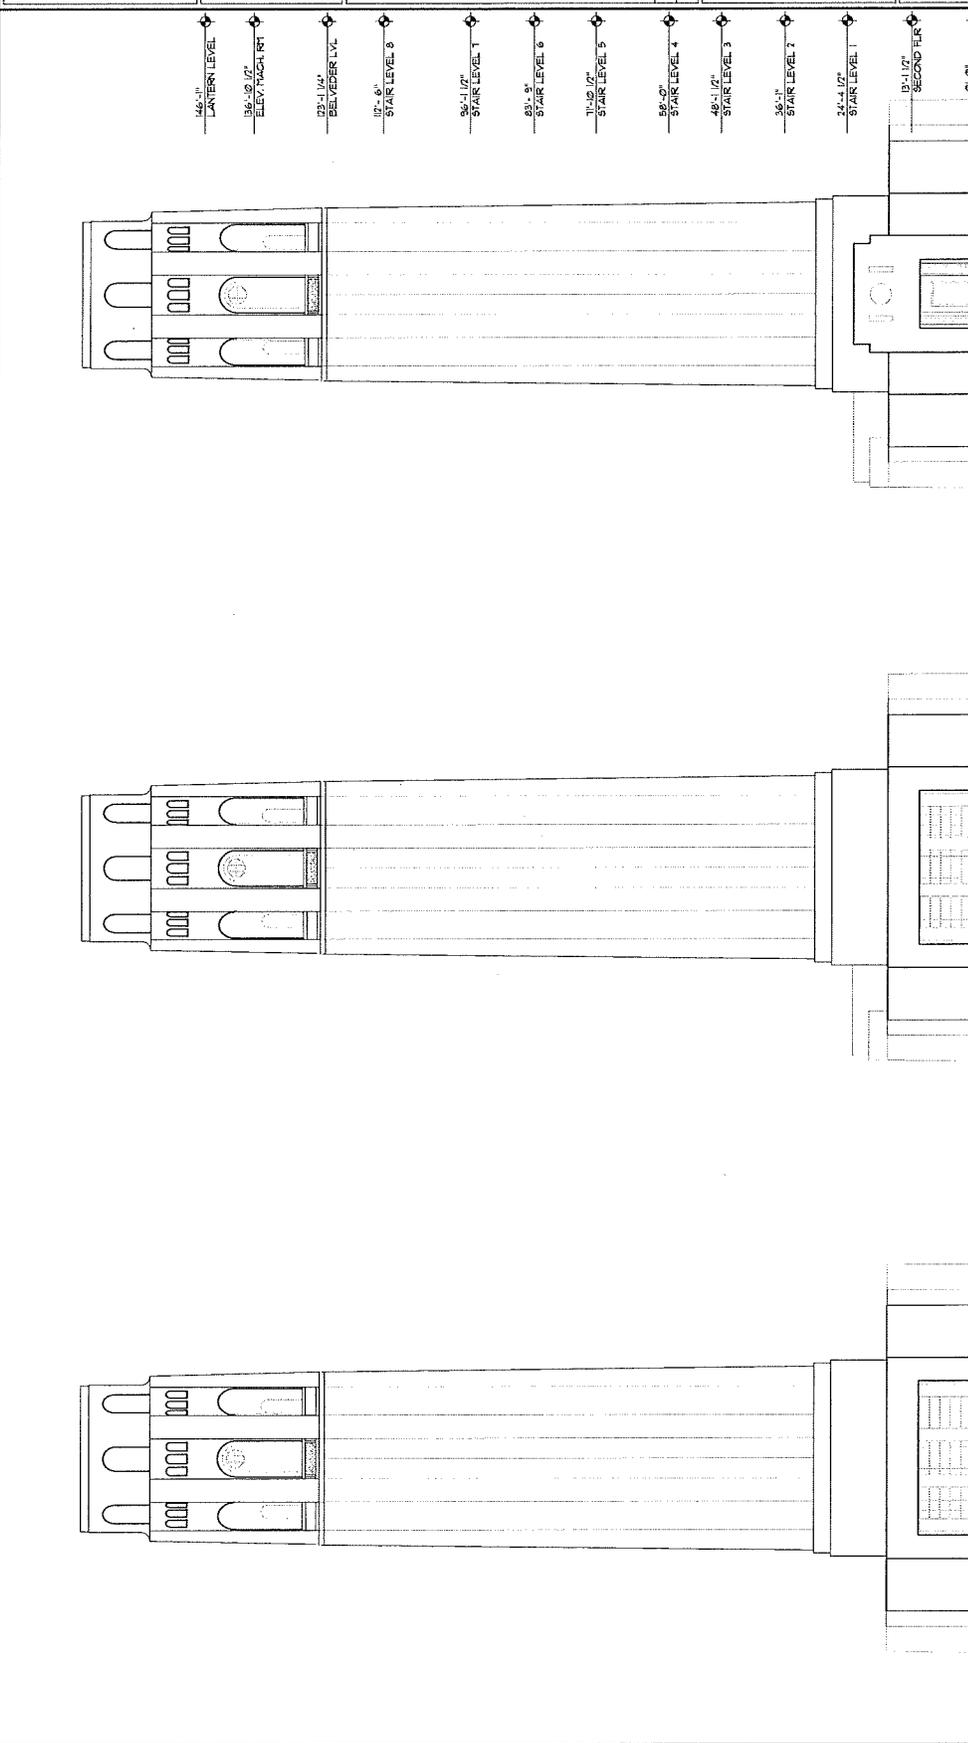
**SOUTH ELEVATION**  
SCALE: 3/32" = 1'-0"

- BUILDING TO BE CLEANED WITH WARM WATER AT MEDIUM PRESSURE.
- STRIP CEILING PAINT AT BASE OF BUILDING AS REQUIRED. REPAINT TO MATCH BUILDING COLOR.
- DASH COAR REPAIR. CONFIRM EXTENT OF REPAIR OF DASH COAT AT CRACKS AND SPALLS.
- CONCRETE REPAIR. CONFIRM EXTENT OF CONCRETE REPAIR, INCLUDING CRACKS AND SPALLS EXPOSING REINFORCING METAL.
