# SAN FRANCISCO PLANNING DEPARTMENT

**MEMO**

**DATE:** November 9, 2011  
**TO:** Historic Preservation Commission  
**FROM:** Rich Sucre, Historic Preservation Technical Specialist, (415) 575-9108  
**REVIEWED BY:** Tim Frye, Preservation Coordinator, (415) 575-6822  
**RE:** **Review and Comment**  
**850-870 Brannan Street**  
**Case No. 2011.0583B**

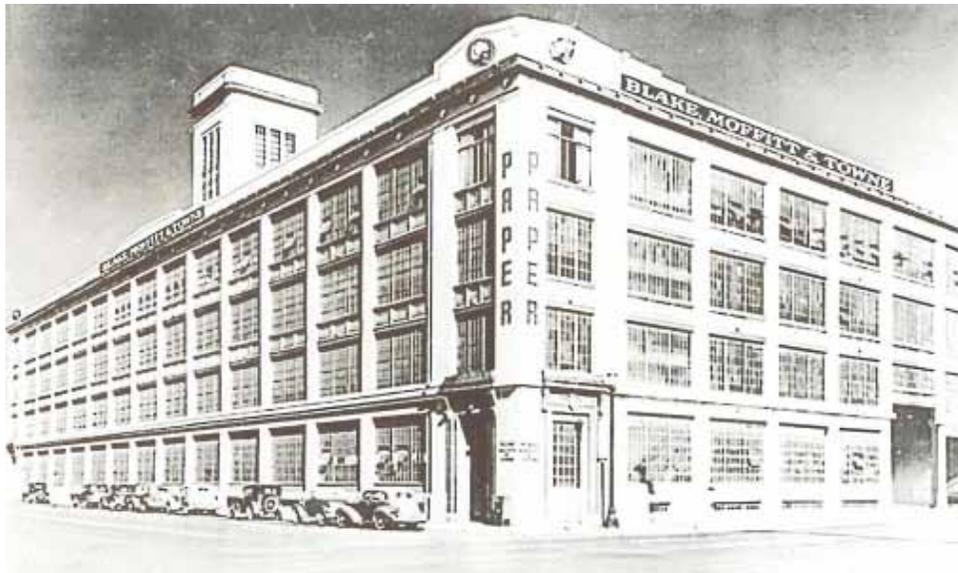
Figure 3

The original steel windows along the Brannan and Eighth Street elevations share the following features. A 1940's photograph of the building is shown in Figure 3.

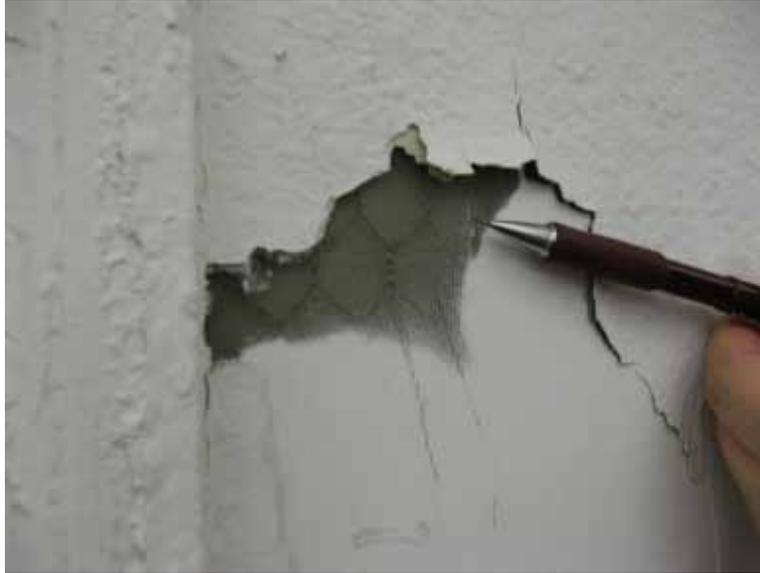
- The exterior “nose” of the steel framing is “coved” or “fluted”.
- The original glass appears to have been a translucent (not clear) wire glass. The interior face of the glass is corrugated while the exterior face is smooth (refer to Figure 4).

Figure 4: Original glass.

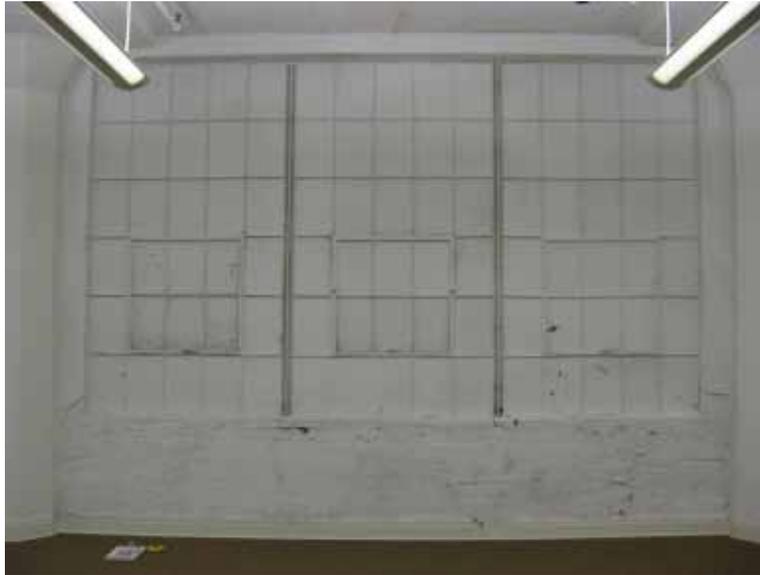
- Type “A” The most common window type is found at the second through fourth floors along the central portions of both public elevations, the three sashes are each five lights wide by six lights tall. They occupy an opening approximately 16-feet wide by 9-feet tall. Originally there were 33 of these window types along Brannan Street and 39 along Eighth Street. One of the Type “A” windows along Brannan Street and three along Eighth Street have been modified. Refer to Figure 5 for a photograph of a typical Type “A” window.

Figure 5: Window Type "A"

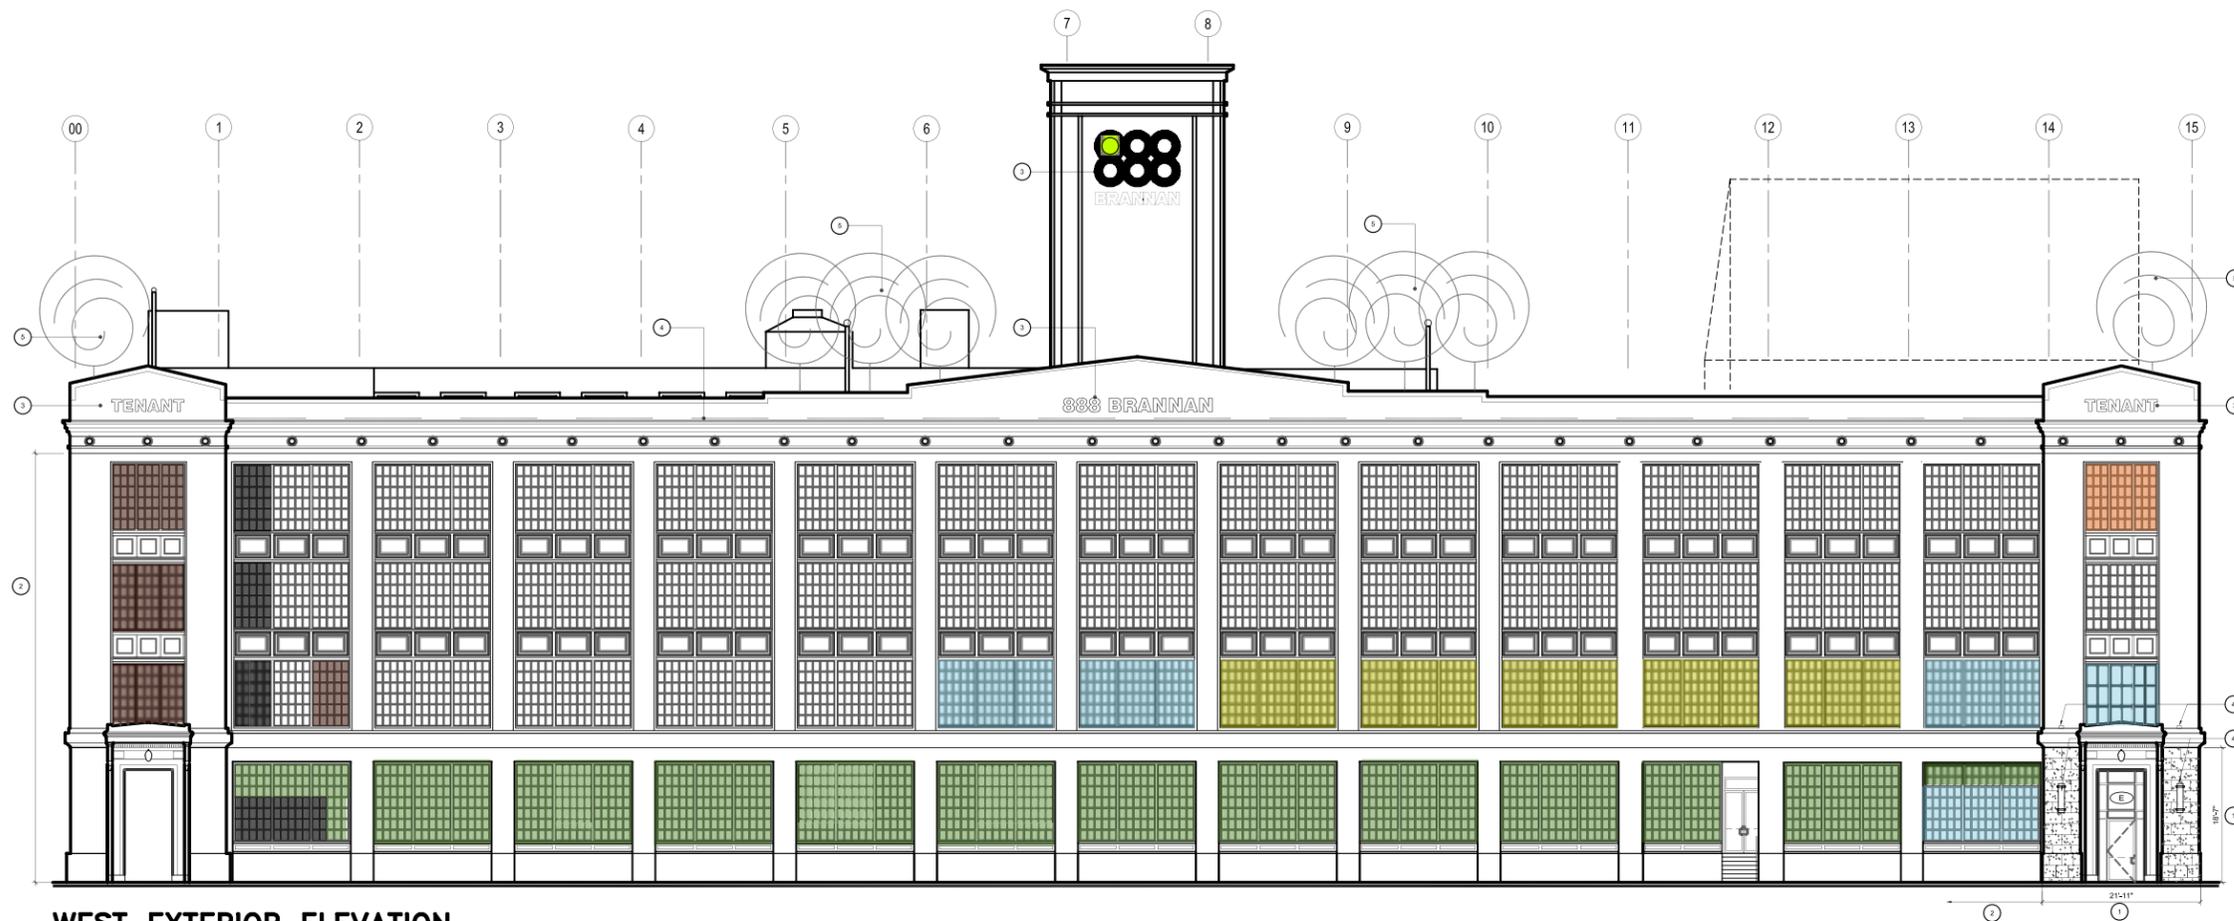
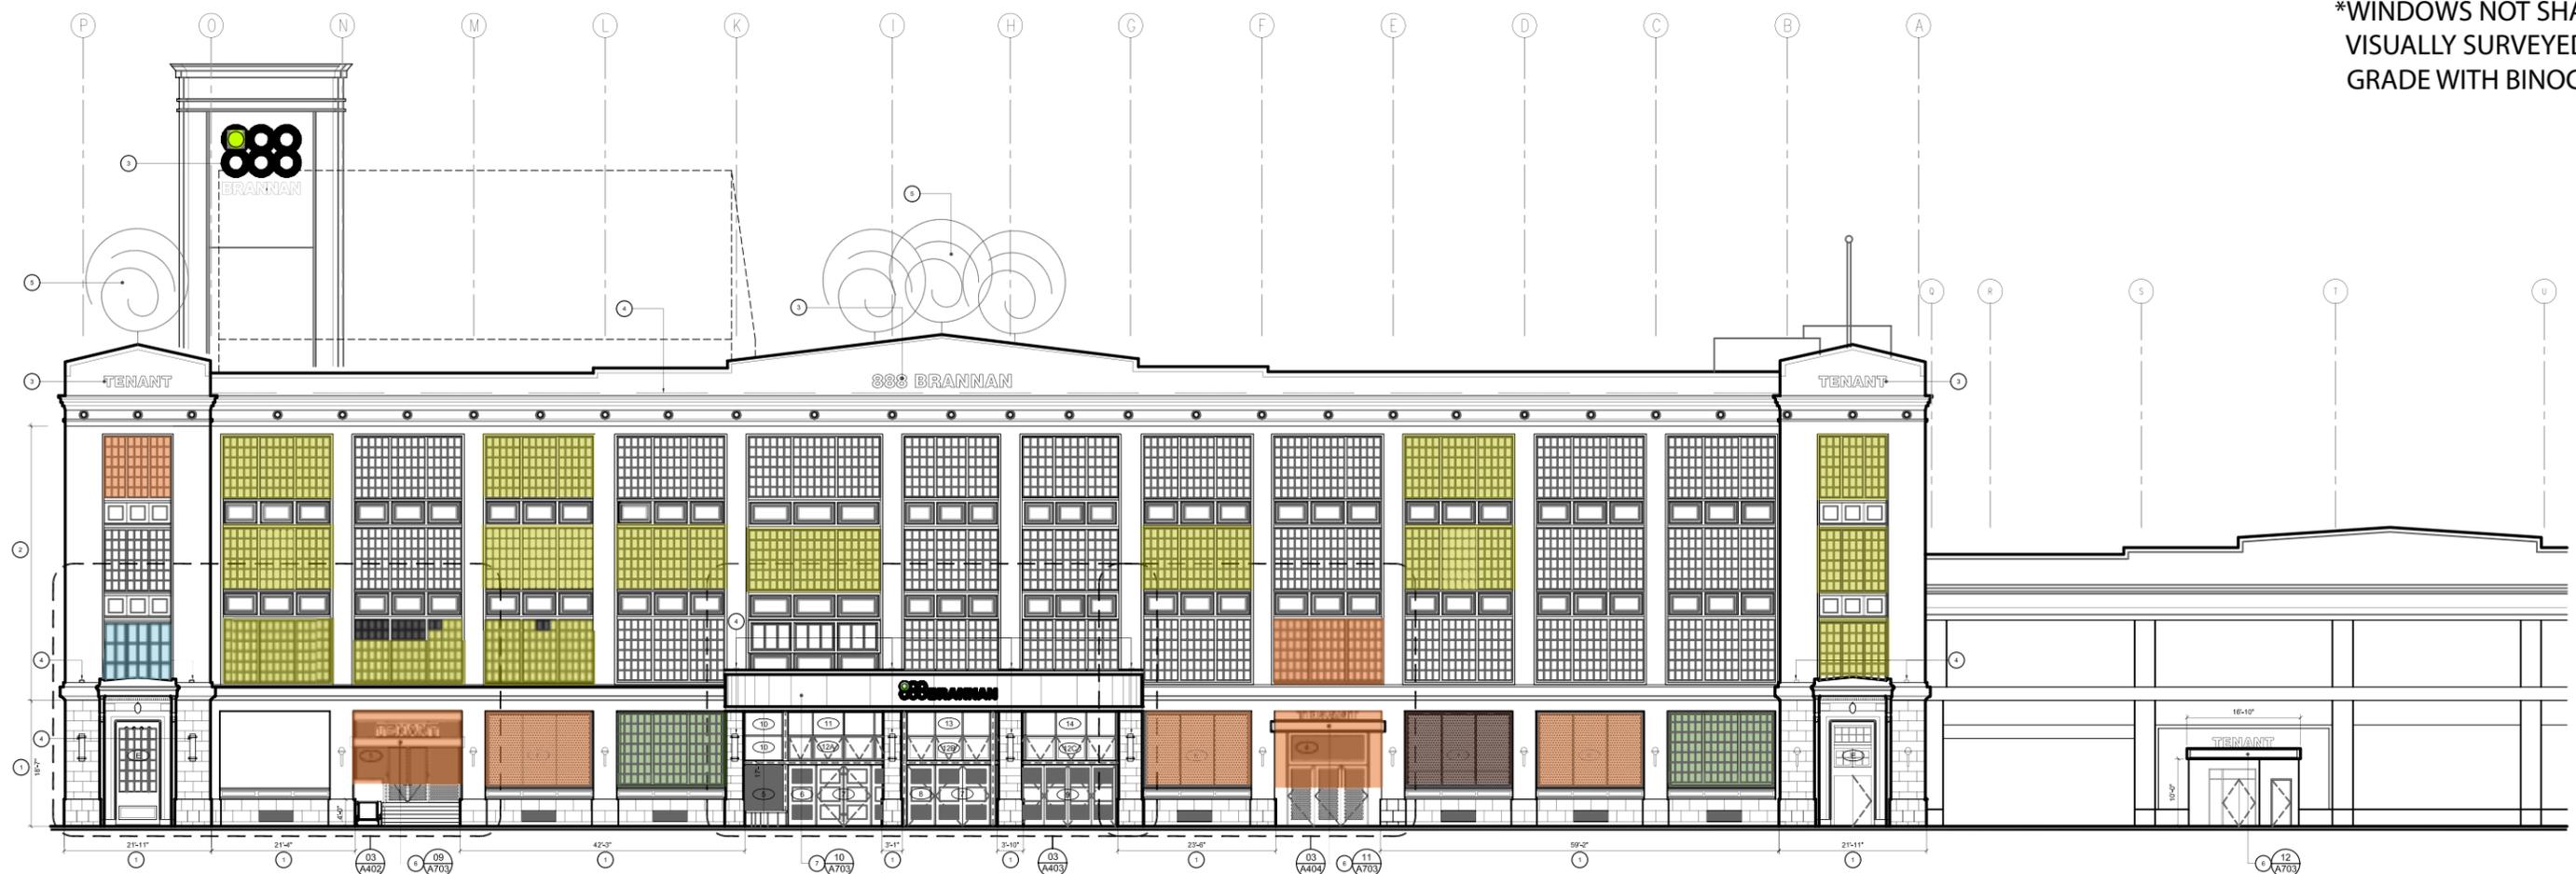
**SK 1** VISUAL SURVEY

Page & Turnbull was able to gain up-close interior access to 10 original windows at an empty showroom on the second floor along Eighth Street and 12 windows on the Brannan Street facade. Additionally, we performed up-close observations of original windows at grade along Eighth and Brannan Streets. Therefore, approximately 40-percent of the windows were observed up-close. The remaining windows were observed using binoculars at grade, but as noted above, the paint coatings obscured the subtleties of deterioration conditions noted below. A number of the original windows have been over-clad (or removed), modified, or replaced with non-matching windows. Additionally, the owner has performed mock-up repairs of four of the windows observed at the second floor. Refer to the attached SK1 sketch elevation diagram for more information regarding extent of the window observations.
