SAN FRANCISCO PLANNING DEPARTMENT

Certificate of Appropriateness Case Report

HEARING DATE: JULY 6, 2011

Filing Date: June 13, 2011
Case No.: **2011.0613A**
Project Address: **130 Sutter Street**
Historic Landmark: No. 37 – The Hallidie Building
Zoning: C-3-O (Downtown Office)
80-130F Height and Bulk District
Block/Lot: 0288 / 027
Applicant: Bruce Albert, The Albert Group
114 Sansome Street, Suite 710
San Francisco, CA 94104
Staff Contact Sophie Hayward - (415) 558-6372
sophie.hayward@sfgov.org
Reviewed By Tim Frye – (415) 575-6822
tim.frye@sfgov.org

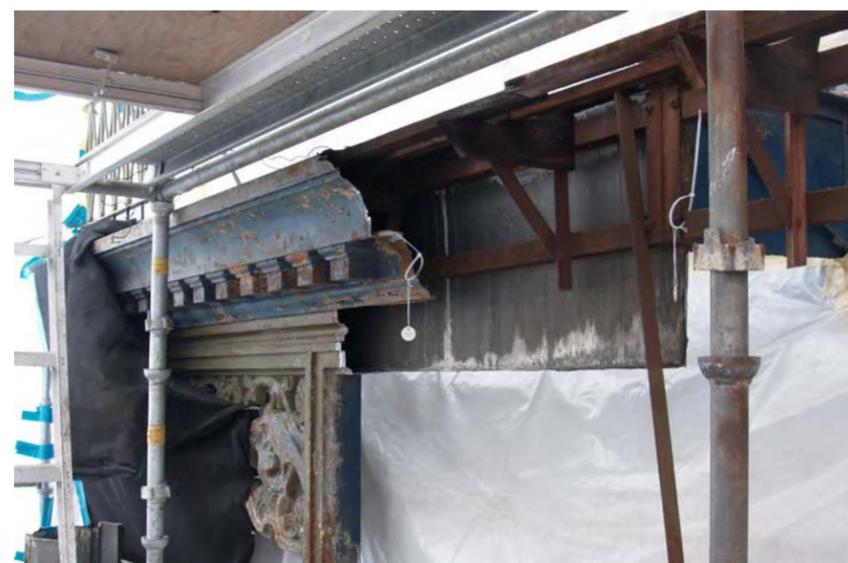
Cataloging and removing of decorative sheet metal

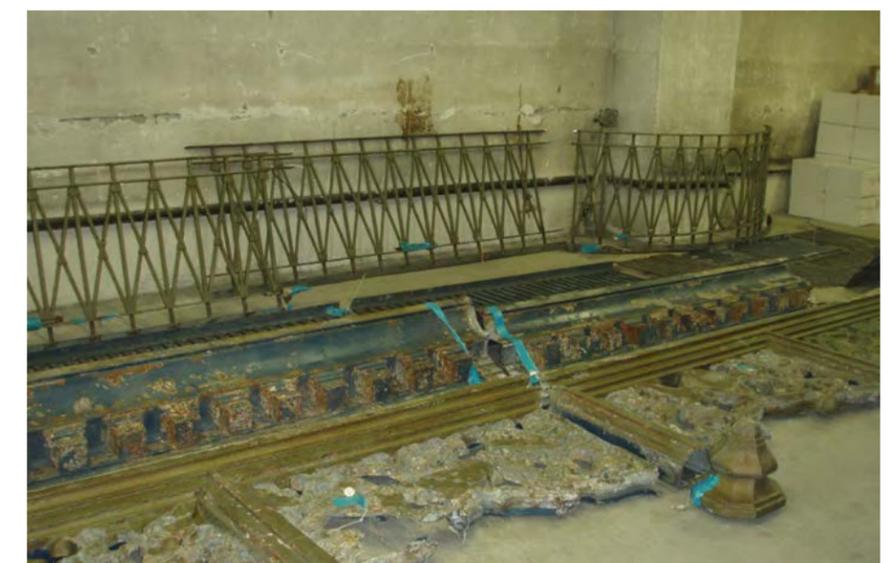
Storing of decorative metal

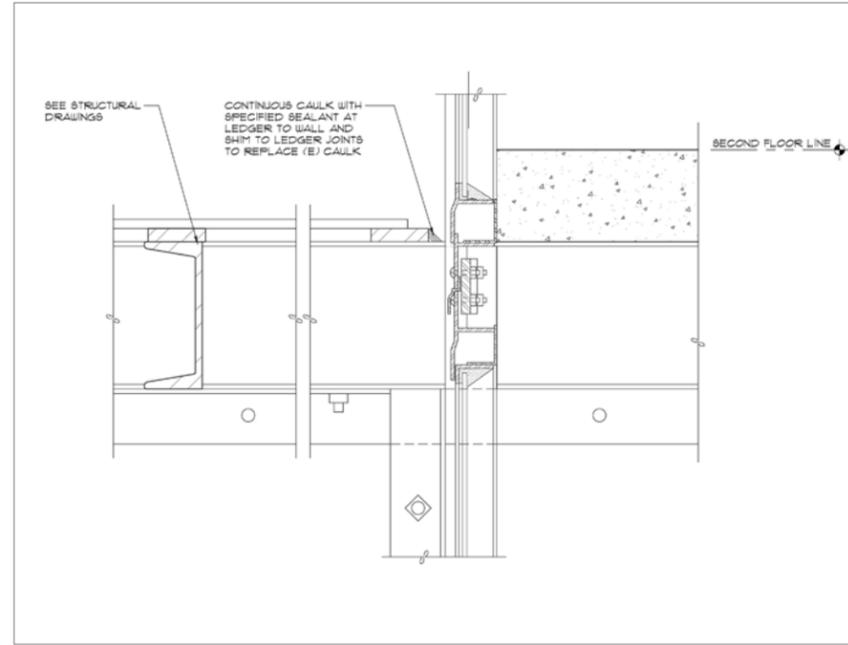
New detail at balcony

The existing condition is such the W4x13 beam that supports the balconies is in contact with the curtain wall (see existing detail above). This beam will be replaced with a new steel channel that will be held back about six inches to allow future repairs of the curtain wall (see new detail above).

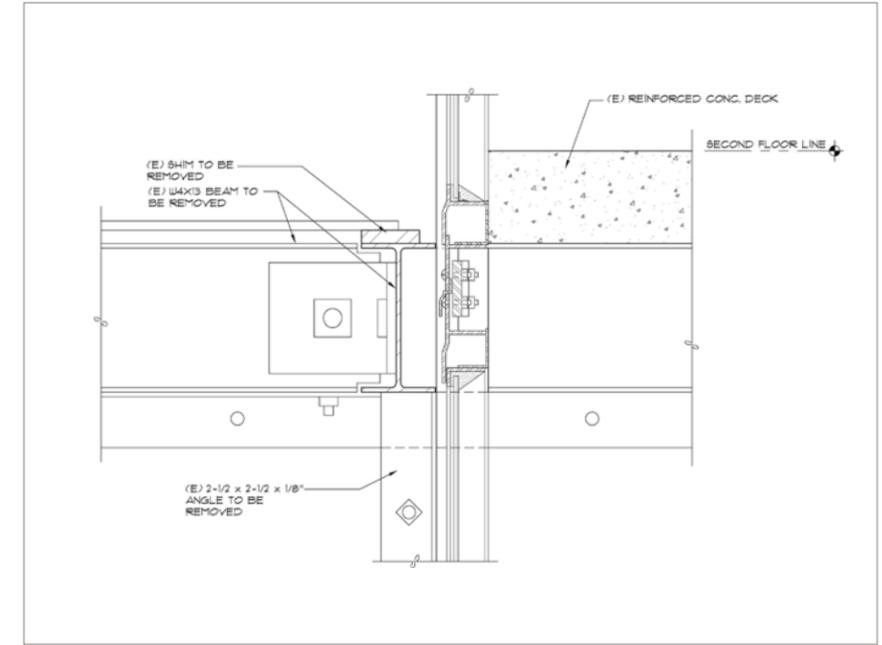
Existing detail at balcony

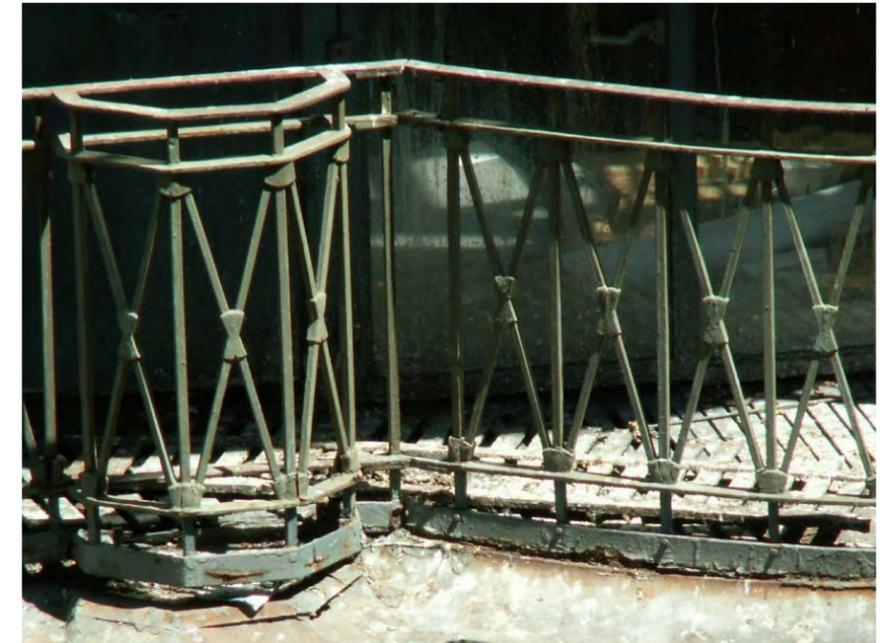
Deterioration at picket bracket

The railings and balconies consist of simple iron flat steel bars at the floor of the balconies and square iron pickets. Where elements have deteriorated beyond repair, they will be replaced in kind. Repairs to the iron railings will include the removal of rust, in-kind replacement of elements deteriorated beyond repair, and painting. The railings have brackets where the pickets cross. The original brackets were made of lead and many are in poor condition. These will be replaced in kind. The metal railings and balconies will be painted using original colors, blue and gold.

Original mechanical connections were rivets. Where flat bars need to be replaced, they will receive a bolt connection. The bolt head will be round similar to the original rivets.

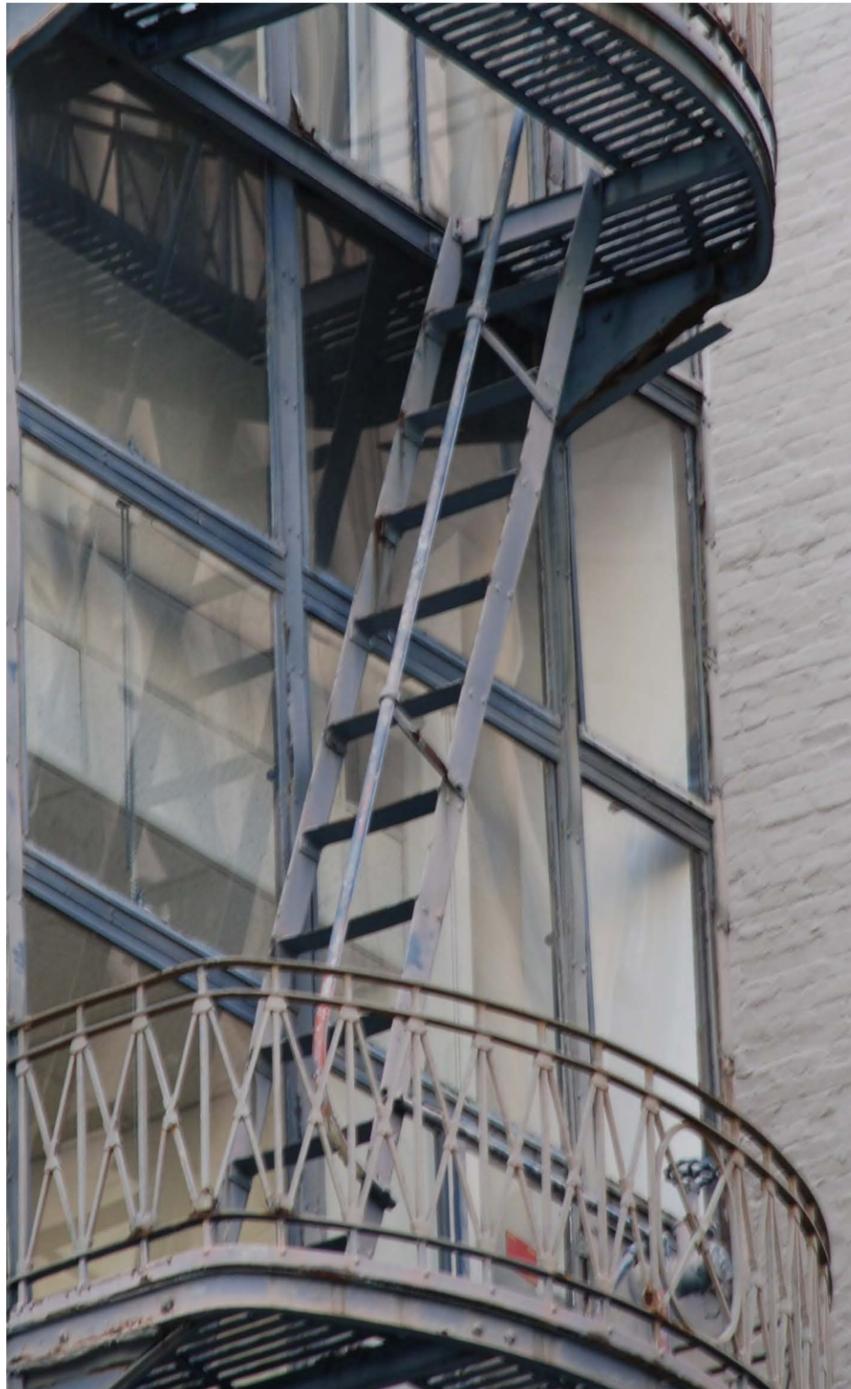
Ladders at fire escapes

The fire escape ladders are severely deteriorated at the rung welded connections. The ladders will be replaced with new ladders to match the existing ladders in color and material. The design will be similar except that the ladders rungs will be positioned so that they are able to shed water and therefore be less prone to deterioration. The new rungs will be supported by steel angles instead of relying only on a welded connection.

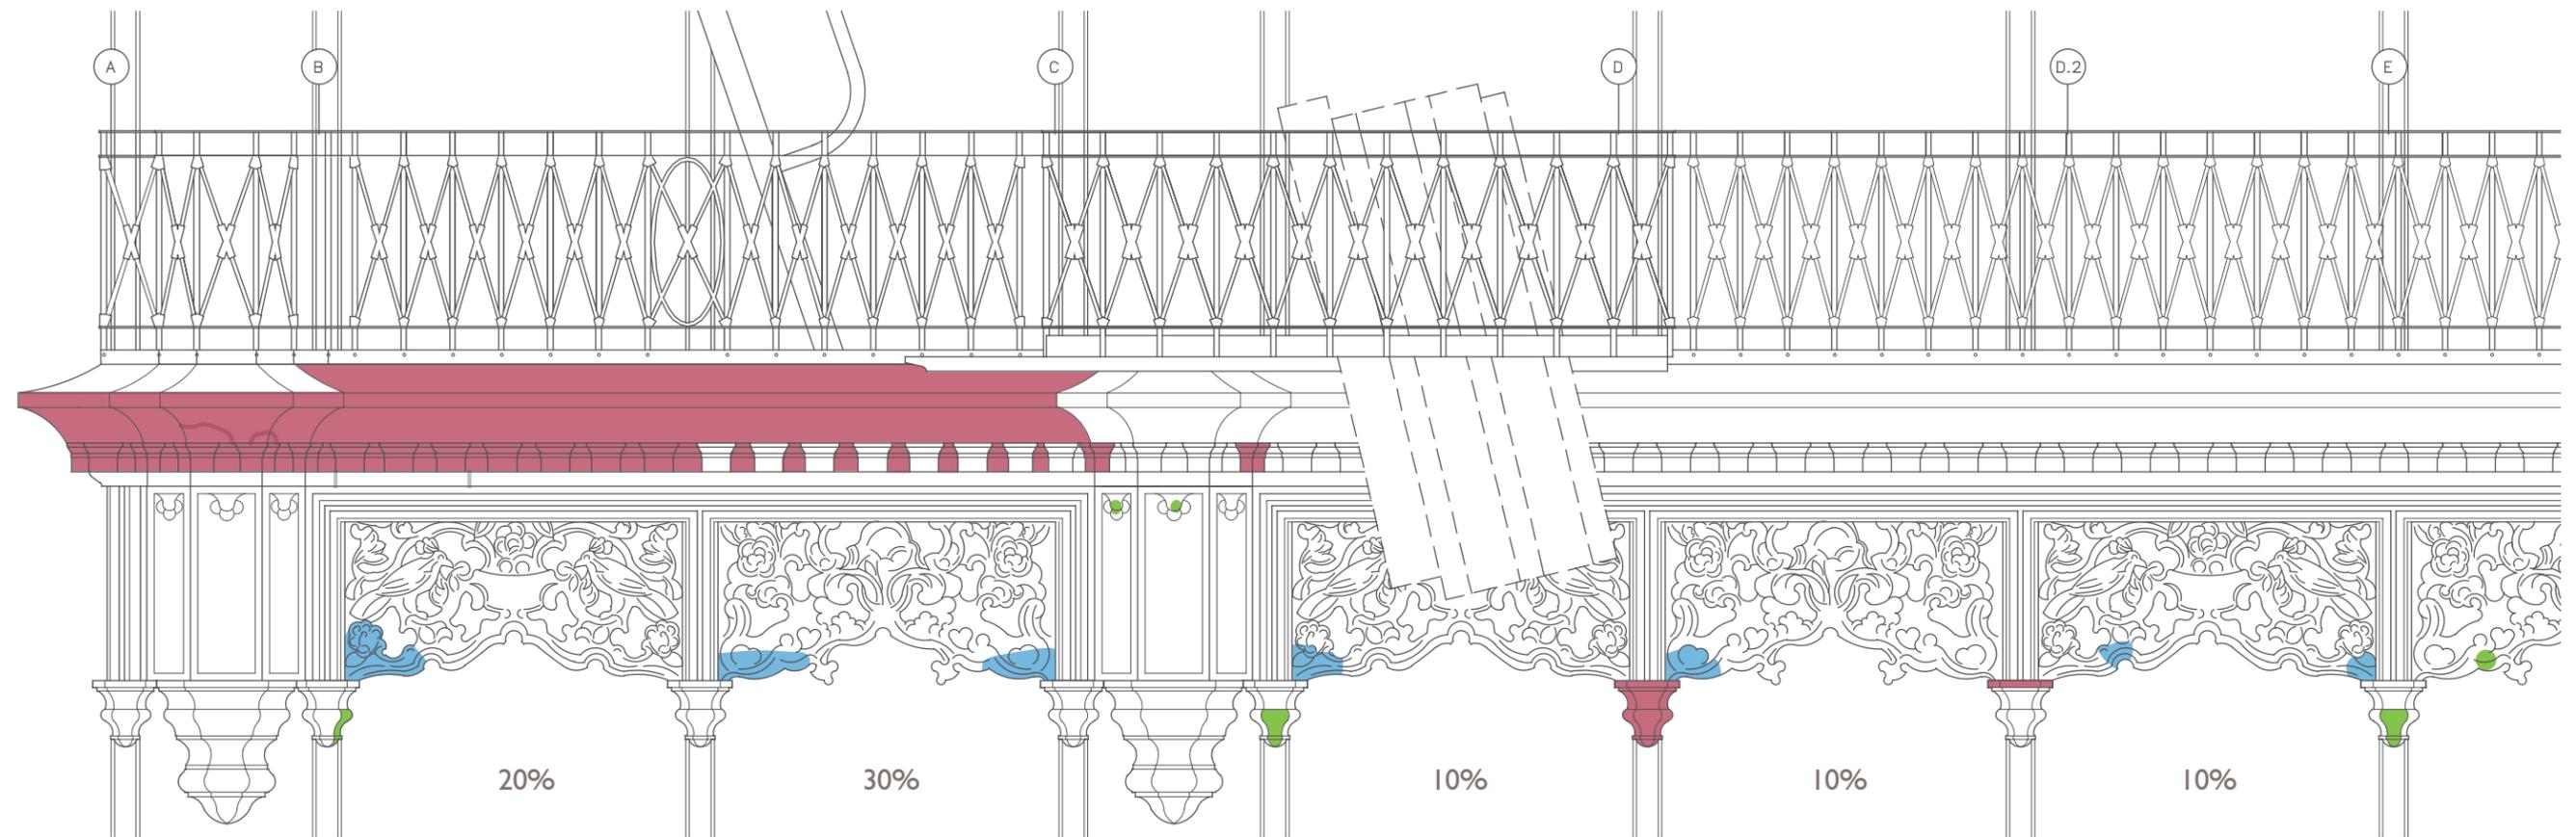
Partial Elevation between Column Lines A through E

The elevation and table below provide an overview of the required and recommended repairs to the sheet metal on the second floor balcony. The elevation has been broken into four sections shown in more detail on the following pages. The information is an estimate based on a survey conducted by Van-Mulder Sheet Metal. Extent of repairs on the third and seventh floors are expected to be similar.

- a. Where 5% or less of the decorative frieze panel is missing, the panel will be patched with 1# lead.
- b. Panels that have between 5% and 50% of the panel missing will be repaired with a fiberglass patch. The patch will be made from molds made from frieze panels that are still intact.
- c. Frieze panels that have 50% or more deterioration will be replaced with full fiberglass panels. The new fiberglass panels will match the historic in detail and size.
- d. Missing frieze panels will also be replaced with fiberglass panels.

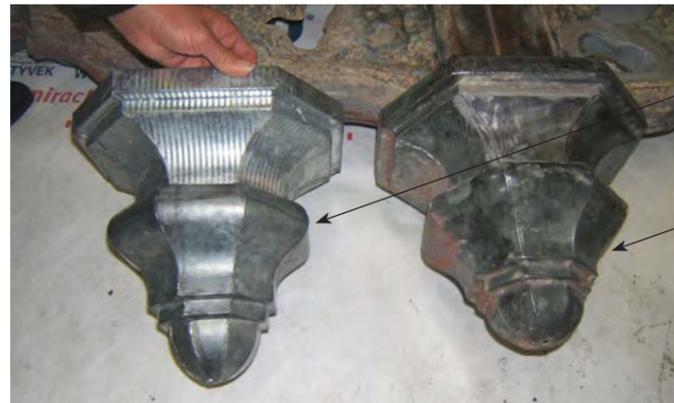
pendant replacement in kind -
note striations in finish

original pendant

- The ornamental sheet metal (cornices, dentils, and pendants) will be cleaned using water, mild detergent, and a brush. Corrosion will be removed through garnet blasting.

- The ornamental sheet metal will be patched and repaired as required. Elements that are deteriorated beyond repair will be replaced in kind. New elements will be attached to the original elements using 1/8" diameter rivets.

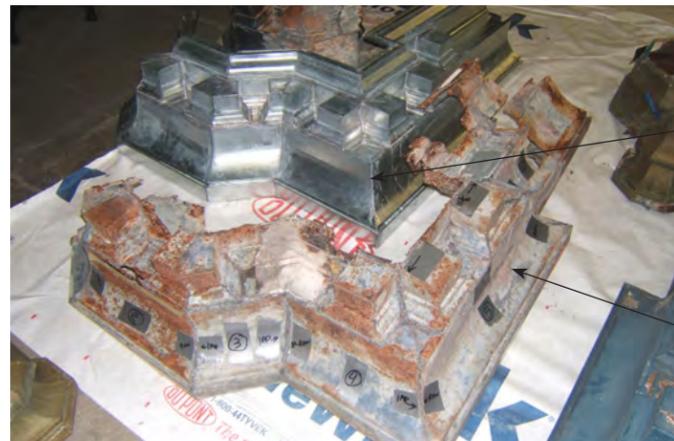
cornice replacement in kind

deteriorated cornice

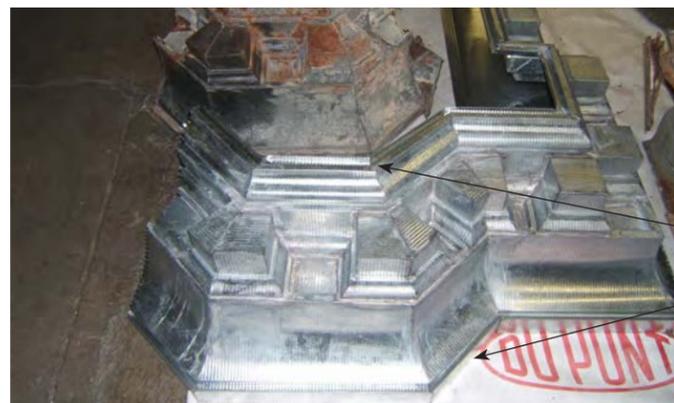
deteriorated cornice

cornice replacement in kind -
note striations in finish

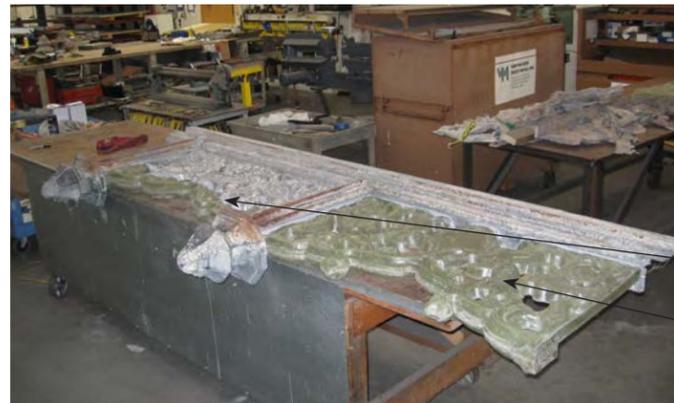
Panels that have between 5% and 50% panel deterioration will be repaired with a fiberglass patch. Two panels were mocked-up.

panel with fiberglass patch

panel replaced entirely with fiberglass patch

- Panels will be patched and repaired as required. Patches representing less than 5% of the panel will be patched with 1# lead using Sikaflex-1a as an adhesive component. Patches representing 5% - 50% of the panel will be patched with a fiberglass patch and attached with Sikaflex-1a and mechanical fasteners.

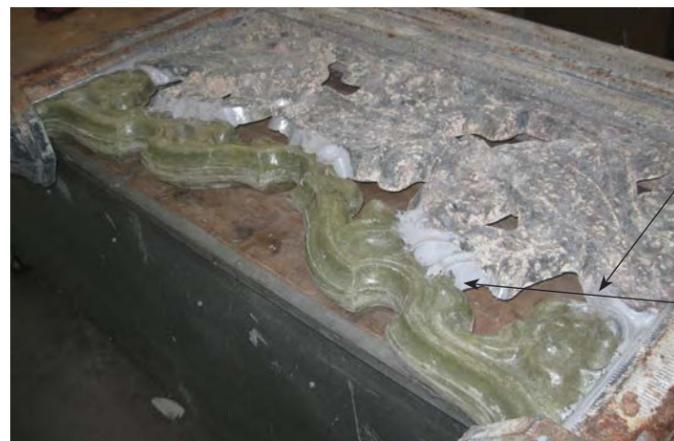
close-up of panel with fiberglass patch

fiberglass patch is attached to zinc panel with standard 1/8" diameter rivets made of zinc plated steel

joint between fiberglass patch and zinc is smoothed out using a polyurethane sealant and feathered out to lessen visibility of joint

- Joints used to tie-in patch materials with existing zinc frieze panels will be sealed using Sikaflex-1a polyurethane sealant.
- Panels with lead repairs will be primed with Tnemec Series 90-97 Tneme-Zinc at 2.5 to 3.5 mils dry film thickness (DFT).

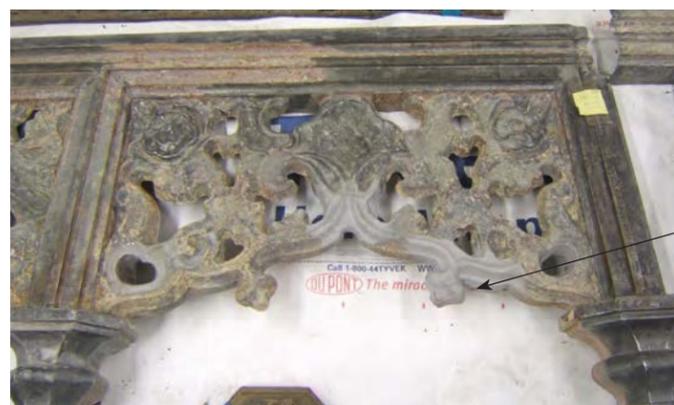
Panels with less than 5% deterioration will be patched with 1 # lead.

1 # lead patch. No mechanical fasteners are required for the lead patches.

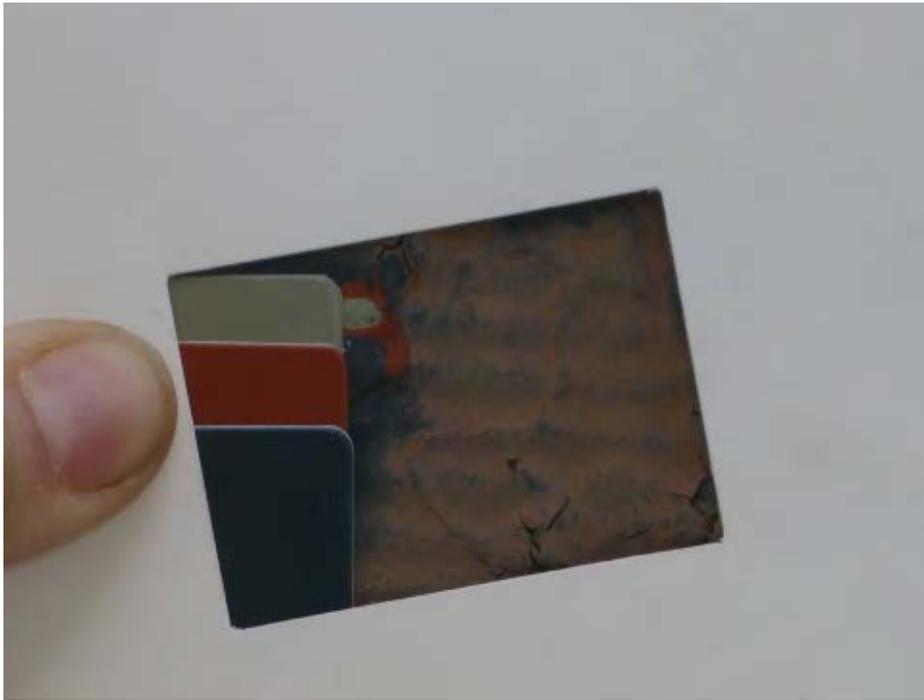
Figure 5: Sample 2 scrapings with matching Munsell colors.

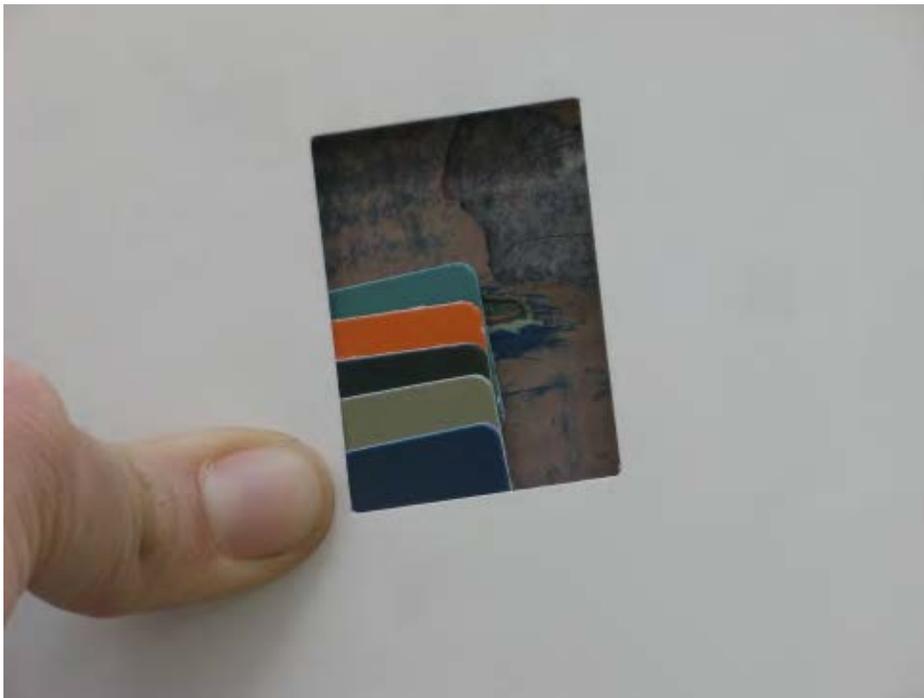
Figure 6: Sample 3 scrapings with matching Munsell colors.

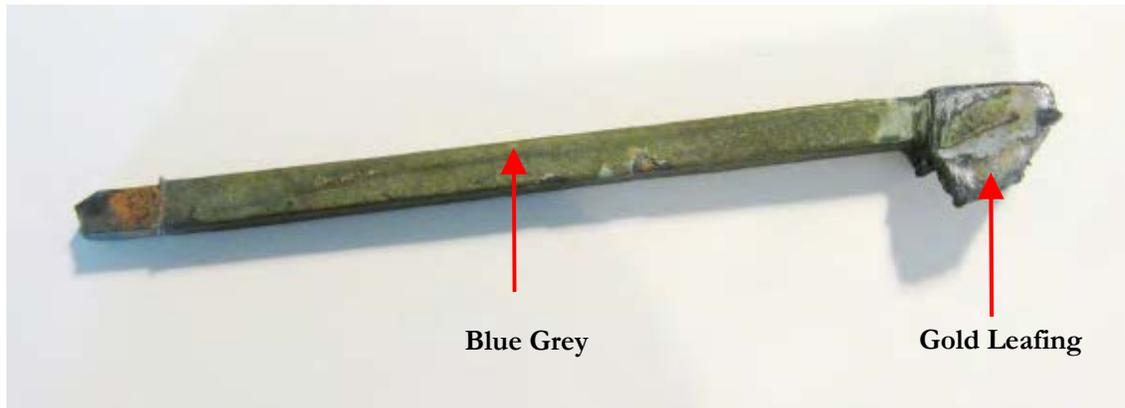
Figure 7: Sample 4, railing spindle.

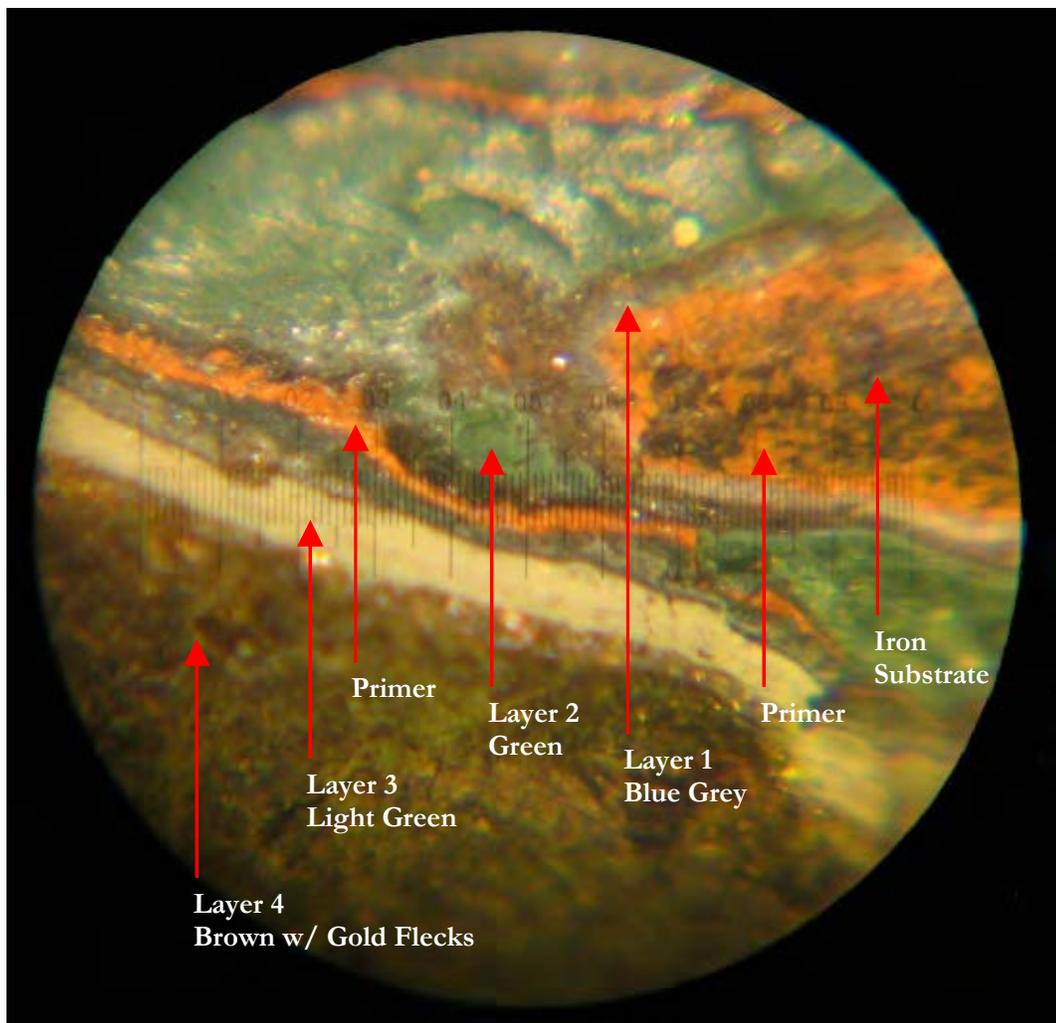
Figure 8: Sample 4 at 50x magnification using Tooke Gage

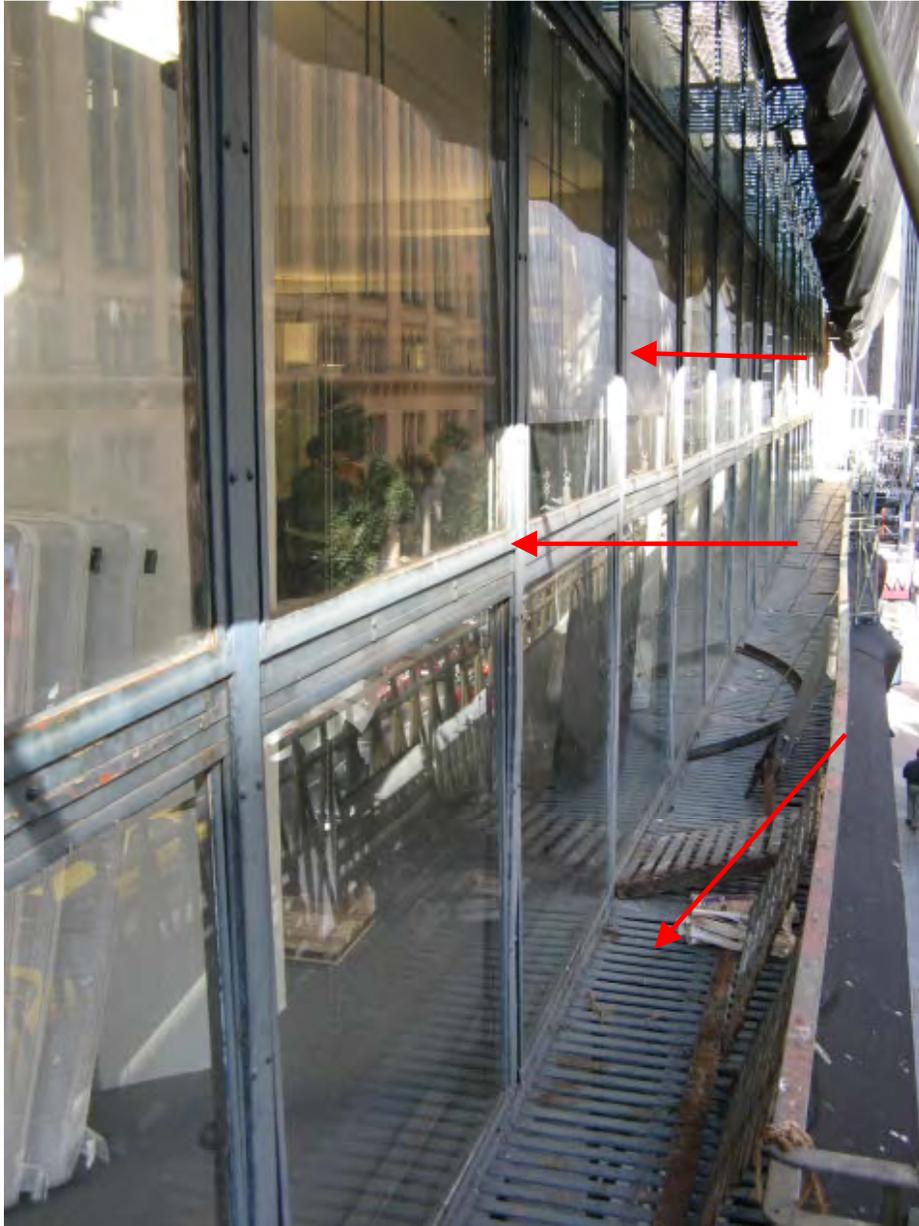
1. Second floor mullions (Figure 1, samples 1-3)
2. Second floor window frames
3. Second floor balcony/fire escape.
4. Section of pressed metal tracery provided by contractor (figure 2).

Figure 1: Hallidie Building, second story balcony. Red arrows denote the location of paint samples taken from mullion, window frame and balcony.

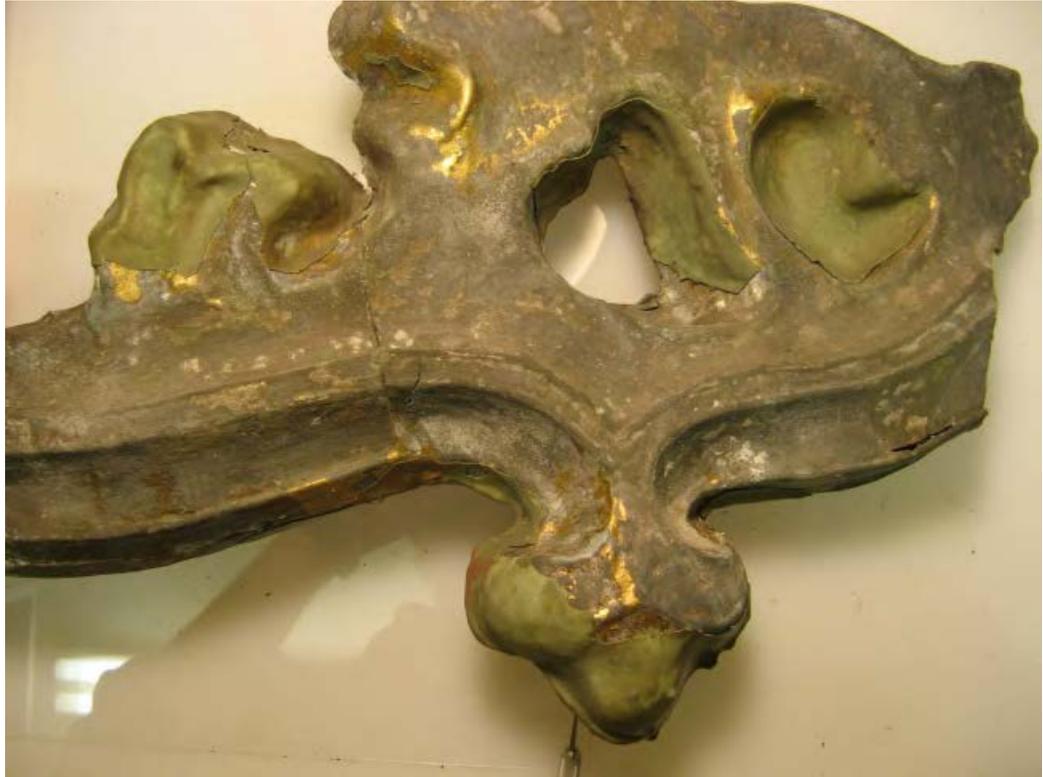
Figure 2: Section of tracery removed from lower (second story) cornice.

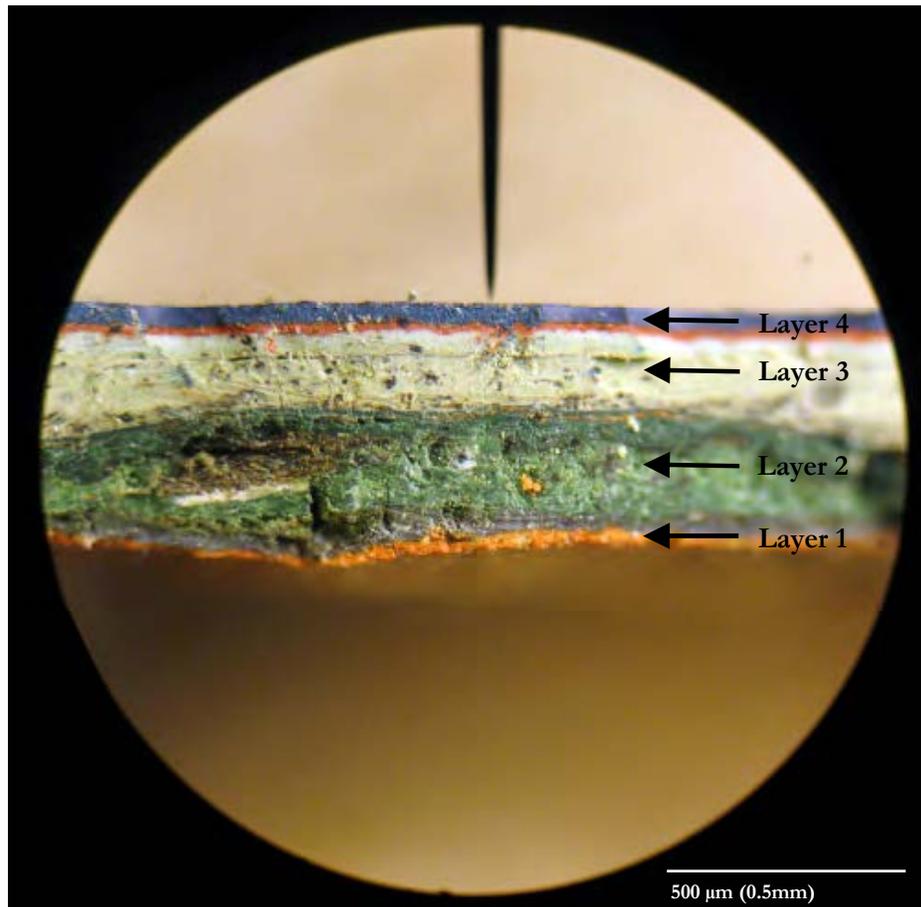
At least four separate paint schemes can be seen on the façade of the Hallidie building. These layers are evident under microscopic magnification at 100X (figure 3). The four distinct layers include:

Figure 3: Cross Section of paint sample from window mullion magnified at 100X, showing at least four paint separate schemes. Black arrows show the earliest blue scheme (at bottom) and present blue scheme (top). Orange layers are corrosion inhibiting primer and were not meant to be seen.

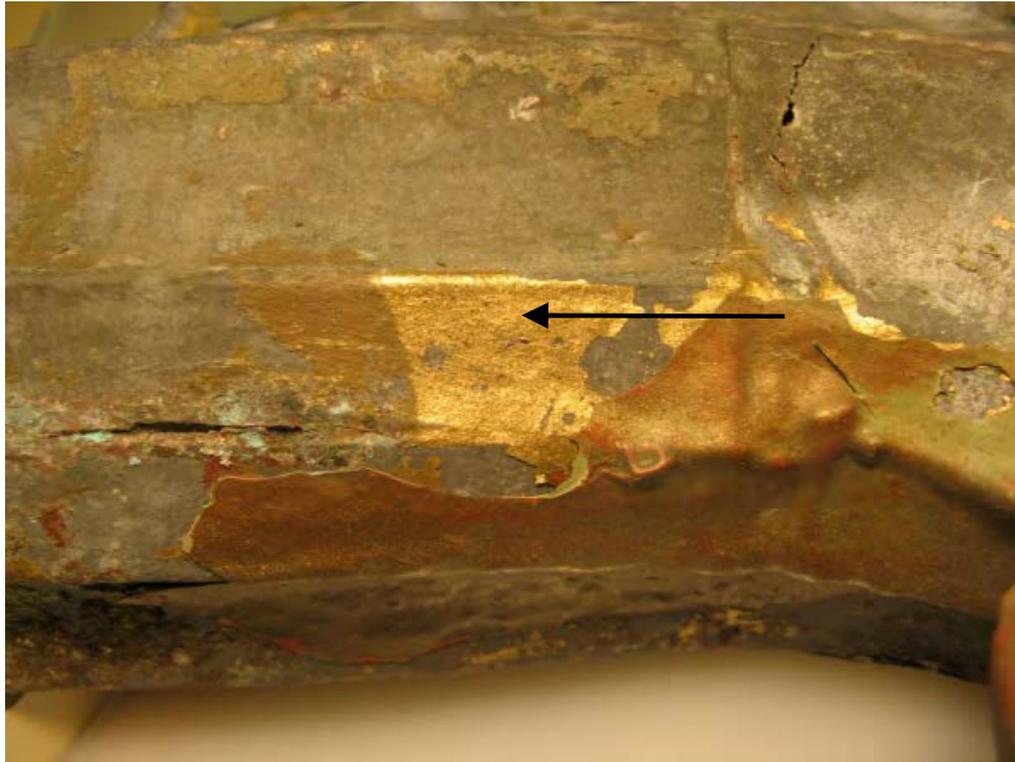
The first paint scheme appears to have been applied over an orange rust-inhibiting primer. Grayish Blue paint was applied on mullions, balconies, and pressed metal cornices that surround the Gothic style tracery. The tracery detailing was gilded with gold leaf (figure 4).

Figure 4: Detail of metal tracery showing historic gold leaf gilding revealed under later paint layers. The gold leaf was applied over a thin red clay bol preparatory layer.

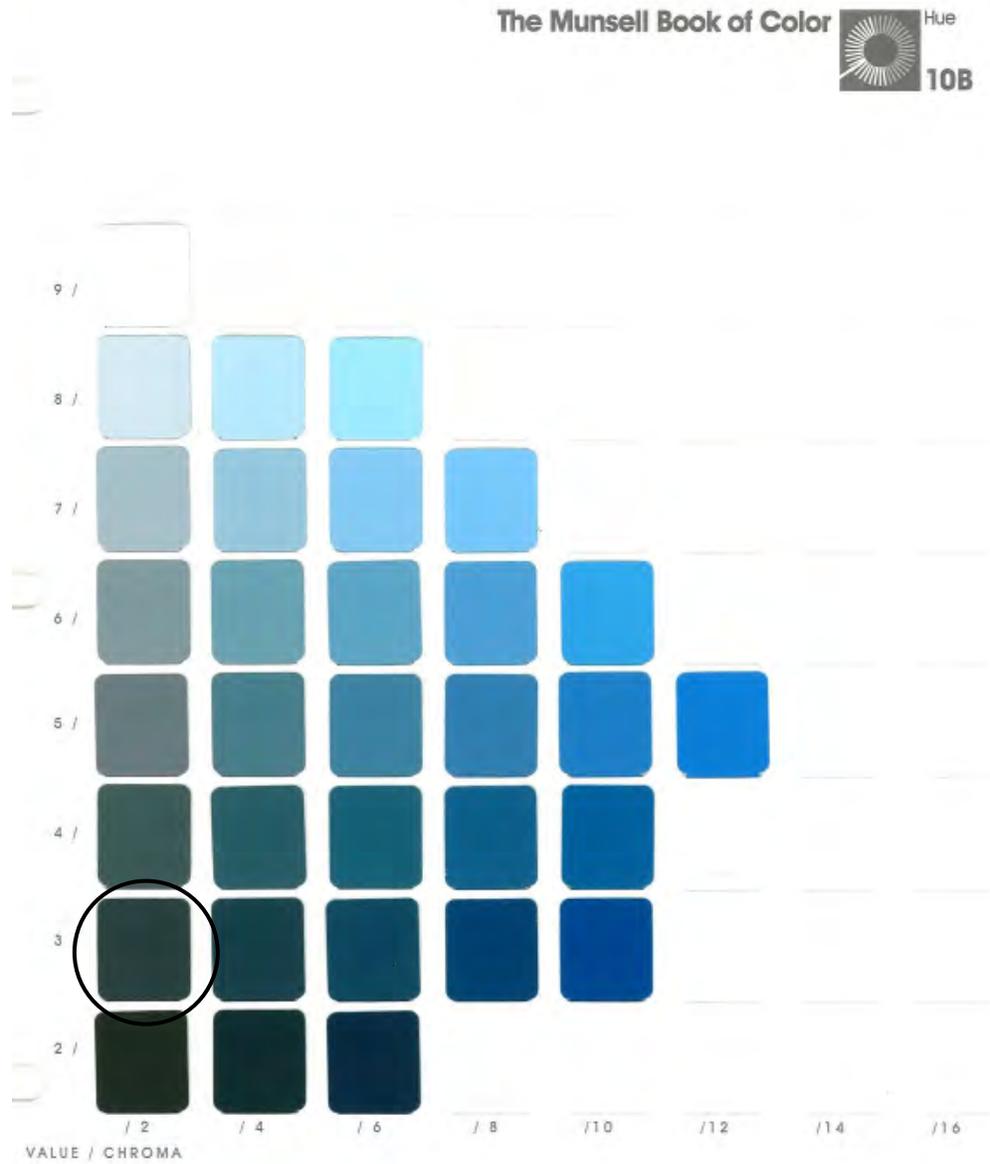
Matching paint colors of the earliest layer was conducted using color balanced lighting and Munsell color chips. The original gold leaf can be matched to current samples of manufacturer’s gold leaf and is best described as standard yellow 24-karat gold leaf. The following chart describes the location, color, and Munsell number of the earliest layer in three test locations (see figure 5 for Munsell chart).

Figure 5: Munsell chart showing match of original blue color (circle). Note: this reproduction is for reference only, exact color chips may be obtained for reproducing color.

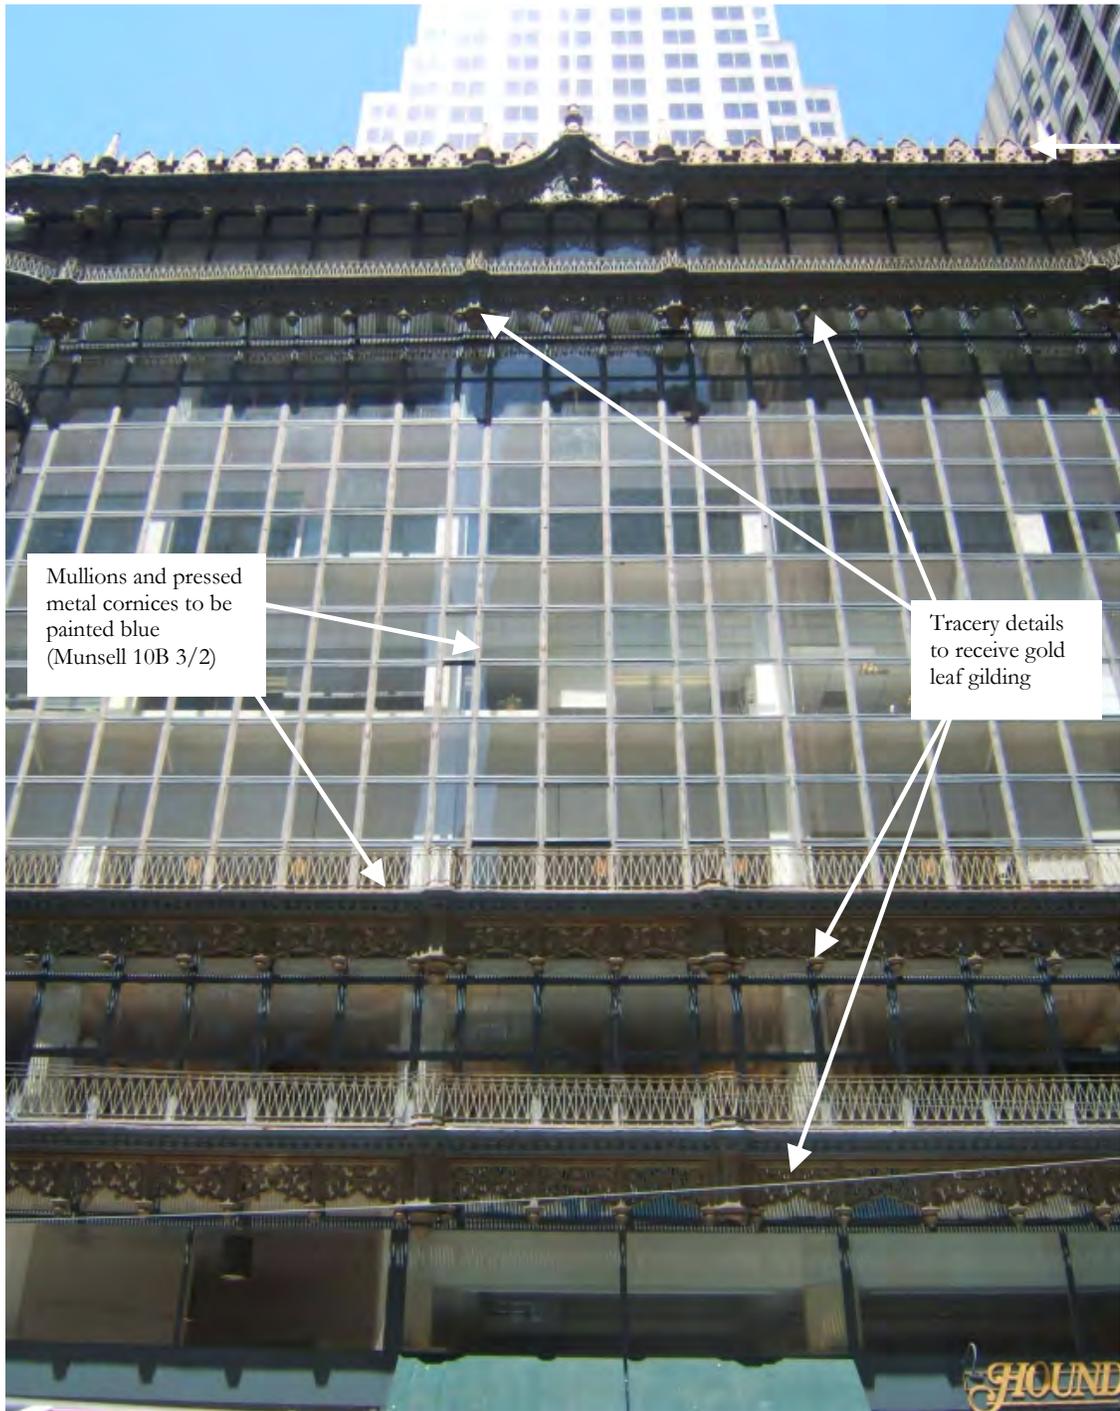
Figure 6: Halladie Building with arrows indicating areas to receive blue paint including mullions and pressed metal cornice, and Gothic style tracery area to be gilded.

Additionally, historical documentation states that the building was original painted blue and gold. Page & Turnbull recommends reproducing the original blue color and gilded tracery color scheme. Figure 6 notes the location of areas to receive gold leaf or other gilding, and those that should be painted blue. True gold leaf is recommended because of its durability in outdoor environments. Page & Turnbull’s findings should be confirmed at other locations on the building and all paints or decorative finishes should be field tested before application.
