Discretionary Review Analysis Residential Demolition/New Construction

Date: May 3, 2012
Case No.: 2010.0636D / 2012.0259D
Project Address: 622 – 27TH AVENUE
Zoning: RH-2 (Residential House, Two-Family) District
 40-X Height and Bulk District
Block/Lot: 1569/031
Project Sponsor: Wah Wong
 622 – 27th Avenue
 San Francisco, CA 94121
Staff Contact: Glenn Cabreros – (415) 588-6169
glenn.cabreros@sfgov.org
Recommendation: **Do not take DR and approve demolition and new construction as proposed.**

The project is to demolish an existing three-story, single-family residence and to construct a new four-story, two-unit building.

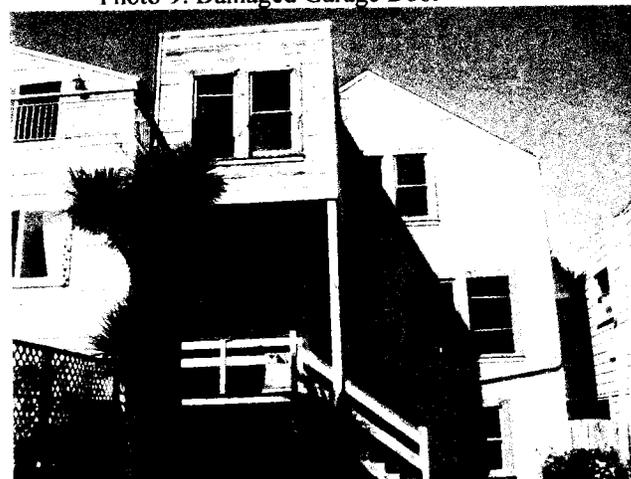
Photo 11: Rear View of Building

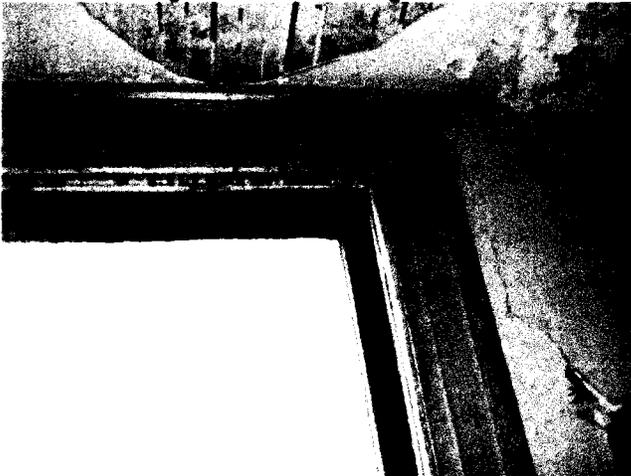
Photo 51: Wood Decay at Kitchen Window

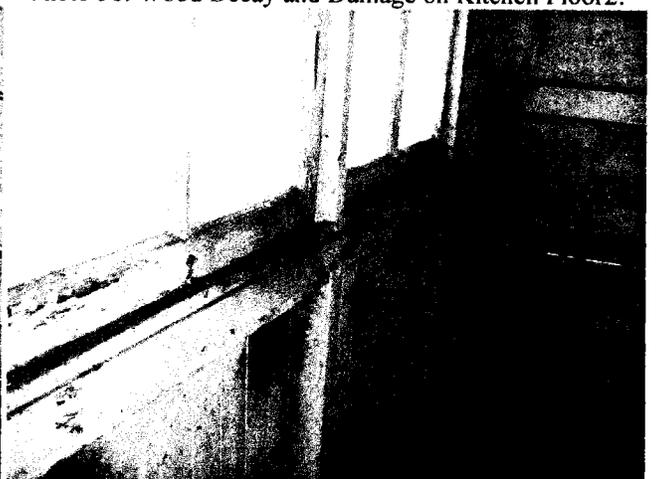
Photo 58: Questionable Framing at Laundry
